Lessons learned from dam construction in Patagonia Argentina

Oscar A. Vardé^{1, #}

Lecture

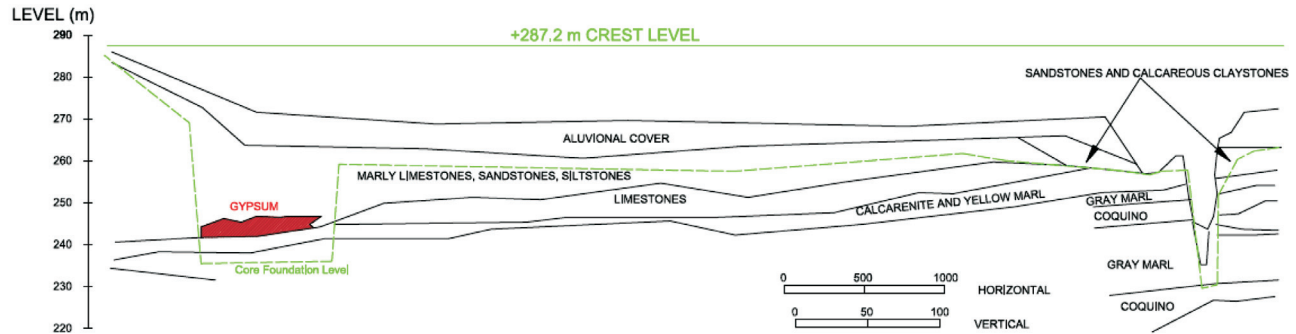
Foundations are mostly marine deposits of upper Cretaceous and Lower Tertiary, including marls, claystone, fossiliferous and coquina, and limestones (Figure 5).

Figure 5. Longitudinal profile, showing location of the gypsum stratum.

The program allowed to determine the extension of the karstic gypsum bed, 20 m deep 5 m thick, which lies over the pervious calcarenite and underneath the red claystones. The test excavation had a defining impact on the scheduling of subsequent tasks. Pumping tests were carried out and blasting test allowed the selection of the excavation method.

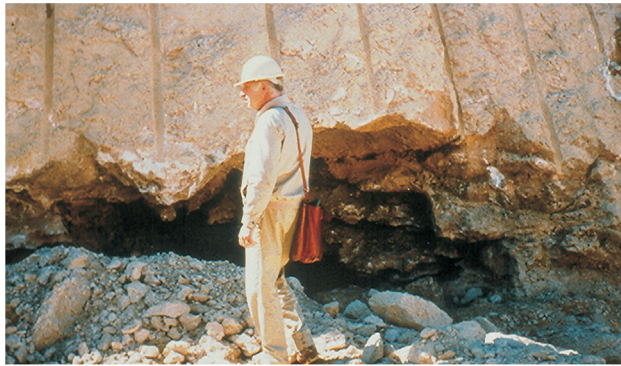
Unfavorable geological features were detected during work dam foundations, consisting of caverns (Figure 6) and dissolution channels through massive gypsum below a zone of the left bank, with a length of 800 m, between stations 700-1500 m, (Vardé, 1986; Vardé et al., 1990; Etcheon & Speziale, 1989). The impact in the project construction and the total costs were very significant. The investigation of the problem was initiated because of a fortuitous event. The presence of a saline paleo layer prevented the setting of the concrete from a cut-off in that sector. The noticeable presence of gypsum, the loss of injection water in the boreholes and the fall of tools detected

Figure 6. Karst cavern.

the cavities. It was possible to define the extent of the anomaly and also rule out the existence of karst formations outside the delimited area.

Several alternatives were considered for the foundation treatment of the affected zone, and a big excavation of about 2.000.000 m³ was adopted to remove all the potential karstic materials in the core, filters and part of the shell foundation. The treatment through injections and the partial removal by sectors was evaluated. Finally, due to the associated uncertainties, the total excavation of the area affected by karsting was decided.

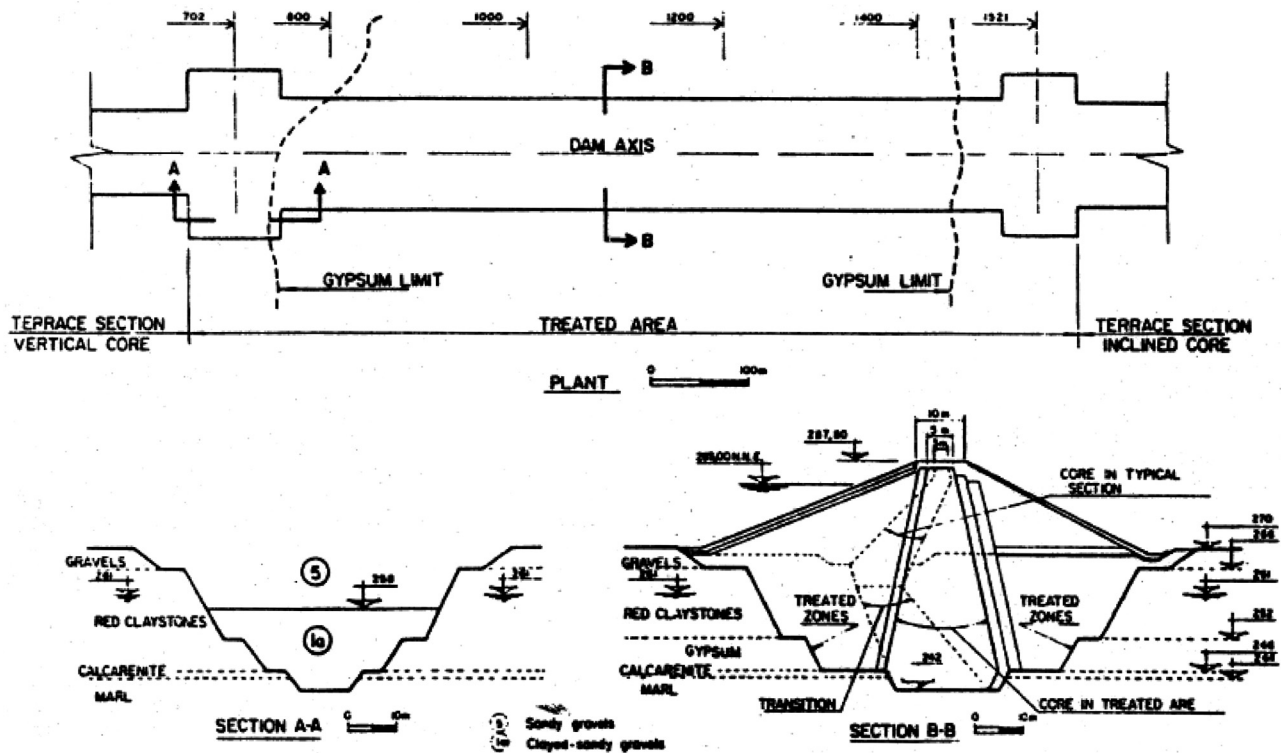
Figure 7. Casa de Piedra - Adopted Solution S700-S1500.

The central excavation was complemented by two symmetrical trenches, normal to dam axis, 86 m long, founded in the gray marls and filled with core material, to avoid potential short seepage paths through the more pervious materials (Figure 7). In situ permeability tests and numerical modeling were made to check critical hydraulic gradients and piping potential.

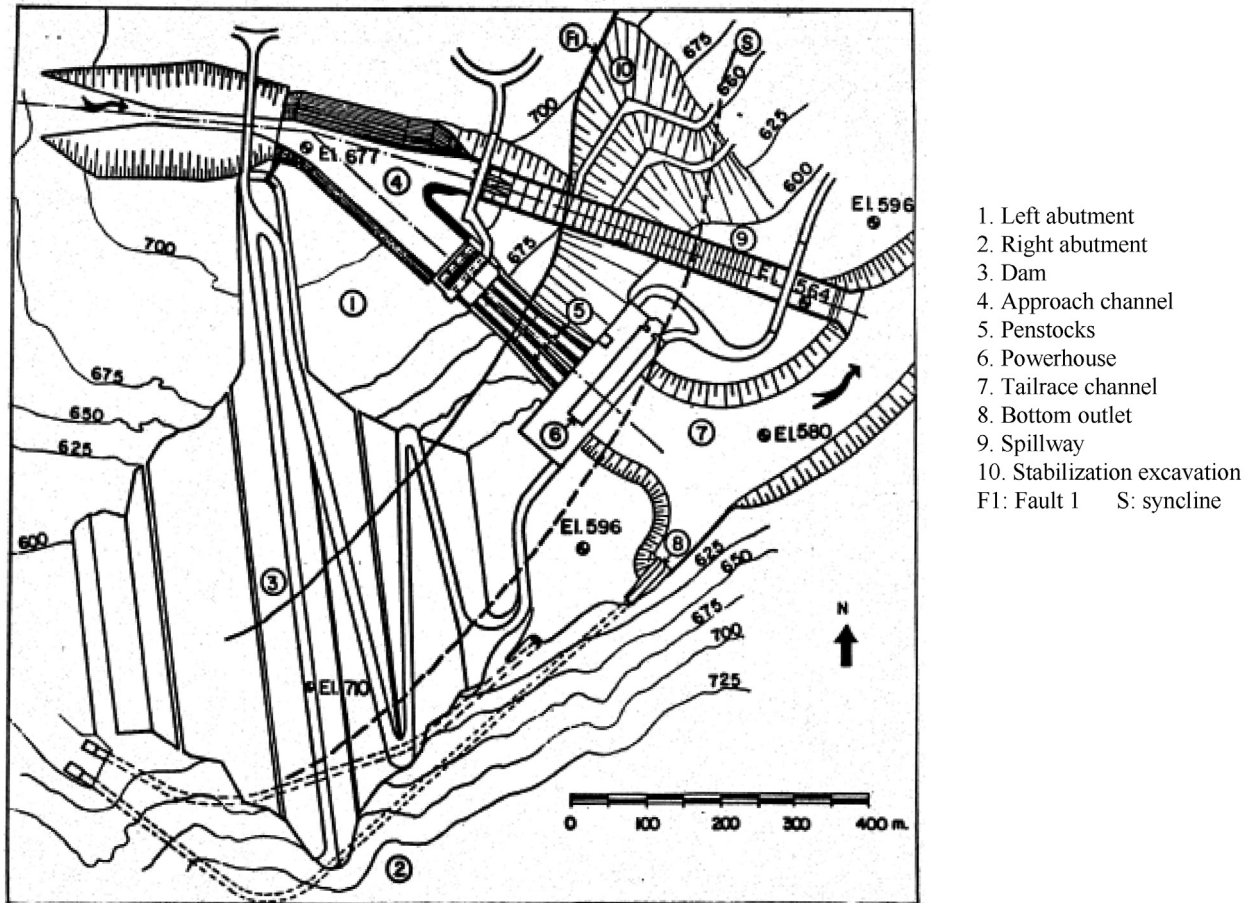
The bedrock of the project area consists of a succession of psammitic (sandstone) and pelitic (mostly mudstone and siltstone, some claystone) rocks of Liassic (Lower Jurassic) age. Planar sedimentary structures do not persist over any considerable distance and individual sandstone or pelitic layers cannot be correlated between drillholes and outcrops, affected by neotectonics movements (Vardé et al., 1986). The bedding interfaces are the dominant structural element in the bedrock, being in general horizontal with some very gentle folding. A major fault, denominated fault 1, running roughly NNE to SSW and dipping steeply SE intersects the penstock trench and spillway chute downslope of the corresponding intake structures (Figure 9 and Figure 10).

At the downhill side of the fault, in the penstock, as well as in the spillway area, the bedding of the rock abruptly changes to a dip of 20 to 38° SE to E, i.e. parallel to the slope (Figure 11). The existence of the zone of inclined bedding on the left bank was not known at the initial design stage, when the investigation was based mainly on geological mapping of outcrops and 8.000 meters of rotary drilling borings size NX. The inclined bedding was subsequently encountered in trench excavations in the area of penstocks

Figure 9. General layout - Fault alignments.

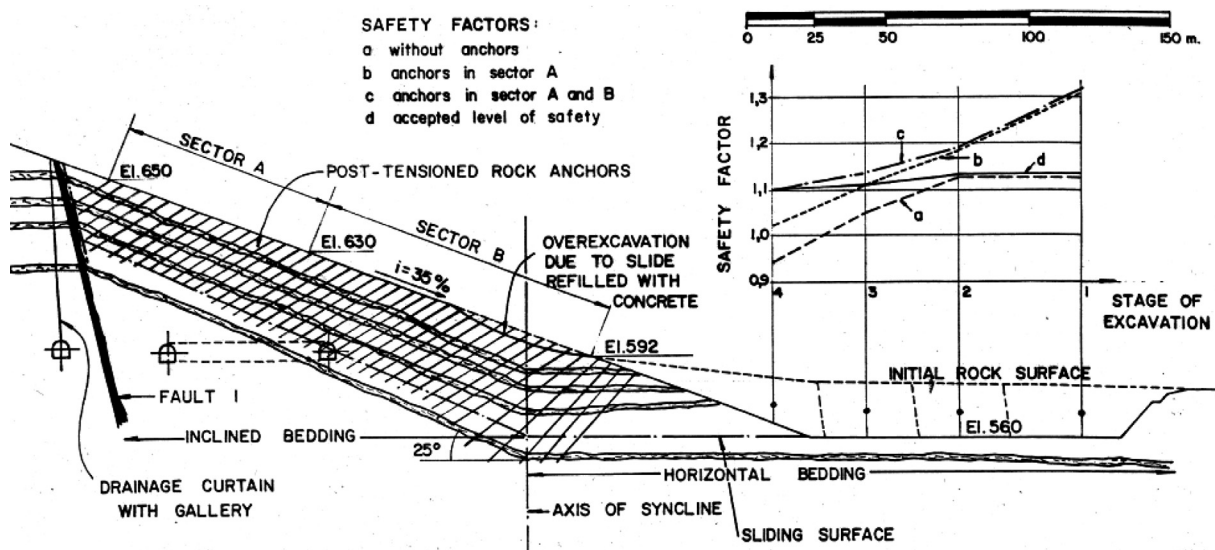
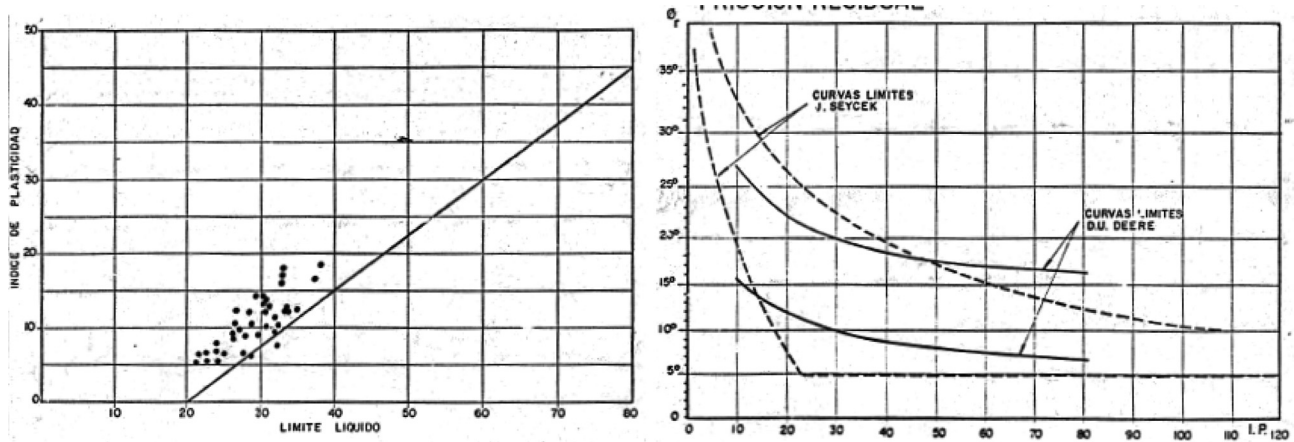
The residual friction angles are plotted against the corresponding range of plasticity indices in Figure 12, where the empirical boundary curves proposed by Deere and Seycek, respectively are indicated.

It can be observed that the values obtained by direct shear tests are lower than those by triaxial tests and rather close to the lower boundary. The direct shear test in this case is the most appropriate procedure due to the possibility of orienting the samples and allows greater deformations of the specimens, including repeated and reverse cutting stages to reach the residual condition.

Figure 12. Plasticity chart showing results from sheared pelite; Deere and Seycek curves relating plasticity index and the residual friction angle.

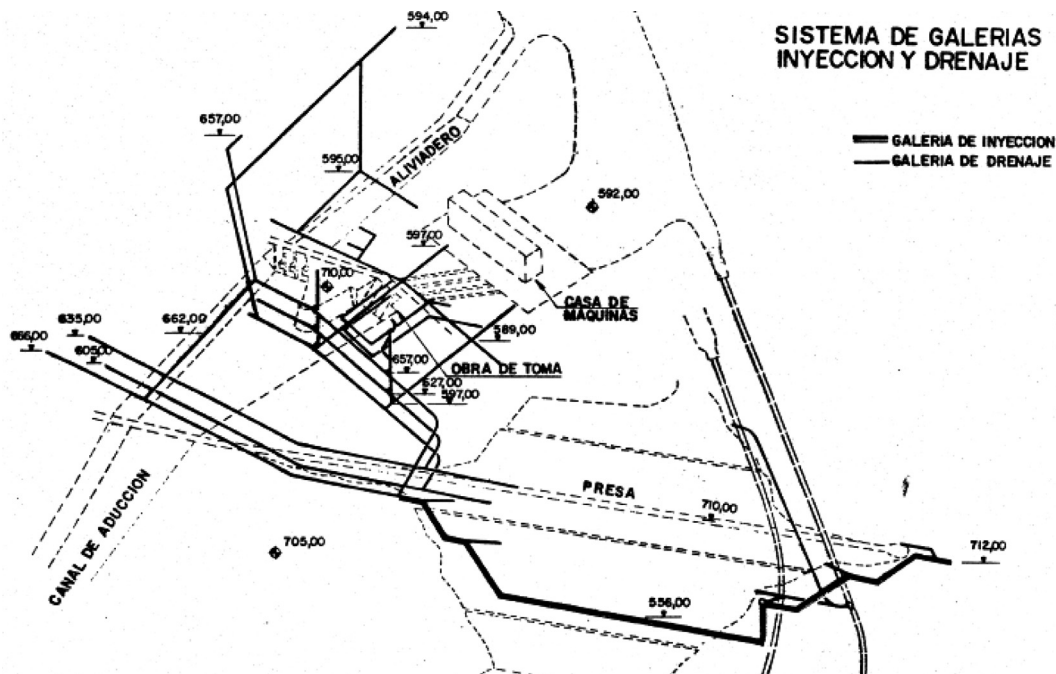
Figure 13. Drainage system on the left abutment.

The stability of the left bank had to be improved by an extensive drainage system, shear keys and post-tensioned rock anchors (Andersson et al., 1985). These included 5.500 m of drainage galleries with 35.000 m of drain holes to form 150.000 m² of drainage curtain, a 1360 m long grouting gallery and 65.000 m³ of grout curtain (Figure 13).

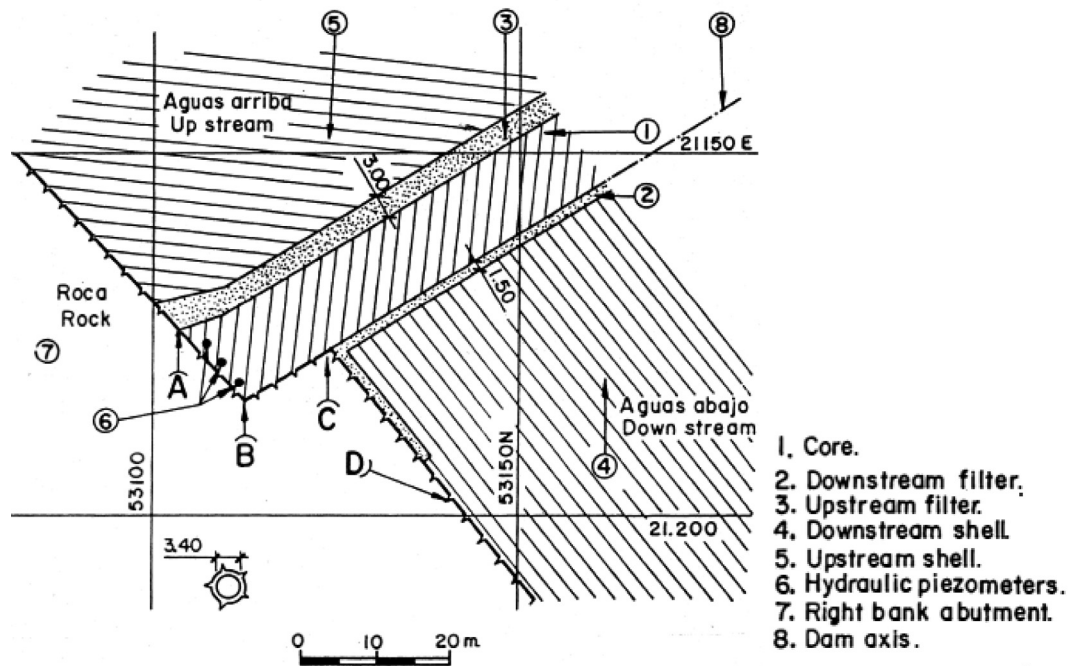
A shaft in the rock, 107 m deep and three galleries at elevations of 346, 308 and 282 m were constructed to permit remedial grouting and drainage treatment of the rock abutment in the zone adjacent to the rock-core contact. The core is founded at the right bank in a cut off trench. A horizontal section of the abutment core-rock contact at El. 357 m is shown in Figure 18.

The first few holes drilled towards the contact face AB revealed worse conditions that had been anticipated. A number of rack joints near the contact were found to be open and full of water at hydraulic pressures near reservoir level. The core when contacted was found in some cases to be either in a near fluid state or with very low consistency. The samples were recovered using special procedures.

Figure 18. Horizontal cross section at elevation 357.

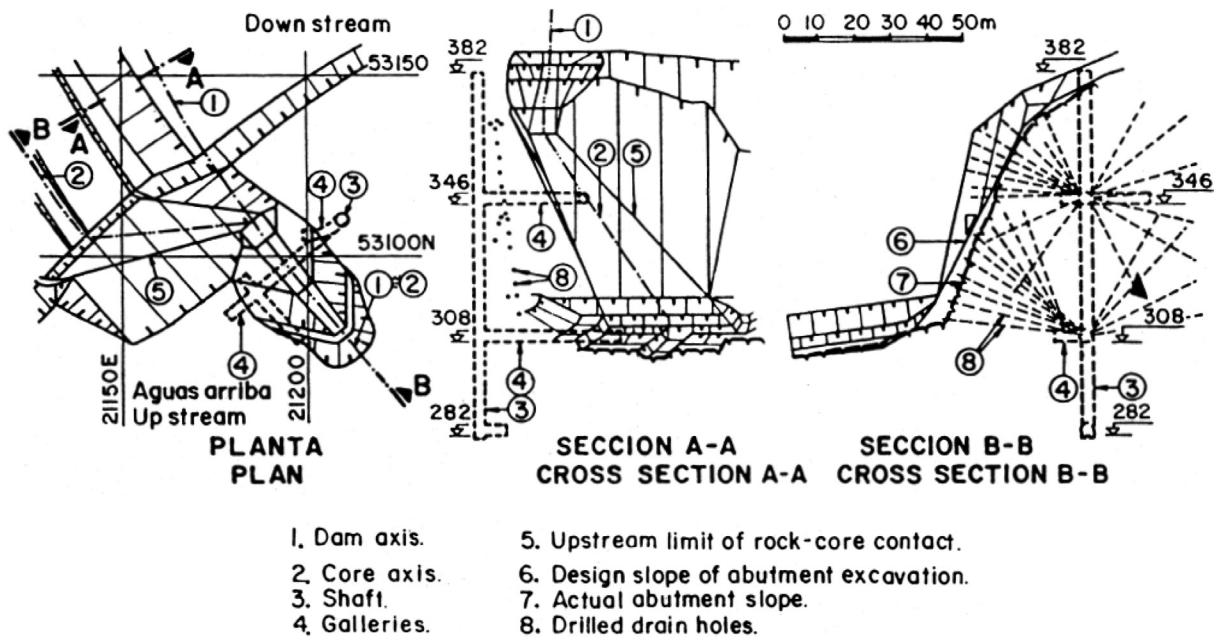
Figure 19. Layout of right abutment shaft and galleries.

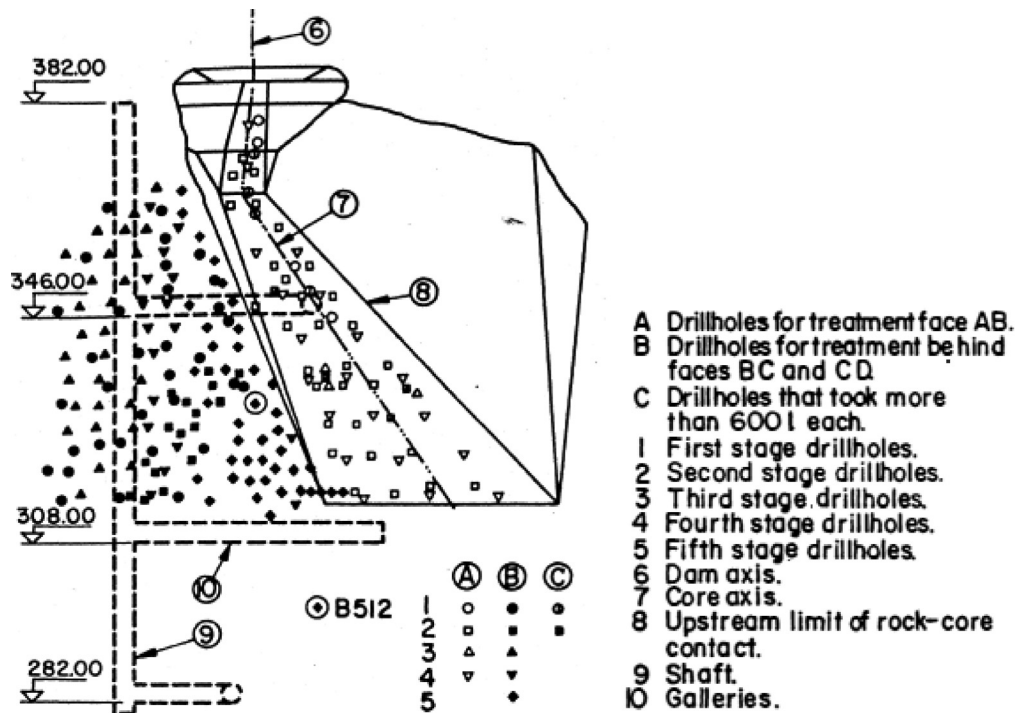
It was concluded from the observation of the rock cores of drill holes that the rock near the contact was highly

fractured due probable to stress relief and to blasting effects. Hydraulic piezometers located in the core adjacent to the steep abutment rock, 1 to 4 horizontal-vertical provided a way to assess the state of stress in the core. These tests show that with a reservoir level at El 369 m there was zero effective stress at the rock-contact above El 357 m. These data confirm that a crack existed within the core close to the steep abutment, cause by differential settlement and arch-

Figure 20. Drillholes for right abutment treatment.

ing between the core and the rock face. An additional drainage system of the rock mass downstream of the BC rock-core contact face was installed. A second stage of grouting operations of the core-rock contact using a pressure controlled system. Grout takes up to 10,000 l per hole were recorded at El 340 m. Core samples containing hardened grout were recovered during the grouting program provided evidence of core cracking. Exploratory holes confirmed using impression packers showed open joints up to 2 cm wide.

The fissures, subvertical and parallel to the river valley, are attributed to stress relief in the recent geological past due to valley erosion and possibly widened by blasting during construction. This condition, considered critical to the dam soundness and its safety and remedial grouting and the drilling a new drainage system was programmed in several stages.

with a relative cohesion 0.4 to 0.3 mm as defined by Lombardi (1969), to avoid the risk of hydraulic fracturing of the core. The volume of grouting resulted in about 53 m³ at face AB, in 4 stages, and about 60,000 m³ at face CD, in 5 stages. Total volume injected was more than 100 m³, sealing the rock mass open joint system and the cracks existing in the core.

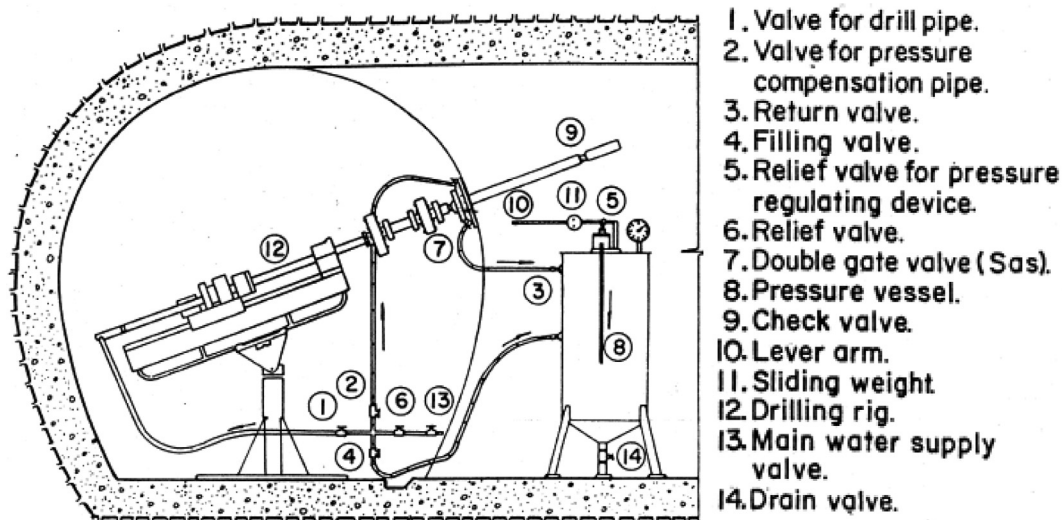
Figure 21. Gallery working station.

All drilling and grouting done afterwards using a double gate system (SAS, Figures 21 and 22), and a pressure

regulation device (PRD), mounted at each borehole mouth. This system permits maintaining the pressure inside the hole equal or larger than the reservoir pressure to eliminate the danger of piping through the drillholes. More details of the special techniques used to treat the abutment of El Chocon can be found in Aisiks et al. (1991b).

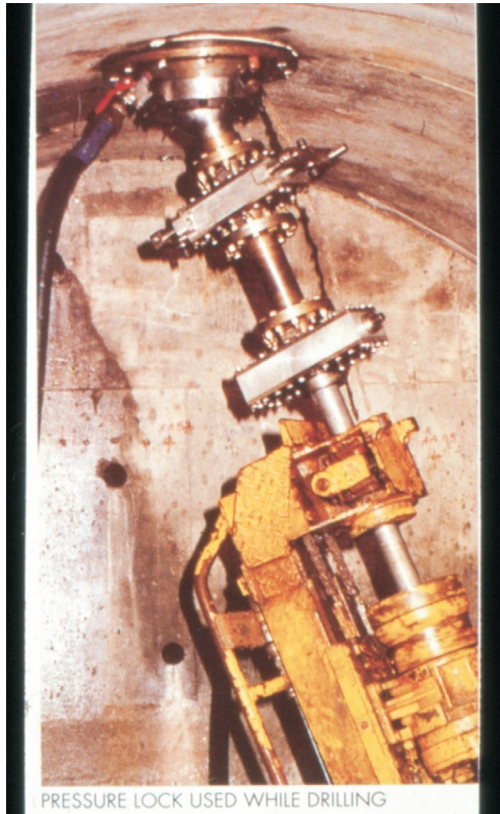
Figure 22. Double gate valve (#7 in Figure 21).
