# Grouting of TBM Rock Tunnel for the Pinalito Hydroelectric Plant, Dominican Republic

Marcos Eduardo Hartwig

**Abstract.** The Pinalito main hydroelectric tunnel, with a length of 11 km, is located in Cordillera Central mountain range, Dominican Republic. This mountain tunnel has been mined through extremely fractured andesitic-basaltic and rhyolitic tuffs. These rocks are been subjected to shear and collisional displacements between Caribbean and North America plates since middle Eocene. As a result, geological and hydrogeological conditions along the tunnel alignment are rather complicated. This paper presents the main aspects and results employed in order to overcome an unexpected water bearing incompetent rock zone, approximately eleven meters wide, that cross the tunnel alignment at Sta. 5+237.40. Ground treatment was well succeeded and took six months to be concluded. Procedures adopted took into account three steps, respectively: (1) geological drilling; (2) drainage; and (3) spilling and grouting injections.

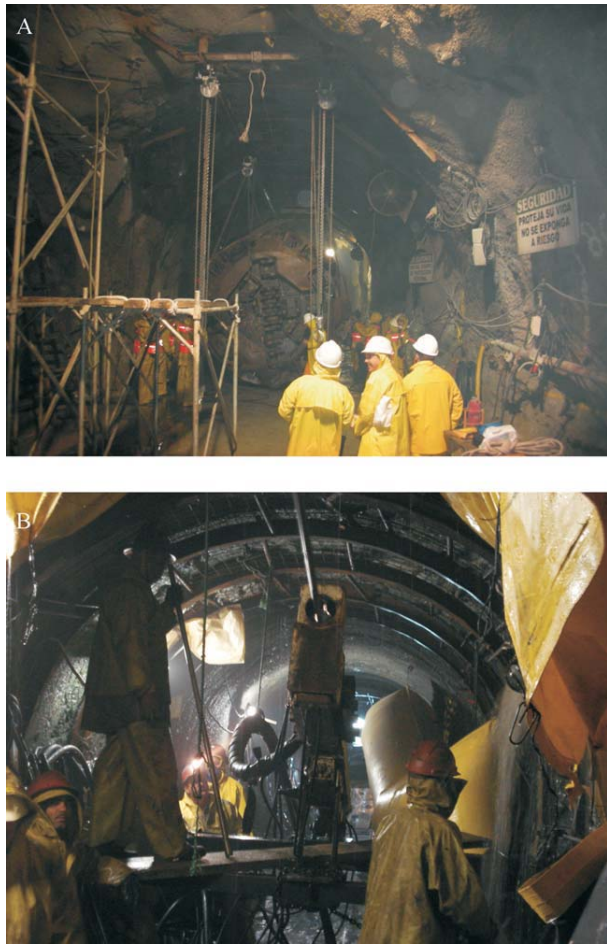
The Pinalito main hydroelectric tunnel has been mined by a Robbins open TBM built in 1981 and refurbished in 1983. It has 3.66 m of diameter and contains four electrical motors with 300 horse power each of it (Fig. 5A). The machine was not designed to operate through terrains with high groundwater flow, and does not present any pre-treatment capabilities inside, such as probe drilling and

**Figure 5** - A – TBM being disassembled (front view); B – External rock drilling adapted to operate during TBM entrapment.

geophysics. For this reason, it was adapted an external rock drilling as showed in Fig. 5B.

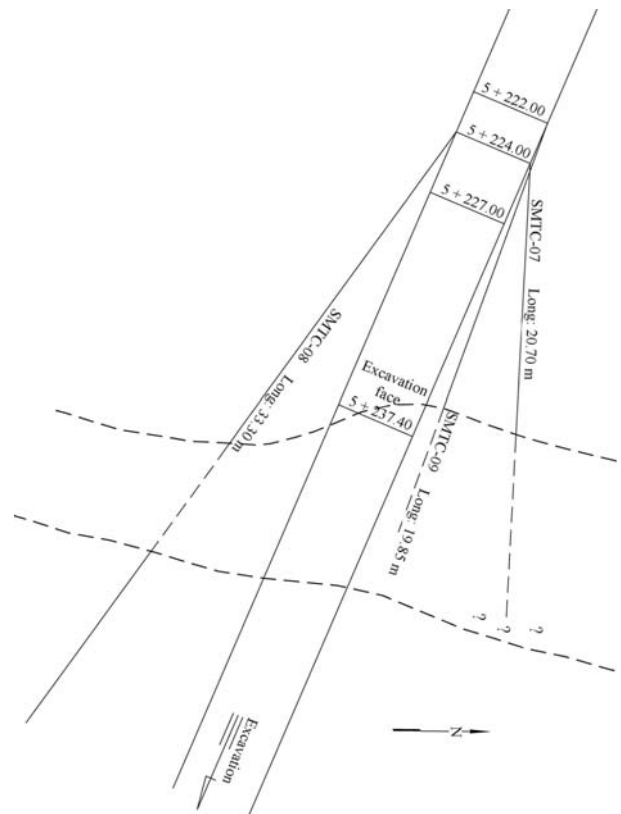
Horizontal geological drills were performed in order to investigate characteristics of the incompetent zone, like extent, direction and material contents. Basically it showed up a heterogeneous irregular-shaped incompetent zone of nearly N-S trending, with approximately eleven meters wide (Fig. 6). This zone cross the tunnel alignment at Sta.

5+237.40, and is mainly made of highly jointed andesitic tuff cut by minor clay and epidote-bearing faults.

**Figure 6** - Plain view of geological drills performed through the water fault zone (dash dot lines), Sta. 5+237.40 m. RQD = Rock Quality Designation.

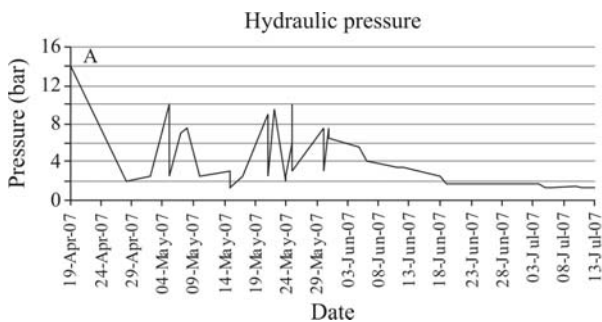
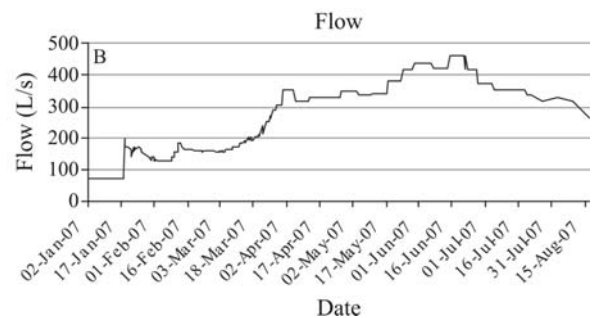
geological drills (see Fig. 6). After a period of four months groundwater pressure decreased significantly, in contrast, groundwater influx was continuously growing until its highest value (~460 L/s) in the beginning of July (Fig. 7).

**Figure 7** - Groundwater parameters: (A) hydraulic pressure (in bars); and (B) total groundwater flow (L/s). Parameters show opposite trend with time.

In order to relieve groundwater pressure, it was drilled fifty two drains at different locations comprising a half cone-like roof. The amount of it is concentrated in the hydraulic left sidewall of the tunnel alignment, a region where the incompetent zone seems to be wider according to

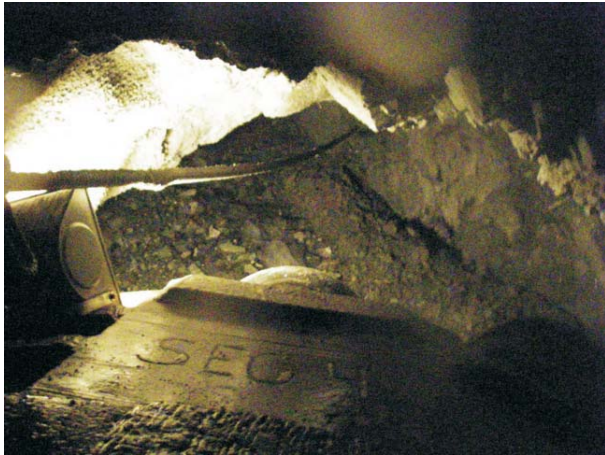
Once the machine was free, it was observed a meaningful change of the groundwater flux in the excavation face, subsequently, was observed a sudden rock collapse that filled almost 70% of the released area ahead of the TBM (Fig. 8). In order to overcome it and carry on the excavation, collapsed material must be treated before consolidating the fault zone. The method found in order to stabilize the col-

**Figure 8** - Photo taken from the upper portion of the TBM head. It shows the ground condition ahead of the TBM after sudden rock collapse. Note fault content occupying almost 70% of the released area and a hanged spilling bar previously drilled through the fault zone.

lapsed material was to set thirty one pipes of 1/2 and 2" of diameter straight into the collapsed material. All pipes were previously pierced with small holes in order to permit resin and cement slurries get into the collapsed material. Initially, it was made an attempt to injected 5.1 ton of cement/microcement slurries with different mixtures (water/cement) combined to additives; however, all of it ran away under the TBM, showing that groundwater was still present. Consequently, was performed the injection of 5.1 ton of polyurethane resin through the pipes until the absolute refuse of the rock mass by high pressure or inflow

into the tunnel. Additionally, was drilled more twenty five spilling bars before consolidation of the fault zone get started. These consumed 3.4 ton of polyurethane resin and 1.6 ton of cement/microcement slurries.

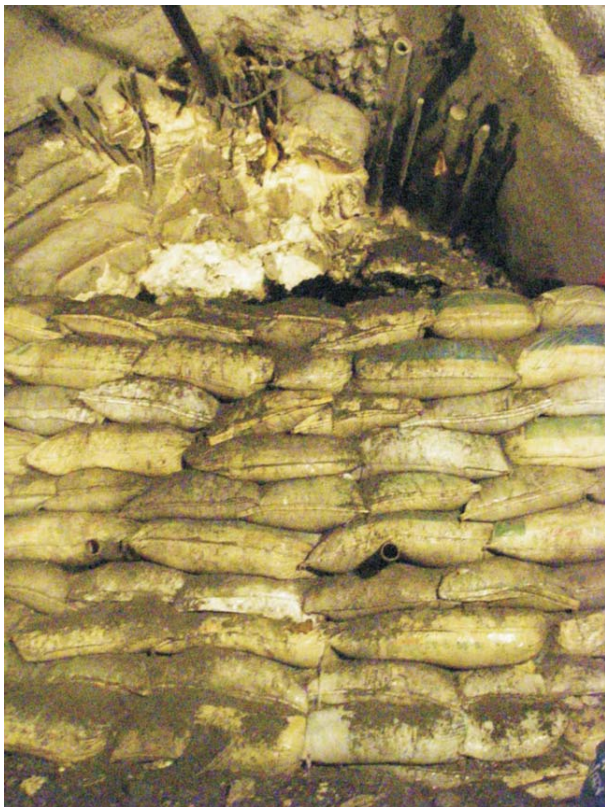
**Figure 9** - Wall of injection built at Sta. 5+237.40 m, in the Pinalito rock Tunnel. Note in the roof area, part of tubes/spilling bars previously drilled and remnants of polyurethane foam.

Once the collapsed material was stabilized, the TBM was pulled back nearly three and a half meters and treatment of the fault zone could proceed. In order to increase efficiency of consolidation treatment, was opted to build two walls through the fault zone, not exactly the same, separated approximately of five meters, comprising 3.66 m of diameter and 1.0 m of wide, made of cement bags and shotcrete (Fig. 9). The walls comprise horizontal and parallel lines with holes of injection through the fault zone and drains in its base, in order to relieve groundwater pressure (Fig. 10). Because of the fault zone showed to be wider in the left sidewall of the tunnel alignment, special attention was given to holes placed in there. The injections started from the foot to the top of the wall and from the right to the left sidewall of the tunnel. It was consumed a total of 23.3 ton of cement/microcement and 1.1 ton of polyurethane.

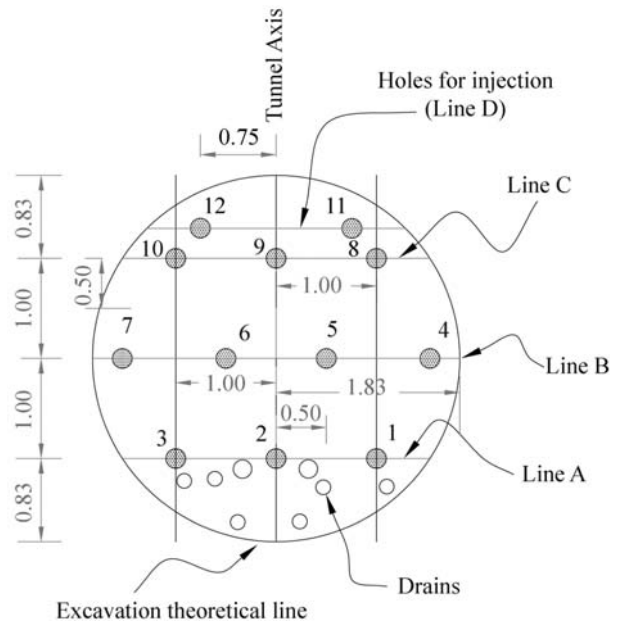
**Figure 10** - Vertical section of the wall of injection at Sta. 5+237.40 m, Pinalito rock Tunnel. Note parallel lines of injection, from A to D, and drains placed in the base in order to release groundwater pressure.
