The Breach Problems in the Tunnels of the Boston Central Artery/Tunnel Project (Big Dig)

John T. Christian

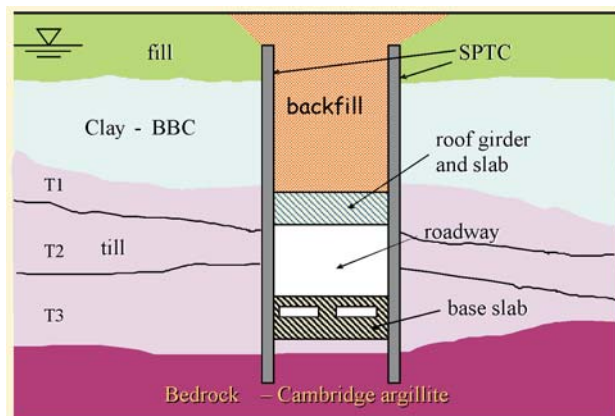
Figure 2 - Simplified cross-section of tunnel.

Investigation revealed that the breach had occurred at a point in the tunnel where the soil outside the tunnel is the T3 till (Fig. 2). Although all three of the tills are sense as a result of compaction under the weight of Pleistocene glaciers, the T3 segment consists of sands and gravels with little or no silt and clay, so that the permeability of the soil is much higher than that of the other tills and the overlying clay. Since the water table is at or near the surface, the head of approximately 21.3 m (70 ft) can drive a substantial flow of water. The questions then was to discover how the breach in the concrete had come about.

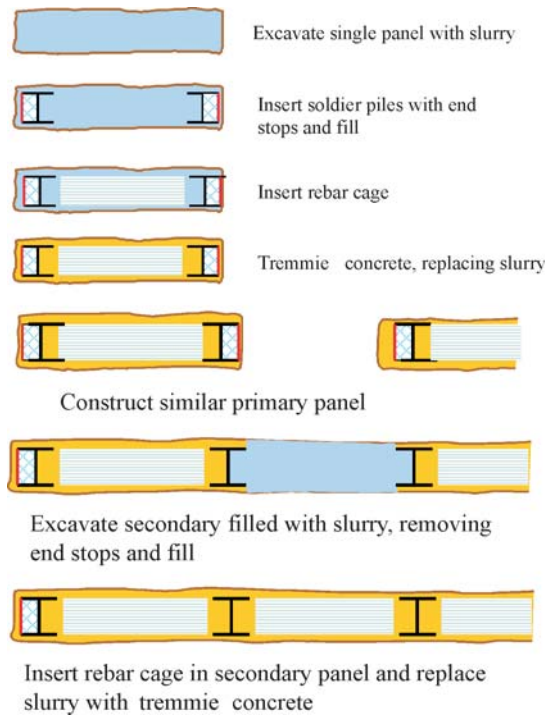
Figure 4 - Construction sequence for SPTC wall.

Figure 4 illustrates the construction sequence for the soldier pile tremmie concrete (SPTC) walls. When the soldier piles are placed in the slurry, the space between the outside flanges is filled with an inert granular material and the space closed off with an end stop, which is made of plywood or thin steel plate. When the secondary panel is excavated, it is essential that the end stop and the granular material be removed so the concrete for the secondary panel makes good contact with the steel pile.

primary panel, creating a mass of concrete that intruded into what would become a secondary panel placed by the contractor for the next section. Rather than excavating the block of extra concrete, that contractor simply tried to excavate under it. This was not successful, so a portion of the soil lying under the excess mass was never excavated and was incorporated in the final wall. Part of this material was T3 till, through which the flow eventually occurred.
