## Structural health monitoring and inspection of dams based on unmanned aerial vehicles photogrammetry with 3D model reconstruction

Article

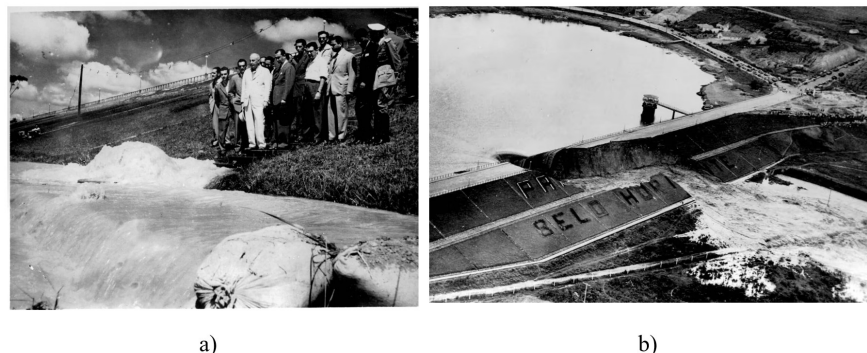
Figure 2. High-risk inspection conducted at the Pampulha Dam, Belo Horizonte (CMBH, 1954): (a) expert group; (b) rupture of the dam.

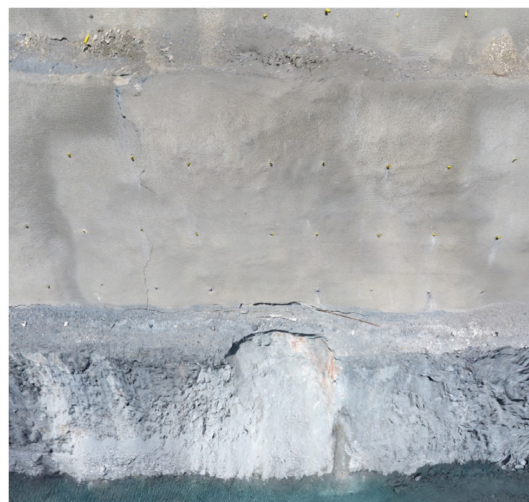
Figure 3 shows an example of a slope about 40 m high, where cracks and slips have been identified. This image was taken from a 3D model obtained from a point cloud generated by processing images taken by a drone. It was possible to identify and map the anomalies in approximately 40 minutes, without putting the inspectors at risk, with the advantage of obtaining an accurate description of the geometry and characteristics of the anomalies. UAVs can be equipped with high-resolution cameras and advanced sensors, including multispectral cameras, radar, LiDAR, infrared, and magnetic sensors. This enables comprehensive data collection across various spectrums, enhancing the detection of anomalies, such as deformations, settlements, cracks, seepages, and wet zones.

**Figure 3.** Visual inspection of a high-risk area using a drone (image extracted from a textured 3D model generated from drone-captured images).

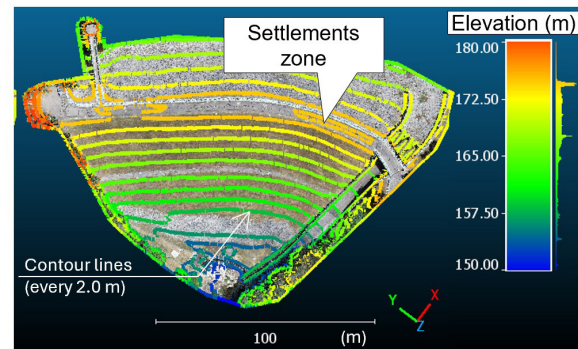
**Figure 22.** Contour lines (every 2.0 m).

As illustrated in Figure 22, this survey enabled the detection of an area of old settlement in the central region of the dam, indicating a loss of freeboard, mass movement, landslides, and cracks in the embankment and/or foundation. In detail, Figure 23 shows the cracks in the area where the settlements occurred.

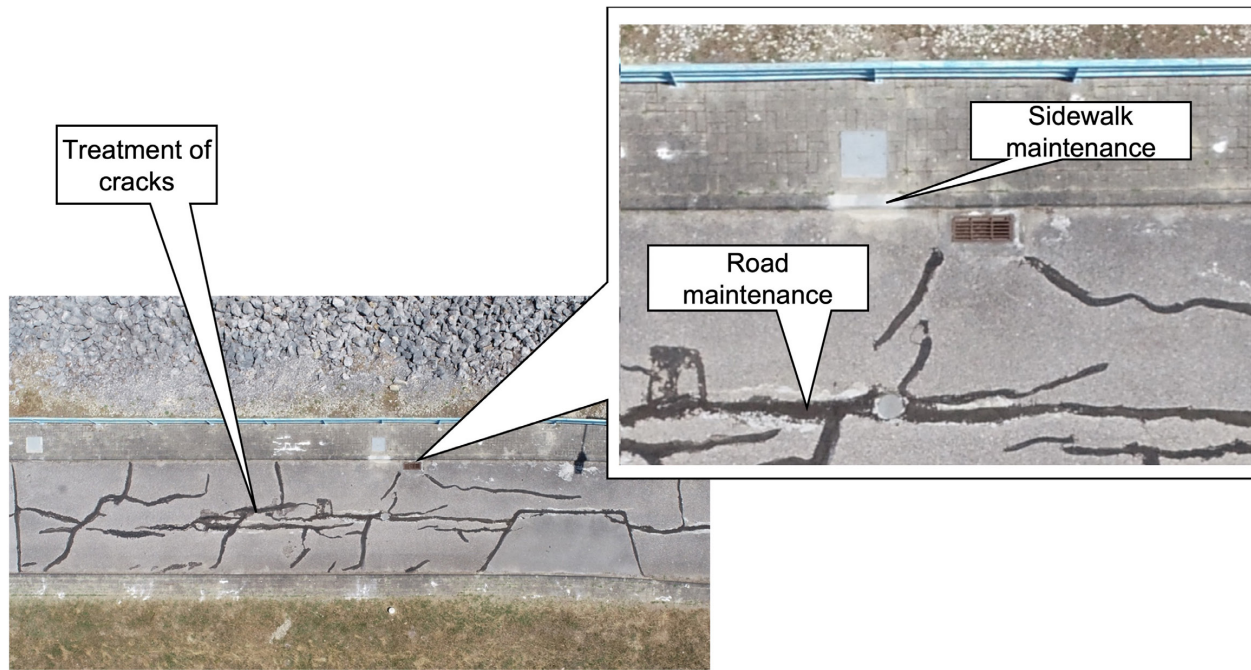
**Figure 23.** Treatment of cracks in the area where settlement has occurred.

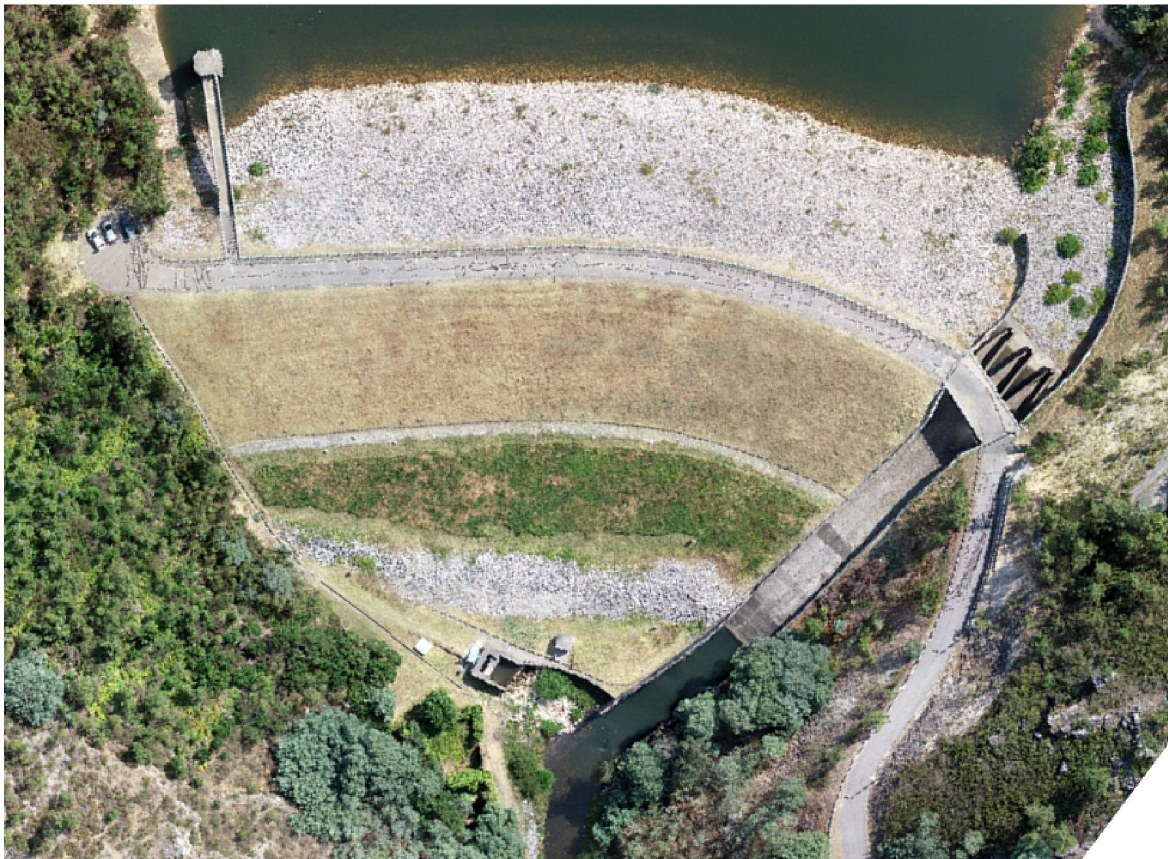
**Figure 24.** Survey performed 07/20/21.

Figures 24 and 25 show a comparison between two orthophotos generated in WebODM, from surveys performed over a period of approximately 10 months, whose differences in vegetation can be easily observed.

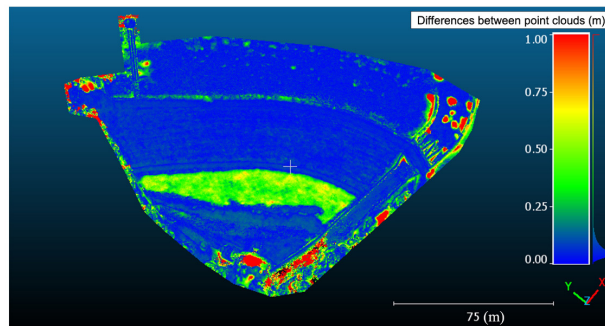
**Figure 26.** Point cloud comparison (CloudCompare).

For a comparative analysis of deformations over a specific period, the use of CloudCompare software is recommended. This program allows for examining discrepancies between point clouds generated from images captured by UAVs, as shown in Figure 26. The areas highlighted in red represent differences greater than 1 m, indicating the removal of shrub vegetation during dam maintenance. The green and yellow areas denote changes of about 0.5 m, associated with the removal of ground vegetation. By analysing the colour patches and comparing them with the orthophotos (Figures 24 and 25), it is possible to distinguish between the deformations in vegetation and minor deformations in areas of interest, such as the crest and upstream rock protection. However, no significant deformations were observed in the

body of the dam (blue patch), indicating that no substantial deformations occurred between the two surveys, as expected.
