# Evaluation of slope failure through the assessment of meteorological conditions and earthworks management

Rainfall triggered landslide  
Infrastructure damage  
Site restoration  
Numerical analyses

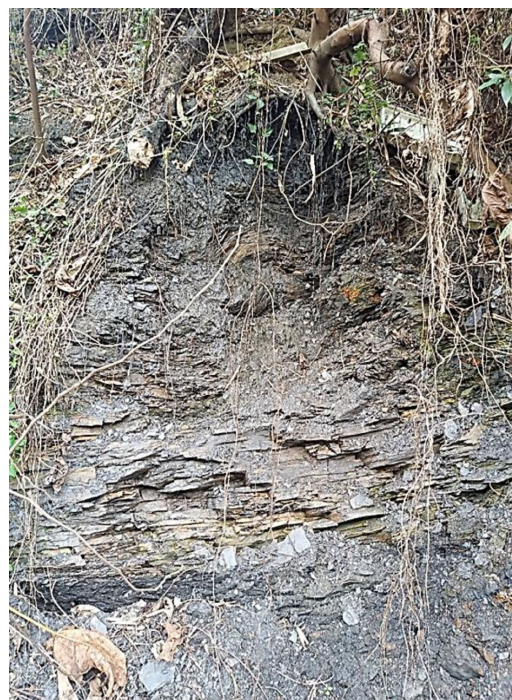
**Figure 4.** Bedrock at the stream bank just beneath the reported failure.

interbedded with dark-grey, fine-grained thin bedded siltstone and argillaceous. According to the geotechnical investigation report, the bedrock is mainly composed of shale interbedded with sandstone which is in accordance with the descriptions in the geological map. The site survey (Figure 4) showed that the shales are strongly folded, and the surface condition was fractured due to a highly weathered surface with cracks and angular deposits.

The rock formations at the study site have two predominant joint sets, namely the bedding joints and near vertical set. Joints are mostly weathered and smooth with a spacing range from a few millimeters to 10 centimeters. Cracks less than 1 mm are usually filled with clay. The shale contains fissures due to shearing. Remarkably, the shale represents softening behavior due to water infiltration. Sandstone is whitish grey, fine grained and thinly bedded. The sandstone presents high uniaxial compressive strength. The bed rocks are randomly intersected by thin deposits of quartz. The presence of thin bedding joints and the tectonically induced discontinuities cause the rock mass to be highly fractured. The sandstone beddings are persistent, and the joint condition is rated to be fair with a moderately weathered and altered surface. Accordingly, the geological strength indices are estimated using Marinós (2019) classification as 15 and 25 for slightly weathered shale and slightly weathered sandstone, respectively.

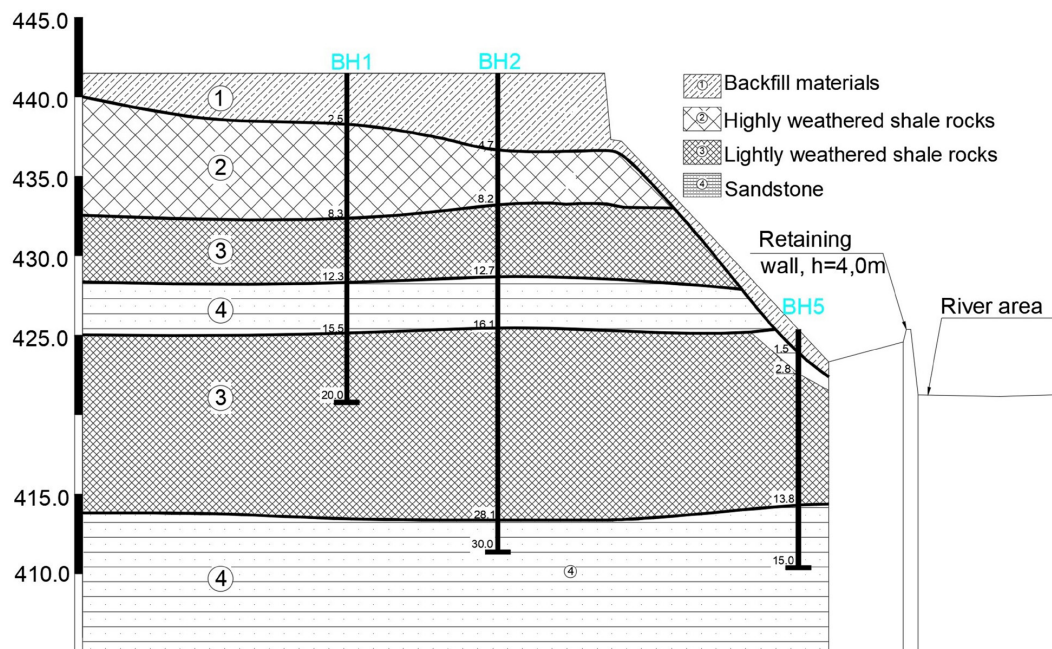
To provide a better understanding of the geotechnical structure the slope profile is presented in Figure 6.

**Figure 6.** Geological cross-section I-I'.

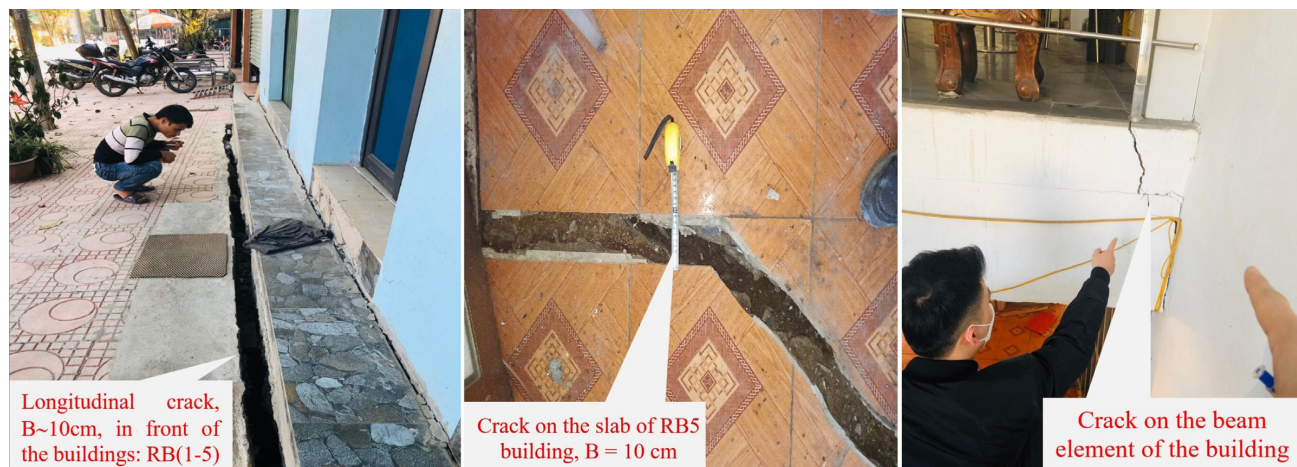
The case study concerns a natural slope with extensive infrastructure developed at the top edge. The infrastructure development started with the construction of a local road near the edge and the design of the drainage system, redirecting the runoff down the 25 m high slope. Following the road construction number of storey buildings were constructed in the section between the road and the slope's edge. At the toe of the slope, there is a natural stream passing with the flow changing depending on the rainfall volume. In recent years, the local community's major concern has been focused on the erosion effect due to the stream continuously cutting the toe of the slope. Thus, a retaining wall was constructed to control the water erosion and improve the slope's stability. After the works were accomplished, significant rainfall events took place. The finger pipe drainage was installed at the back of the wall. A few weeks later, the residents reported the first building cracking, which continued to develop until the next severe rainfall event that was followed by the slope failure and a collapse of buildings located at the study site. The damages to the infrastructure are presented in Figure 8.

Despite these reports, the construction proceeded as planned. Shortly after the completion of the retaining wall, an extreme rainfall event occurred on October 22, 2021, with recorded precipitation levels reaching 30 mm in a single day. It is important to emphasize that the total accumulated rainfall for October 2021 was approximately 2000 mm, highlighting the exceptionally wet conditions in the region during that period. One week later, the first signs of structural distress appeared, as cracks were observed in the walls of residential buildings near the slope edge. Over the next two months, additional damage to the buildings became evident. The situation escalated dramatically on January 16, 2022, when a heavy rainfall event of nearly 45 mm in a single day occurred. Following this event, the slope experienced a catastrophic failure, resulting in the partial collapse of buildings and severe infrastructural damage. During the earthworks phase, the dynamic loads generated by excavation activities and construction-induced vibrations disturbed and loosened the soil structure at the building foundations.

**Figure 8.** Extensive damage to the residential buildings located on the study slope.

This disturbance likely compromised the shear strength of the soil layers, making it more susceptible to external environmental factors. Following this phase, heavy rainfall decreased the stability by infiltrating the loosened soil profile. The increase in pore water pressure within the soil layers led to a reduction in shear strength, thereby lowering the overall stability of the slope. Additionally, the inadequate drainage system failed to efficiently redirect surface and groundwater flow, causing excessive water retention within the slope mass. This progressive saturation contributed to the build-up of pore water pressure in the soil, further weakening its mechanical properties and increasing the likelihood of slope failure. Figure 10 presents a chronological sequence of events, providing a comprehensive overview of the factors contributing to the slope failure. By illustrating the circumstances including construction activities, recorded rainfall events, and the progressive development of structural

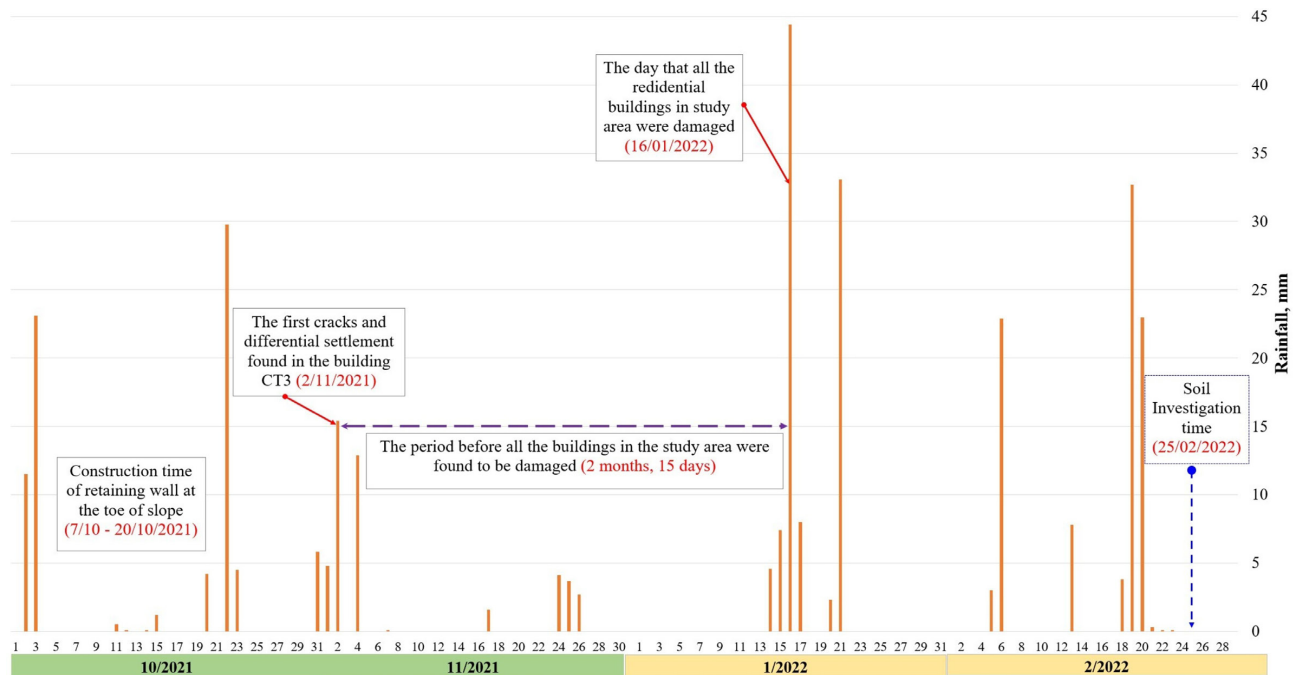
the moment of the final slope failure. To provide a clearer understanding of the interplay between these factors, Figure 9 presents a chronological sequence of events, illustrating the possible causes that ultimately led to the collapse and the severe damage sustained by nearby structures.

Figure 9. The sequence of events leading to a final failure with referencing rainfall data.

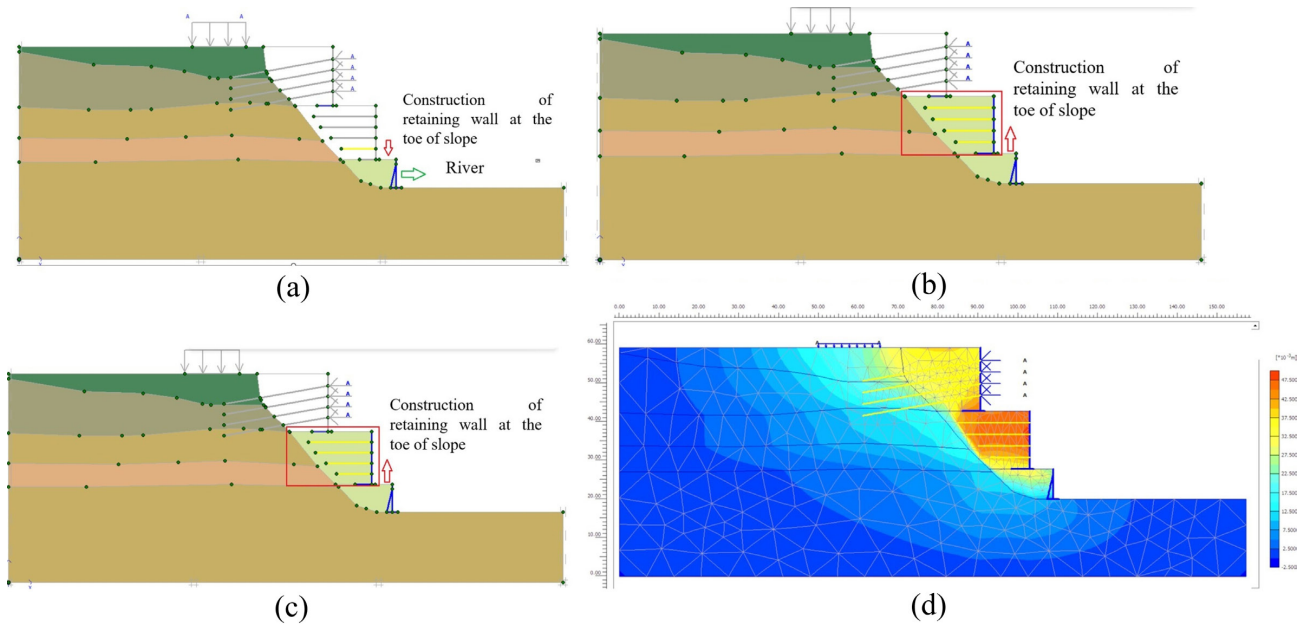
**Figure 11.** Sequence of slope stability improvement a) 1<sup>st</sup> stage-backfill with gabions, b) 2<sup>nd</sup> stage MSE, c) 3<sup>rd</sup> stage soil nails, d) displacements computations.

computations were performed to ensure the long-term stability of the slope and surrounding infrastructure. The slope stability analyses were carried out using the Finite Element Method (FEM), using commercial software Plaxis (Brinkgreve et al., 2016), incorporating geotechnical parameters obtained directly from site investigations. The Mohr-Coulomb soil model was applied to simulate soil behavior under different loading conditions, while the Factor of Safety (FoS) was computed using the Shear Strength Reduction (SSR) method to evaluate slope stability under various scenarios. To account for the hydrogeological influences on slope stability, multiple simulation scenarios were analyzed, considering the changing groundwater levels due to rainfall infiltration. These simulations provided insights into how excessive water infiltration reduced soil shear strength, increasing the likelihood of failure. To ensure long-term safety and prevent further instability, the entire slope was re-engineered using a combination of reinforcement techniques. The proposed stabilization system included: Mechanically Stabilized Earth (MSE) Wall – Implemented to provide additional lateral support and enhance slope resilience; Gabion Retaining Wall – Selected due to its flexibility, permeability, and ability to absorb dynamic loads, minimizing further deformation and reducing the impact of future precipitation events. This integrated reinforcement system was specifically designed to minimize excavation and earthwork disturbances to protect the remaining infrastructure and prevent further damage. The optimum stabilization solution was determined through numerical simulations, where deformation patterns and safety factors were analyzed. The results of these computations, presented in Figure 11, illustrate the effectiveness of the

proposed stabilization measures in improving the overall geotechnical safety of the site. The obtained factor of safety was  $1.34 > \text{FoS} = 1.25$ , and the maximum horizontal displacement did not exceed  $4.25 \text{ cm} < \delta = H/200 = 7.5 \text{ cm}$ , where  $H$  is the total height of the wall.
