## Malpasset arch dam: an example of major accident caused by the effect of water in a rock foundation

Case Study

Malpasset dam accident is considered as the classical example of the detrimental effects of water in a rock foundation. Technically, it represents a unique case of arch dam collapse induced by the water and the subsequent uplift pressures acting on a very large rock wedge in a fractured rock foundation. At the time of the accident (1950's), such an effect was totally unknown by the dam designers and geologists as well. After a summary of the background and geological context, the investigations and the design (initial and final one) are presented. Then, the chronology of events is reconstructed in detail, including the structural deformation of the arch during the filling of the reservoir and the heavy rainfalls. After all, the collapse is analysed based upon the observation carried out immediately after the accident as well as the post failure investigations that took place during the following years. Despite the total failure of the arch dam, the origin of the accident cannot be attributed to the dam structure itself but solely to the rock foundation. The accident o

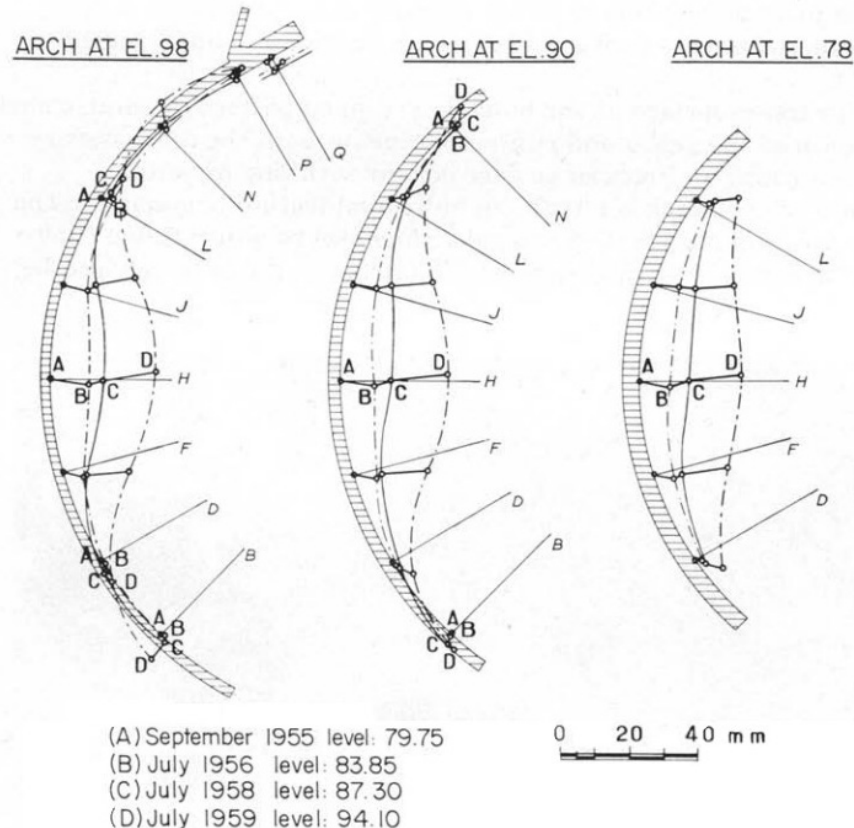
**Figure 6.** Displacements of the targets along the arches for El. 98, 90 and 78 before the rupture: plan view. Segments CD shows deformations occurred between July 1958 and 1959 (Londe, 1965).

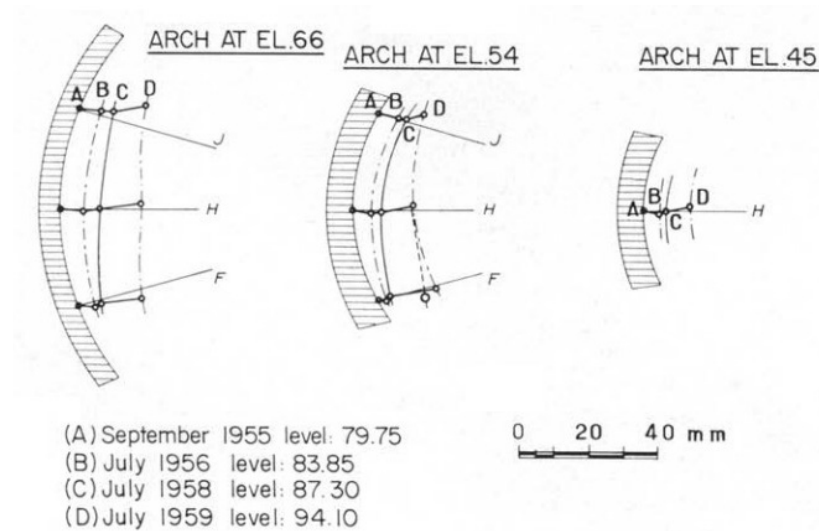
**Figure 7.** Displacements of the targets along the arches for El. 66, 54 and 45 before the rupture: plan view. Segments CD shows deformations between July 1958 and 1959 (Londe, 1965).

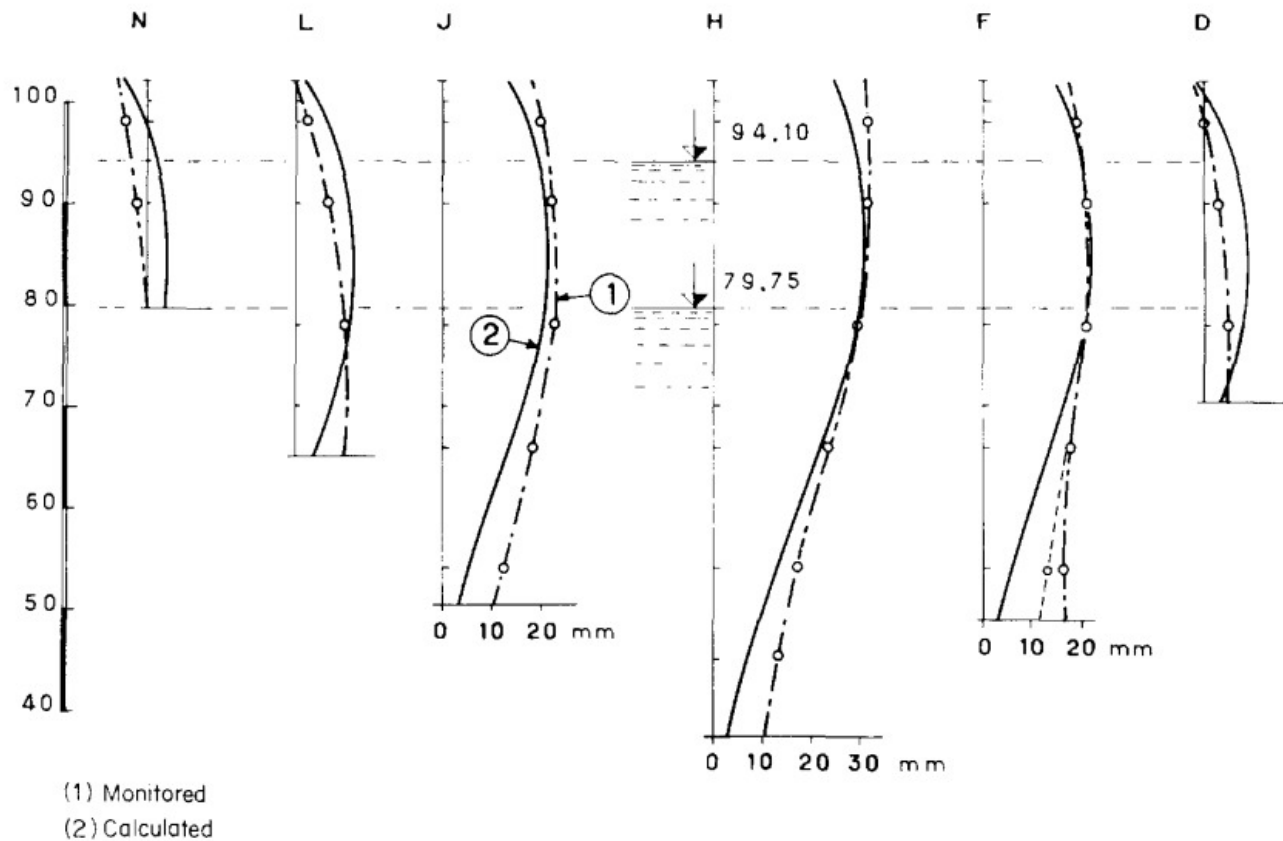
Figure 8 shows the monitored and calculated deformations during the operation of the dam, computed for a foundation modulus 10 times lower than the concrete modulus. Results are in good agreement in general, except at the base of the dam where the rock yielded much more than the calculated results.

**Figure 8.** Comparison between monitored and calculated deformations during the operation of the dam (Londe, 1965).

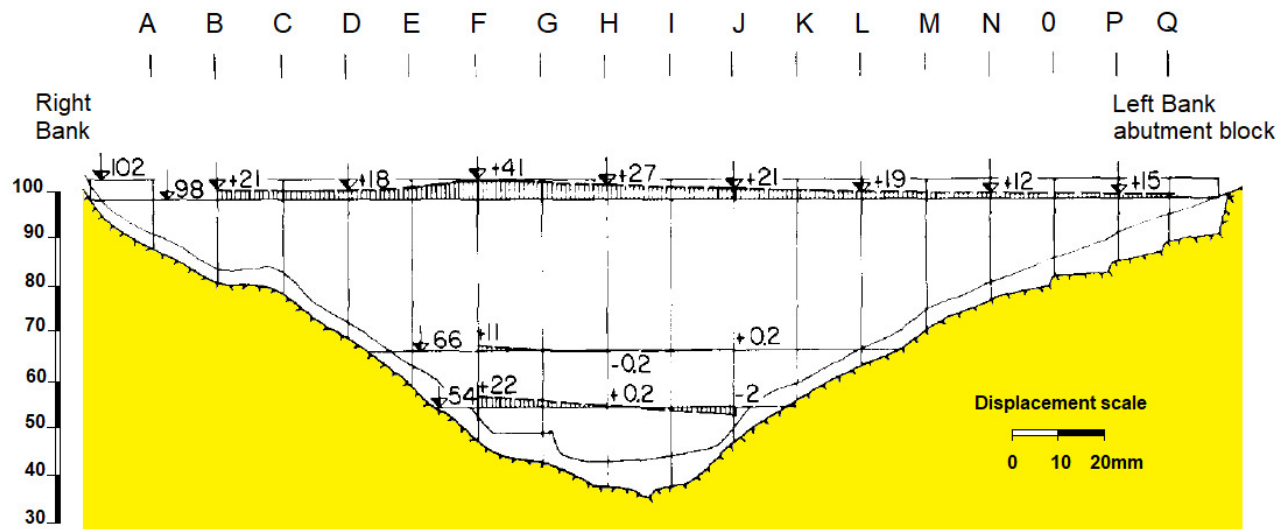
Figure 9 shows the longitudinal section of the dam with the joint displacements between the years 1955 and 1959. A general tilting of the arch structure for the left is observed - the right bank being lifted when compared to the left bank, particularly in the vicinity of the structural joint F. Figure 10 shows the downstream elevation after the

**Figure 9.** Longitudinal section of Malpasset dam before the collapse, showing the rock top on the excavations, the vertical displacements between the years 1955 and 1959 and a general tilting of the arch structure to the left. Modified from Londe (1965).

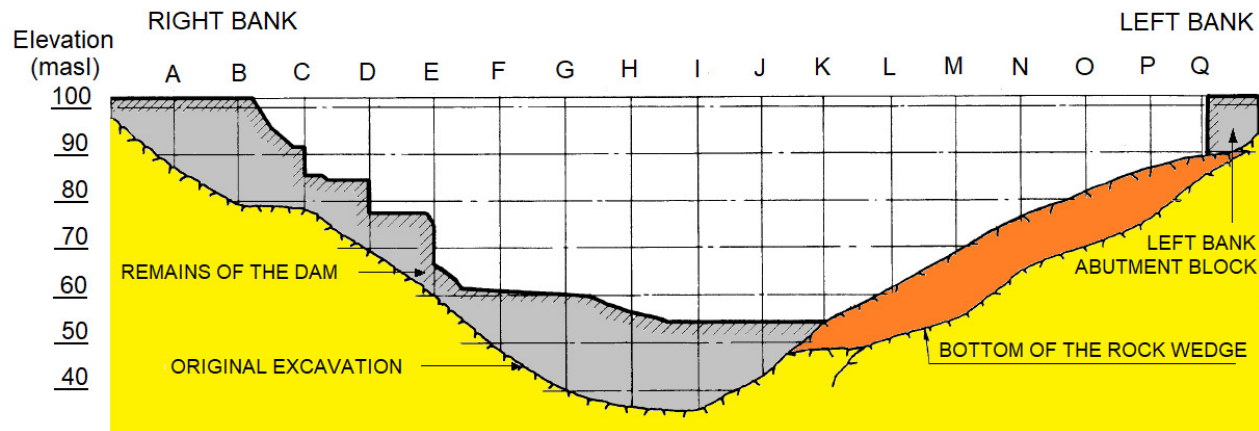
**Figure 10.** Longitudinal section of the Malpasset dam after the collapse. On the right bank, only the base of the concrete arch was still there. On the left bank a huge wedge of rock was ejected carrying away the concrete. Only remains the wing wall on the top, part of the concrete in the abutment and the thrust block, which had been separated from the wing wall and slid downward as showed in Figure 12. Modified from Bellier (1967).

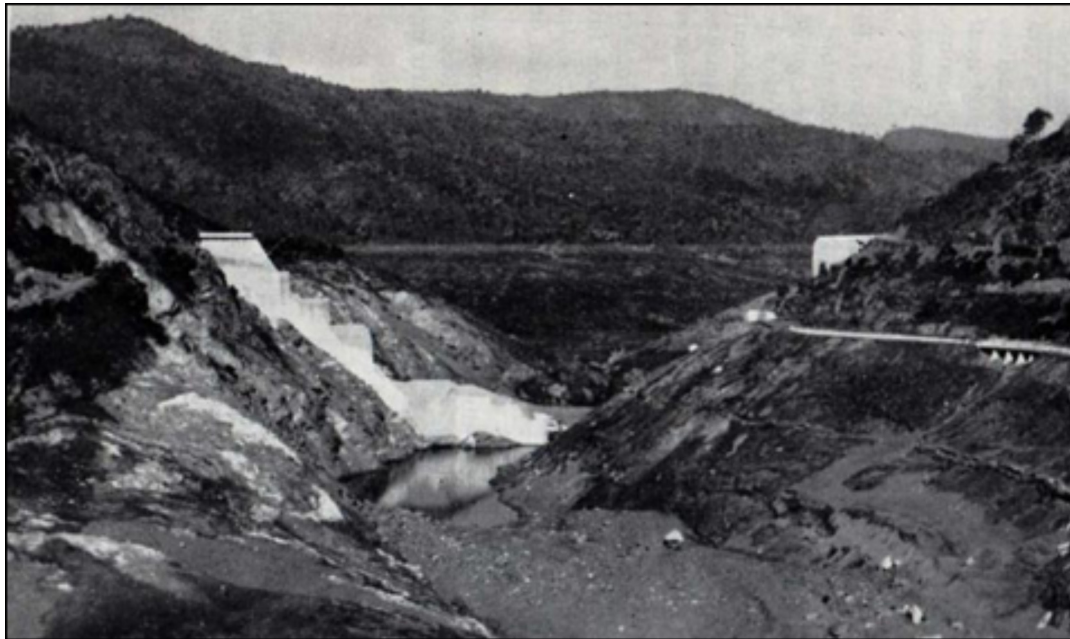
which was still illuminated. Then a huge wall of water surged from the gorge and crashed over the top of the spur on the left bank. At this moment the electric power was cut. The power line of the dam was reported to have broken at 21h13. On the following morning only the base of the concrete arch in the right bank was still there, together with some remain of the thrust block in the left bank (Figures 11 and 12).

**Figure 11.** Photo of the dam after the accident on 2nd December, 1959 (Mary, 1968 in Duffaut, 2013a).

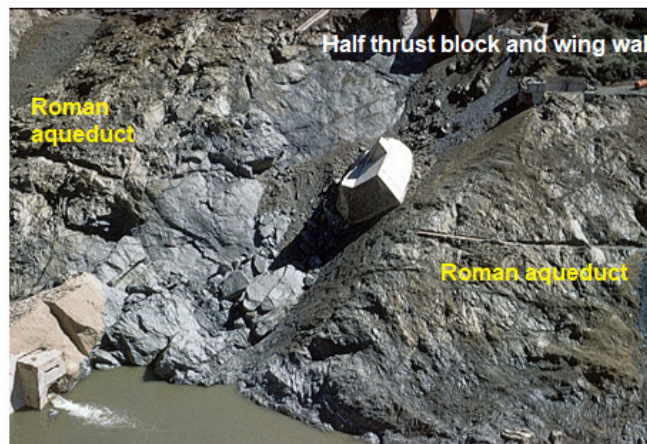
**Figure 12.** Left bank after the failure - Photograph showing the exposed rock formation extensively cracked and some remains of the concrete arch: half of the thrust block and wing wall (T and W in Figure 1) and the bottom gate in the lower left. The tracing of the Roman aqueduct still appears interrupted by the empty space left by the ejected rock wedge (photo taken by Duffaut in May 1960, showed in Duffaut, 2013a).

In fact, there were two types of rock in the left side. One that remained in place after the accident and the other one that was carried away during the process of rupture (see Figure 12), which contained the large wedge that disappeared and most probably had been loosened and weathered more than the rest of the rock in situ due to tectonic effects near the downstream fault. The elastic deformation modulus of the rock derived from jack tests performed in 1960 showed modulus of 850 MPa vertically and 1600 MPa horizontally in the NS and EW direction respectively (Bellier, 1967). According to Mary (1968, in Post & Bonazzi, 1987) the deformation modulus would be around 1000 MPa, perhaps even less. In both cases, however, the modulus is low affecting the stiffness of the foundation.

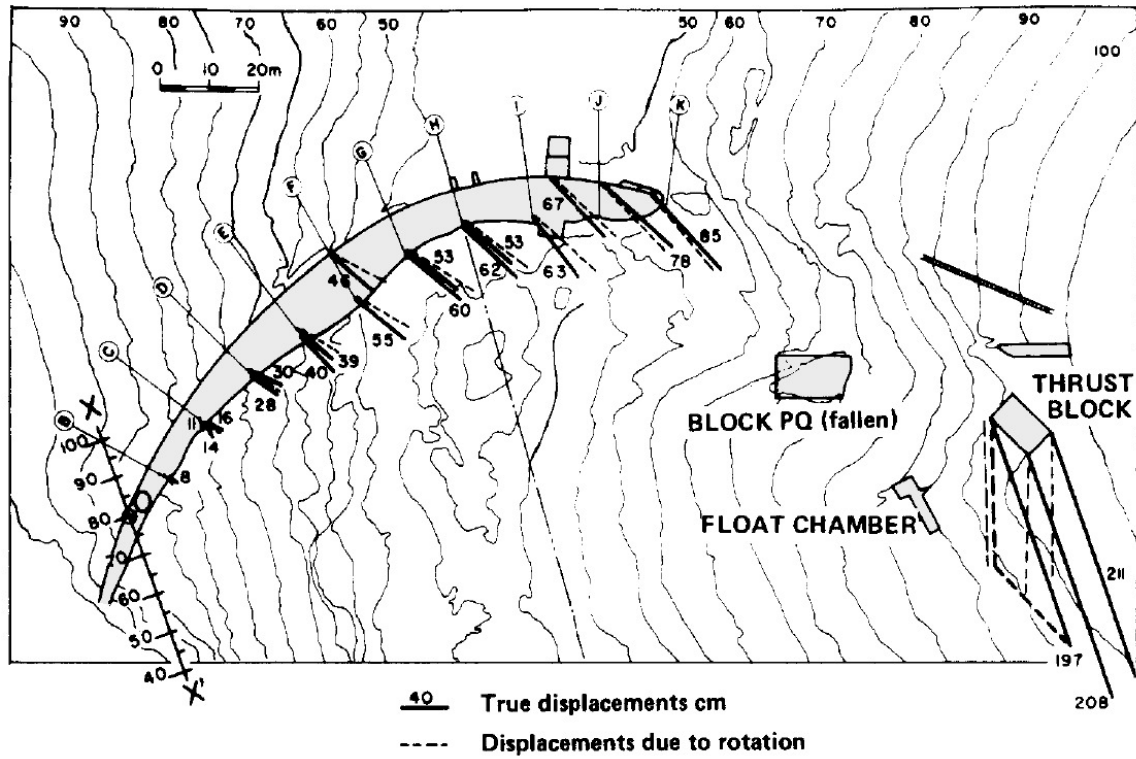
The elements of the concrete arch were cracked and the structural joints were displaced as shown in Figure 13. Some of the structural blocks were found after the accident as shown in the photo of Figure 14.

Figure 13. Displacement of the concrete arch joints. Modified from Londe (1965).

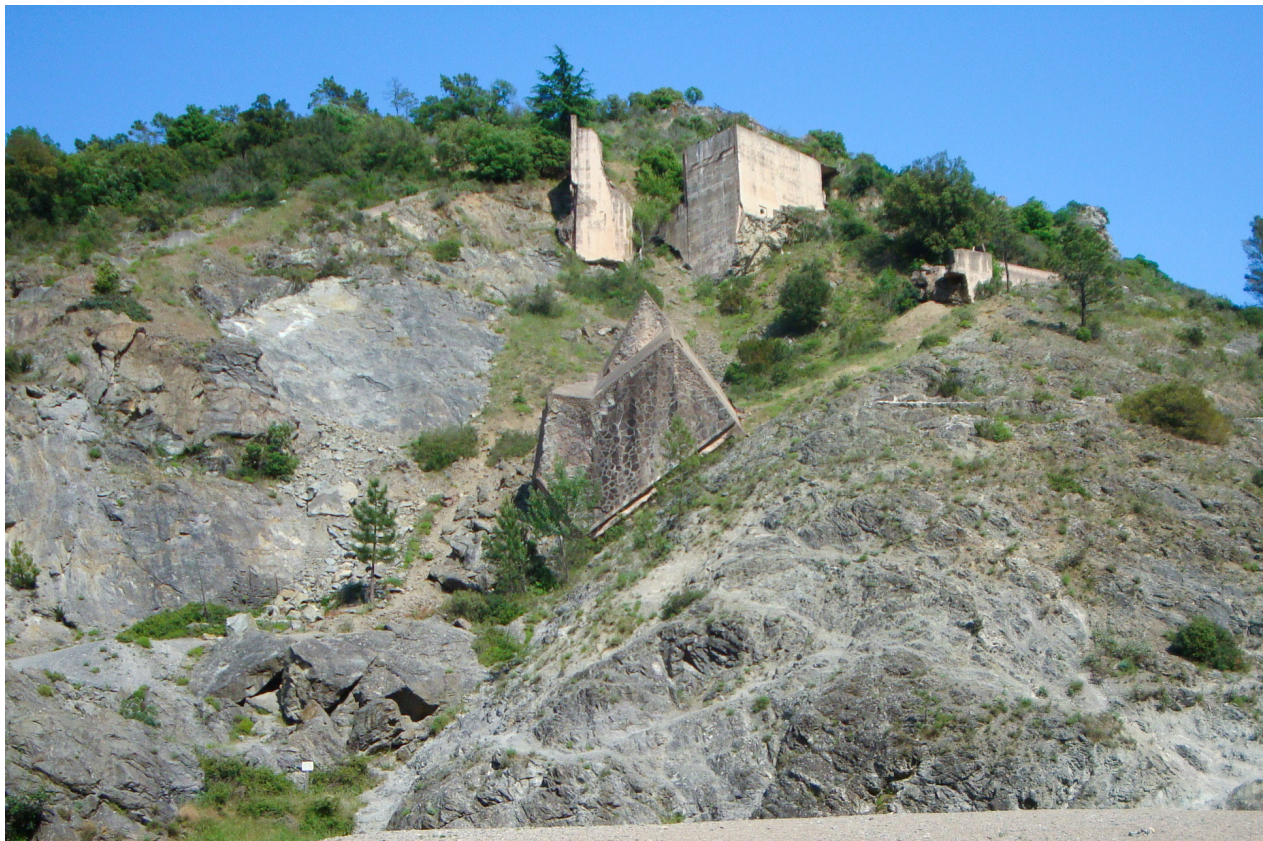
Figure 14. Damaged dam structure after the accident. Courtesy of Pierre Duffaut; Photo taken in 2010.

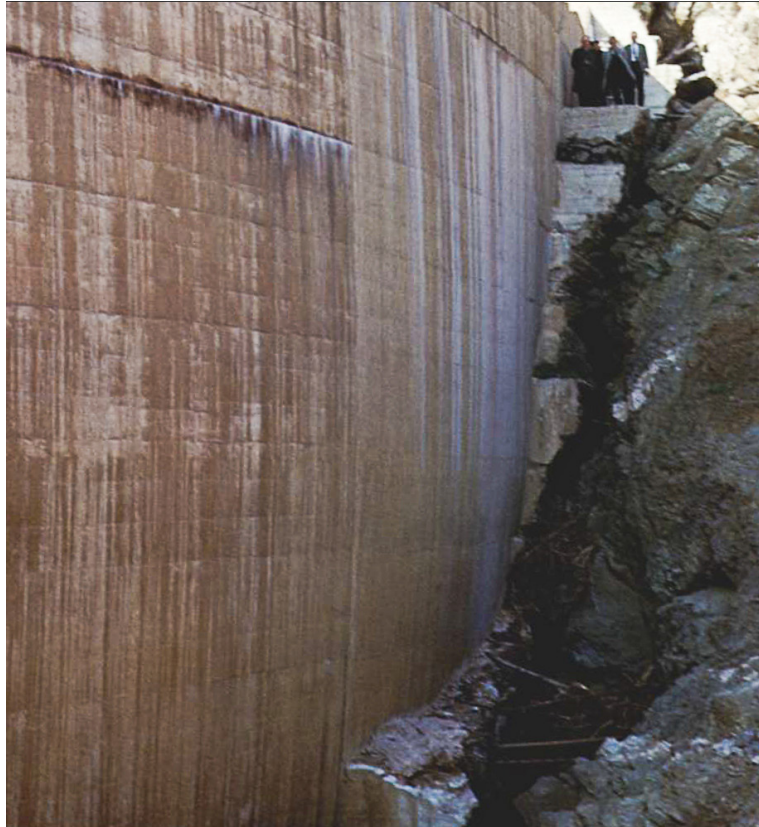
cracked was displayed, making it easier for retrospective geological studies. An impressive demonstration of the dam's movement during the failure was the large gap opened between the upstream face and the right abutment rock as seen in Figures 15 and 16. Investigators were able to enter the gap to a depth of about 8 metres (Londe, 1965).

**Figure 15.** A large gap (crevice) displayed after the accident between the upstream face and the right abutment of the dam. Photo taken in May 1960. Courtesy of Pierre Duffaut.

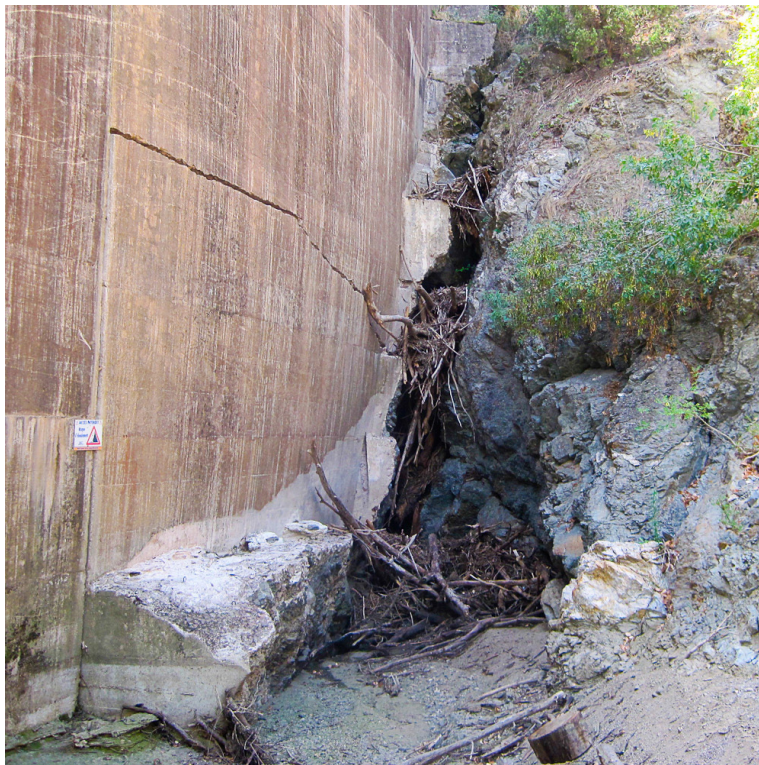
**Figure 16.** The same crevice on a photo taken by Duffaut in 2012. Courtesy of Pierre Duffaut.

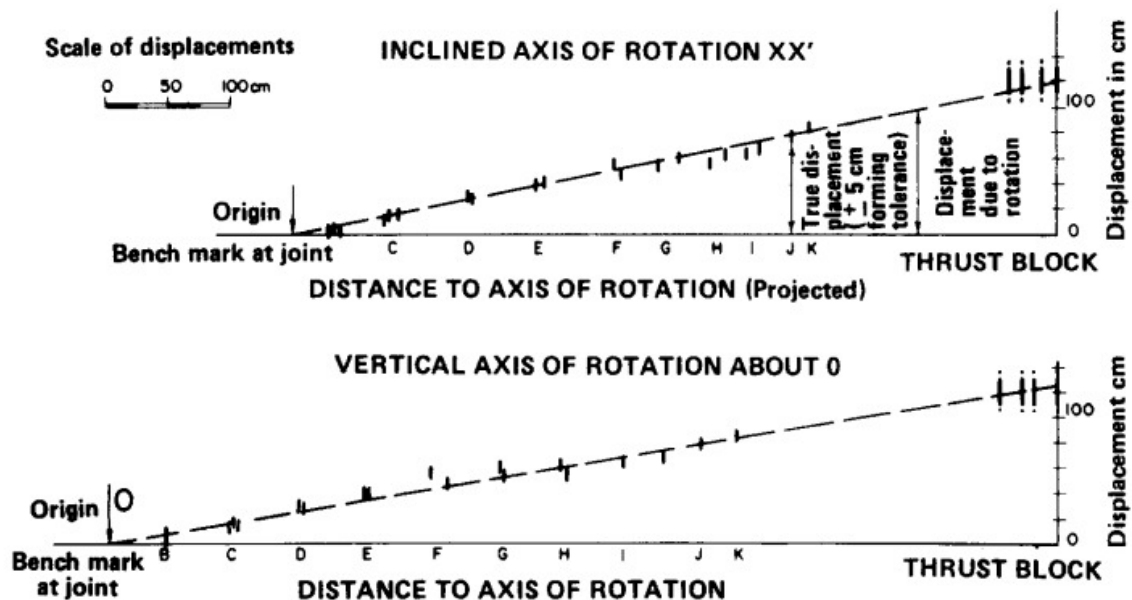
Figure 17. Rotation of the arch (Londe, 1965).

A survey of the post failure positions and measurements of the remaining dam elements, performed under the requirement of the Inquiry Commission showed that there had been a rotation of the dam as a solid body. Figure 17 (Londe, 1965) shows that the axis of rotation was located at the very end of the arch on the right bank and the best fit is given by an inclined axis (XX' in Figure 17) perpendicular to the fault

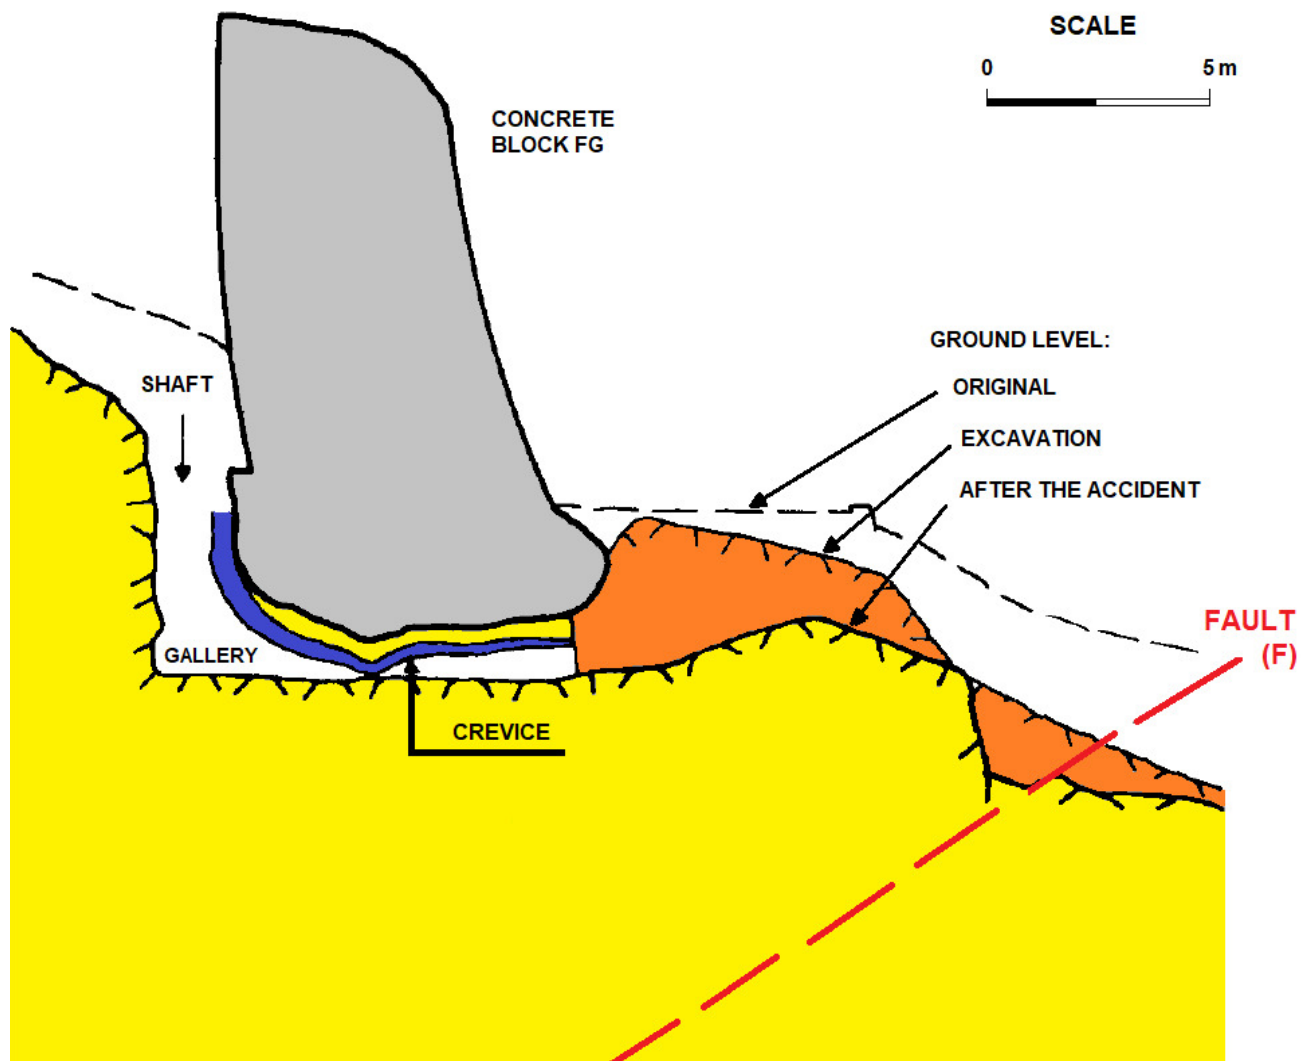
The print of the wedge located on the left bank as seen in Figure 18 is delimited by two of these structural defects, the foliation showing shearing and a fault, both having very close azimuths but opposite dip directions (Table 2).

**Figure 18.** Vertical cross section under the concrete at the foot of the right bank along the shaft and the gallery opened in 1962. The investigations showed the evidence of a continuous crevice in the rock foundation, close to the concrete block FG. This is considered a sign of the movement of the dam on the foundation in the right bank, as described in the text. Modified from Bellier (1967).

This kinematic chain suggests that sliding on this face occurred when the arch dam was still a solid body. The upward component of the movement resulting from this sliding is confirmed by the wide-open crevice under the block FG (right bank) in the investigation shaft and gallery (Figure 18) excavated after the failure (Londe, 1965).

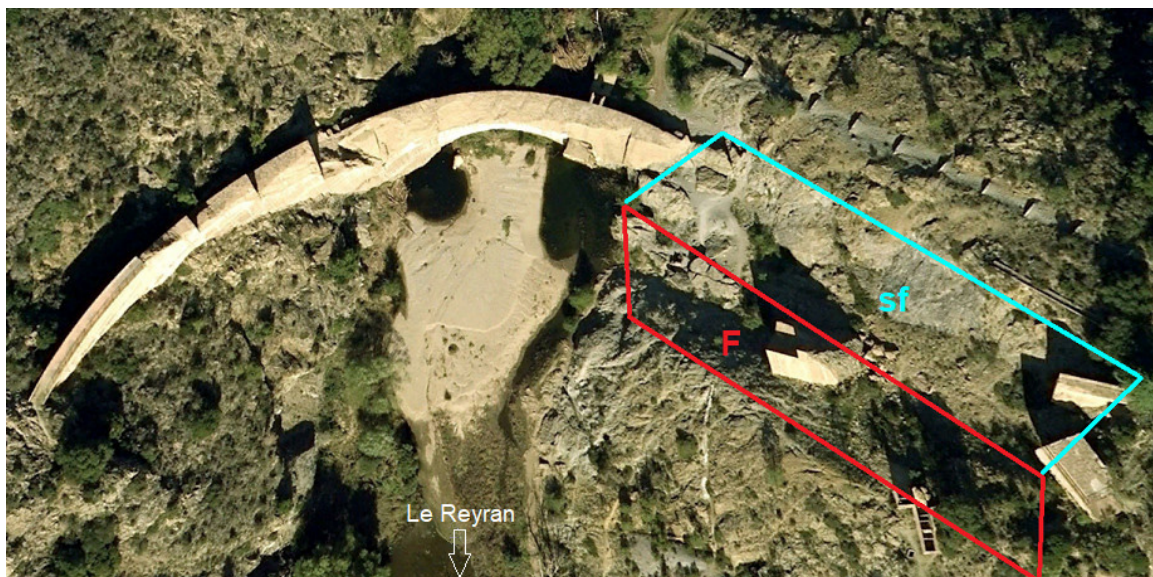
**Figure 19.** View of the print of the rock wedge and the damaged dam structure on the left bank. (Google Earth® 2012 archive view).  
sf = sheared foliation; F = Fault

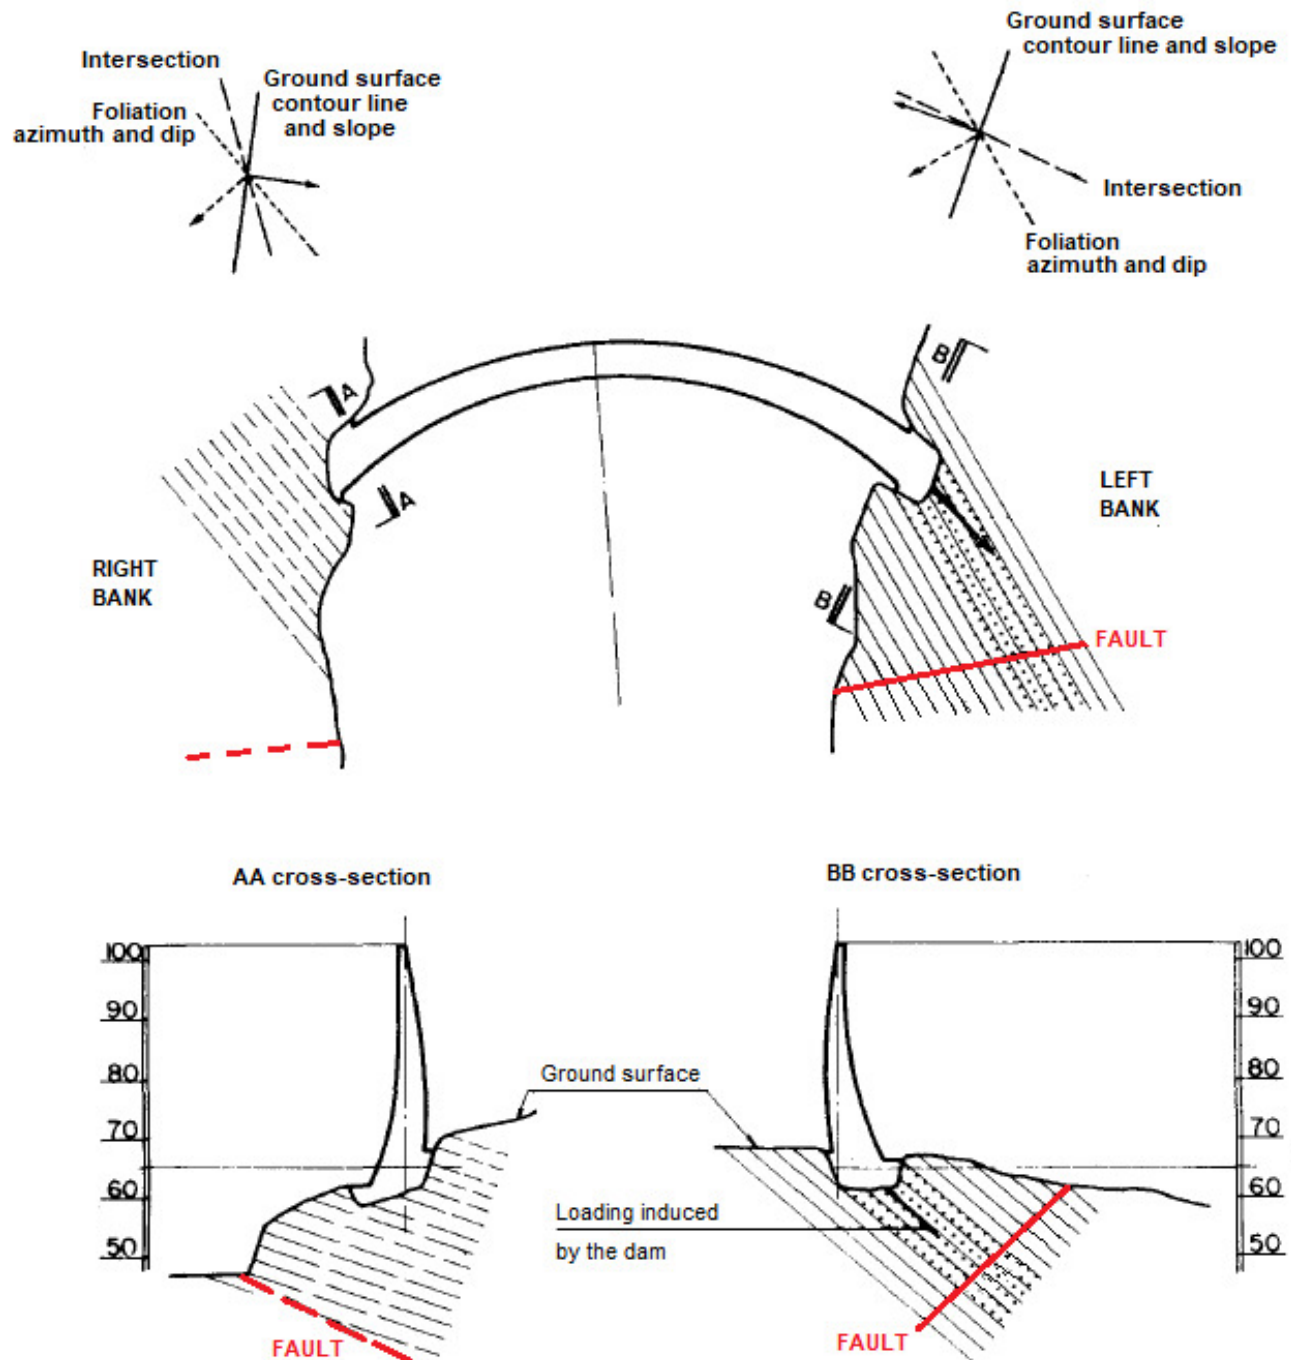
Figure 20 shows that on the left bank, the concrete arch followed the foliation. The axis of the arch is almost parallel to the foliation and the dam loading induced a

compressed zone inside the foundation due to the foliation. This geometrical situation induced an increase of the compressive strength and a severe reduction of the hydraulic conductivity inside the compressed zone which, associated with the water accumulated behind the dam and inside the foundation upstream of the induced hydraulic barrier caused, in consequence, an uplift pressure that lifted up the rock wedge delimited by the compressed foliation and the

**Figure 20.** Plan and cross section of the concrete arch and the integration with the local geology. Modified from Bellier (1967).

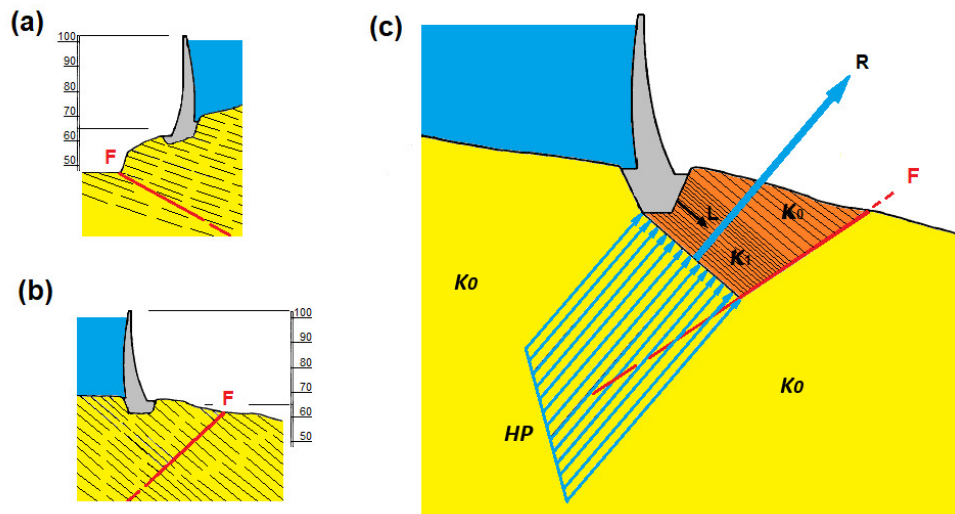
**Figure 21.** Geological cross-sections (modified from Bellier, 1967) with (downstream) fault and foliation (a) on the left bank; (b) on the right bank; (c) sketch showing the resultant  $R$  of the water pressure (uplift pressure) acting on the rock foundation with loading from the arch ( $L$ ) and downstream fault plane ( $F$ ). Common legend: Yellow = foundation; Orange = rock wedge; Dashed lines = foliation;  $F$  = downstream Fault (in red);  $HP$  = full Hydrostatic Pressure corresponding to the maximum water level in the reservoir;  $L$  = Dam Loading;  $R$  = Resulting Pressure (uplift);  $K_0$  = permeability of the foundation;  $K_1$  = reduced permeability in the loaded zone ( $K_1 \leq K_0/100$ ).

Figure 21 describes that mechanism of rupture. The compressed zone of the left bank foundation was made watertight by the closing of the fissures. The permeability has become 100 times or even 1000 times lower, transforming the rock into a real “underground dam” that supports the full hydrostatic pressure ( $HP$ ) of the reservoir. In the figure, it is possible to see how large and in unfavourable direction this force is putting in risk the stability of the whole left bank.
