## The mechanics of iron tailings from laboratory tests on reconstituted samples collected in post-mortem Dam I in Brumadinho

Article

Geotechnical laboratory tests  
Iron ore tailings  
Critical state soil mechanics  
Tailings dam failure  
Instability  
Liquefaction

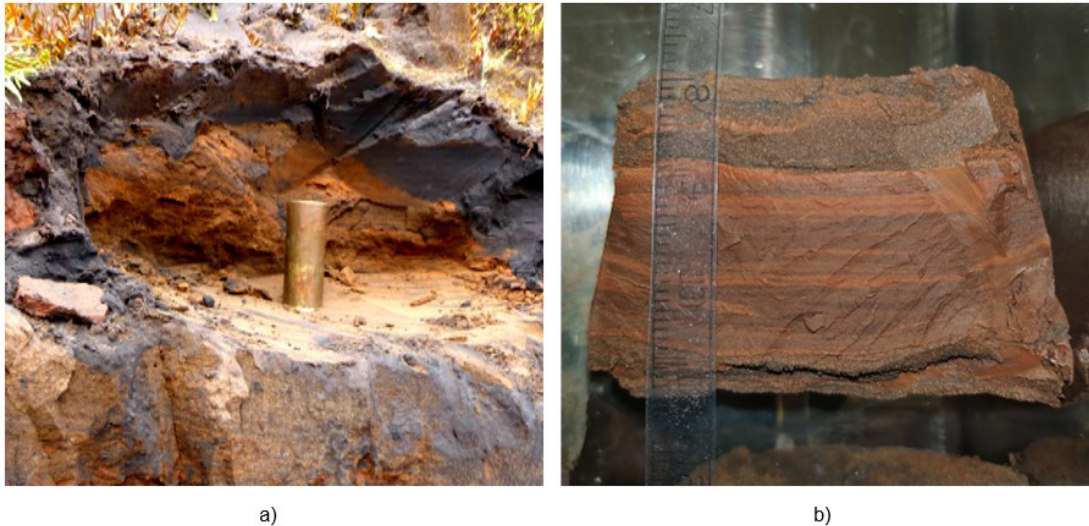
**Figure 2.** Examples of localised layer variability: (a) layering visible in the field; (b) micro layering, visible on an undisturbed sample from Site 1 (12/19/2019) at LabGEO.

representative number of recently performed in situ tests data; that is, static cone penetration tests with measurement of pore pressures (CPTu) and shear wave velocities ( $V_s$ ) by seismic flat dilatometer devices (SDMT). The CPTu and  $V_s$  profiles were analysed before the decision to program the campaigns to obtain new samples in the remains of the dam revealed an expected high variability/heterogeneity in depth as well as in plan. It was clear that the materials involved in the modelling process should be associated to the deposition phases along the years (when distinct mining fronts and injection/spigotting explain the variability). The interlayering was clear in the intact samples directly obtained in the remaining intact blocks, as observed in the trenches created for such purpose. A very thin layer interstratification and anisotropy at lab scale were also observed (see Figure 2).

Two materials were identified as prevailing in Site 1 with quite distinct visual properties, namely a red fine tailing material and a dark (black) granular one. These materials clearly differed on some faces from the large masses that had failed –probably due to the relief of the internal part of the drainage basin– along the exposed slide surfaces in a progressive process. As these were shallow areas closer to the basin margins, they did not collapse, but rather slid along these surfaces at the limit of frictional resistance. So, in the very first campaign, it was realised that it would be possible to find “undisturbed” tailings, that is, not collapsed and with the original fabric and inter-particle structure, allowing the execution of several tests in the laboratory if they were directly sampled with thin-walled blocks and tubes, as illustrated in Figure 2a).

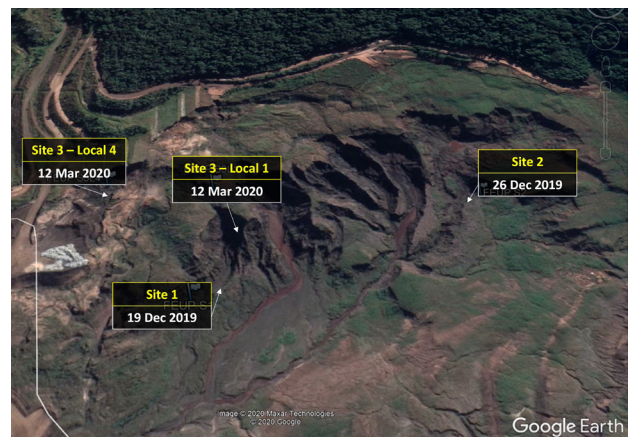
**Figure 3.** Location of the three sampling sites on B1 dam, after failure.

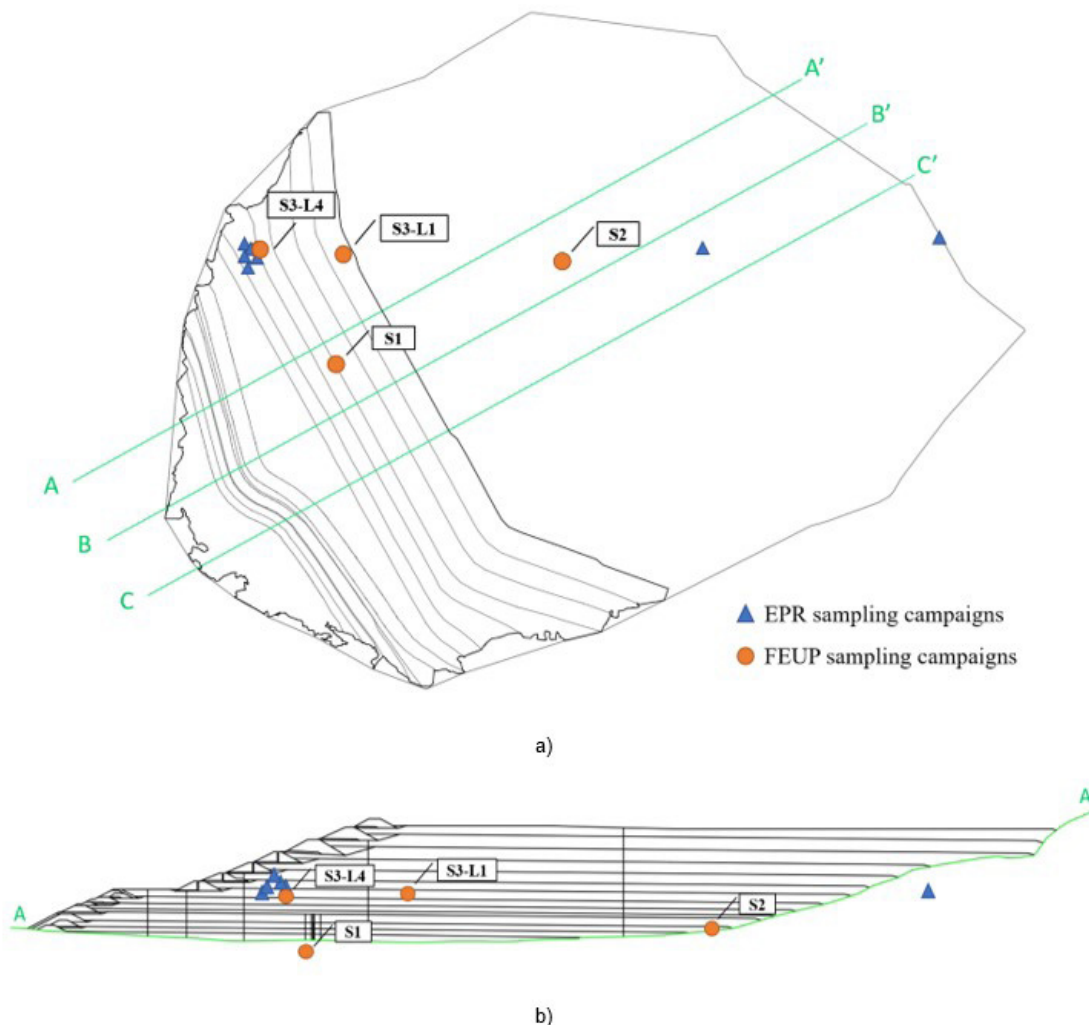
**Figure 4.** Location of the experimental sites from the different sampling campaigns – Projected position: (a) plan view of the dam; (b) alongside the dam section.

EPR and FEUP sampling locations are projected in Figure 4 on the plan view of the dam and alongside the dam section reference axis A-A'. Most samples from the EPR were clustered at a single location close to the remains of the left abutment of the dam (taken from levels corresponding to intermediate dam filling stages), while other two sites were several hundred meters behind the last crest of the dam, with the intention of recovering slimes. The initial failure surface was very far away from these sampling locations.

FEUP experimental sites are deeper and correspond to older tailings than those obtained in the EPR campaign, except for Site 2, located 200 m behind the final crest of the dam, which was chosen with the intention of recovering slimes. Notwithstanding, FEUP sampling sites are likely closer to the location of the initial failure surface.

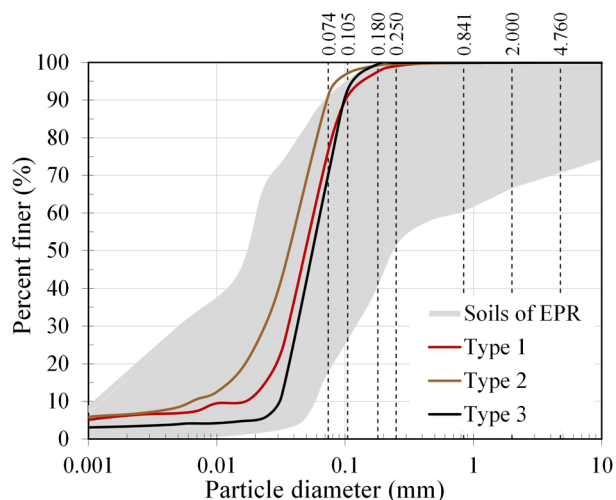
**Figure 5.** Grading curves of the three types of tailings. Comparison with other soils from Brumadinho dam, according to the Expert Panel Report (EPR) (Robertson et al., 2019).

Soil type 1 corresponds to fine reddish, low-ferrous tailings, with a specific gravity of 3.94. Soil type 2 refers to a fine brownish, moderately ferrous tailings, with specific gravity is equal to 4.55. Soil type 3 is a coarse-grained

black iron-rich tailing, with the highest specific gravity of 5.00. The distinct particle densities are related to the initial stages of the tailing depositions, when the process of extracting iron ore from the rocks coming from the mine was less efficient. The percentage of iron is much higher in the dark tailings, produced in the first rising phases of the dam, than in the red, corresponding to more recent operations.

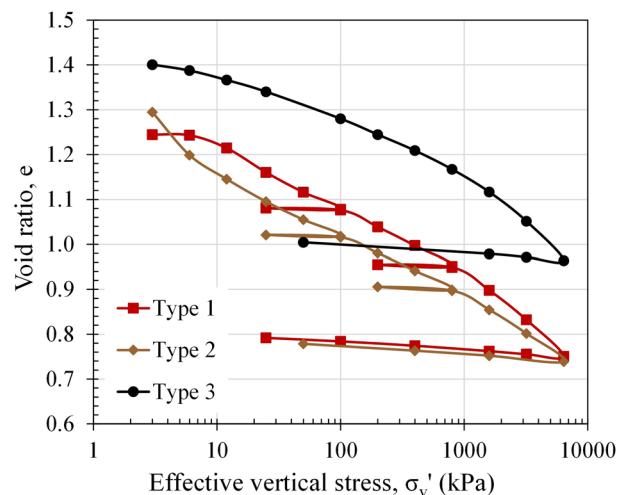
**Figure 6.** Oedometric compressibility curves for the three different tailings.

Several oedometer consolidation tests were performed to assess the compressibility of the three types of tailings identified in the previous section. The testing process followed the international standard ISO 17892-5 (ISO, 2017). These tests were carried out on remoulded samples using the moist tamping technique, ensuring a loose soil state condition. In-situ void ratios were derived from the analysis of several CPTu tests carried out at different locations and undisturbed block samples tested in the laboratory in this study. Comparisons, prior to the dam failure, between initial void ratios of samples collected during the deposition stages presented systematically dilatant behaviour when tested in the laboratory. These contradict the high values of state parameters derived from CPT and CPTU tests, pointing to contractive behaviour. Knowing that critical state locus is reached independently of the initial void ratio and that it is more clearly reached in triaxial tests from the loosest possible state conditions (Viana da Fonseca et al., 2021), the preparation of the specimens was done with the utmost care to obtain higher values than those referred above determined after the failure for this study. After preparing the samples, these were placed in the oedometer cells and submerged in distilled water for a minimum period of 12 hours, to ensure nearly full saturation of the soil. Subsequently, the samples were subjected to a series of loading and unloading stages to establish the compressibility parameters of the three types of tailings, as illustrated in Figure 6.

In view of these oedometer test results, it was observed that the three types of tailings exhibited a slope change on the compressibility curve for effective vertical stresses ( $\sigma'_v$ ) above 3200 kPa. This finding evidences the evolutive nature of these soils, caused mainly by particle breakage (or crushing) or by changes in the shape of particles at higher stresses. On the other hand, no transitional behaviour was observed in these materials, since tests performed at different initial void ratios converged to the same 1D compressibility line (results not shown here, further details in Annex 1 of the CIMNE report).

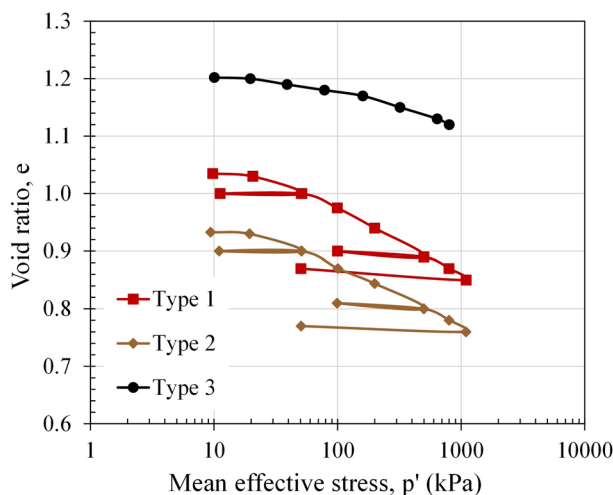
**Figure 7.** Isotropic compressibility curves for the three types of tailings.

of several consolidation stages, with measurement of the volumetric change over time. Since the triaxial cells used for these tests were equipped with bender elements (BE), seismic shear wave velocities,  $V_s$ , were measured to estimate the variation of the small-strain stiffness at each consolidation stage, according to the methodology proposed by Viana da Fonseca et al. (2009) and Ferreira et al. (2021). In addition, seismic compressional wave velocities,  $V_p$ , were measured to assess the saturation conditions, complementing the verification by Skempton's B parameter, as recommended by Viana da Fonseca et al. (2021). Figure 7 shows the isotropic compressibility curves in the  $e - \log p'$  plane, for the three different tailings.

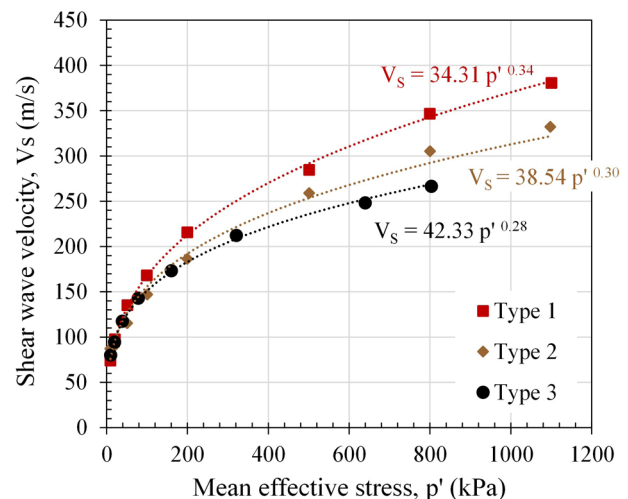
**Figure 8.** Evolution of shear wave velocities as a function of mean effective stress for the three types of tailings.

computer for signal acquisition. In these tests, a series of single sinusoidal pulses at different input frequencies was used to excite the transmitter BE, to minimise the uncertainty and subjectivity associated with signal interpretation (Viana da Fonseca et al., 2009). For S-wave measurement, input frequencies ranged from 1 to 10 kHz were used, from which the results in Figure 8 were obtained for the three different tailings.

These results indicate a higher stress-dependency for Type 1, evidenced by the higher stress exponent, which is typically observed in soils with a weaker fabric or inherent structure. Globally, it can be observed that the denser soils exhibit a lower stress-dependency. Further analyses of this behaviour are currently being performed as complementary studies.

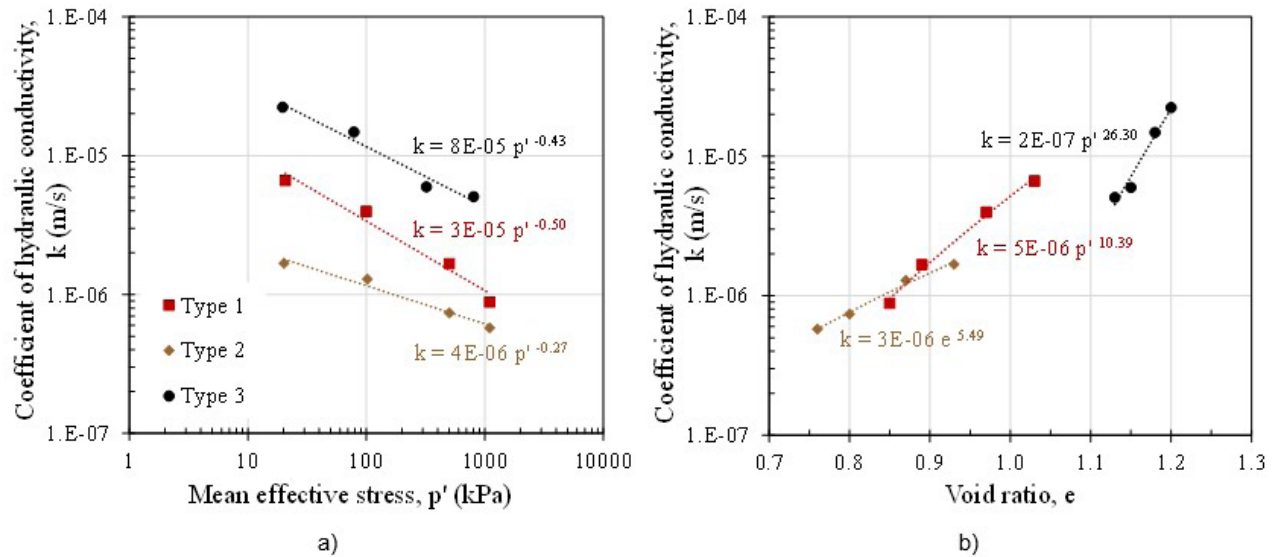
**Figure 9.** Variation of the coefficient of hydraulic conductivity for the three types as a function of: (a) effective stress conditions; (b) void ratio.

coefficient of hydraulic conductivity curves for the three tailings as a function of the effective stresses and void ratio conditions. The void ratios presented in this figure correspond to the estimated values at each loading consolidation stage, in which permeability was measured.

From Figure 9, it can be observed that the three types of tailings have different permeability characteristics, which is a clear indication of distinct soil behaviour. Since the order of magnitude of permeability is correlated with the particle size distribution of the materials, there is an evident correspondence between these parameters and the grading properties of each type of tailings. Based on the differences in permeability coefficients, the selection of the types of tailings to be characterised is validated.

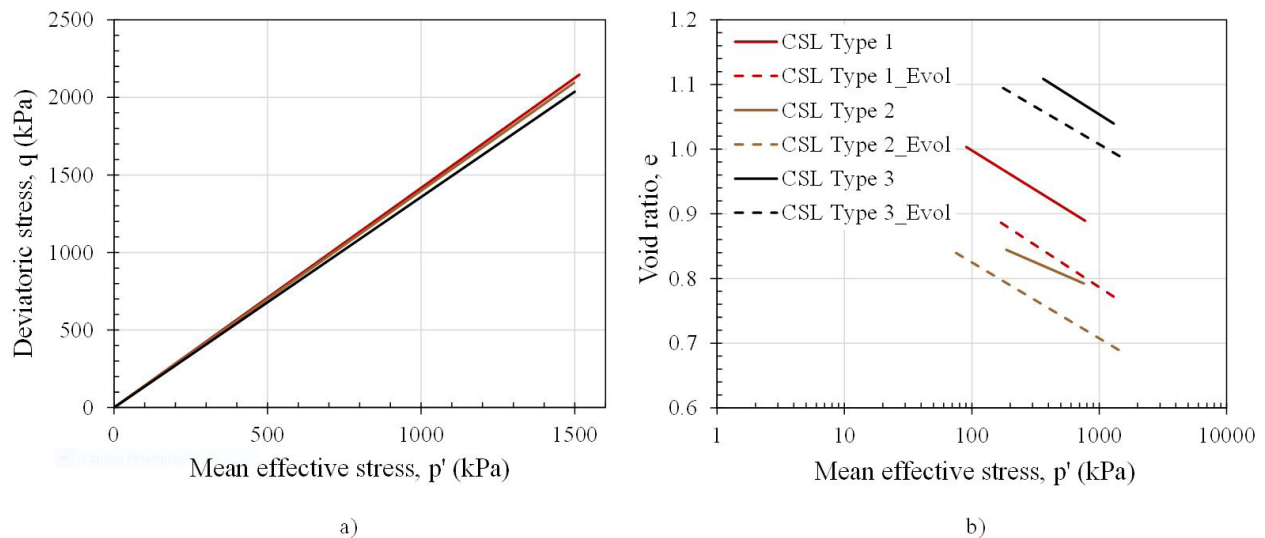
**Figure 11.** CSL of the three types of tailings in natural and evolved conditions in the: (a)  $q - p'$  plot; and (b)  $e - \ln p'$  plane.

the samples were statically compacted in a loading frame. The stress-state paths derived from the dense triaxial tests are also represented in Figure 11. Table 4 presents the peak values of deviatoric and mean effective stresses with its corresponding void ratio.

The evolution in the behaviour of the three types of tailings was only identified in the  $e - \log p'$  plane, thus, only affecting  $\lambda_e$  and  $\Gamma$ , not  $M_c$  (see Table 5). Therefore, two CSL were defined for each type of tailings, one corresponding to

the natural (original) state and another to the evolved state, as shown in Figure 11.

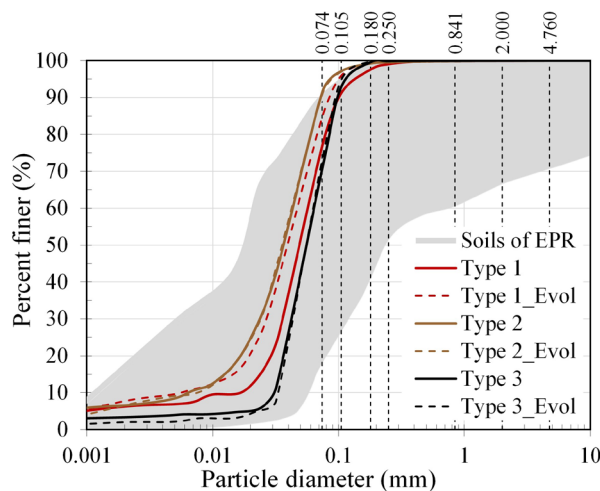
**Figure 12.** Grading curves of the three types of tailings in natural and evolved conditions. Comparison with other soils from Brumadinho dam, according to the Expert Panel Report (EPR) (Robertson et al., 2019).

Given the observed changes in soil behaviour, in terms of the critical state parameters, from tests in natural (remoulded) and evolved (reused soil after testing), a series of particle size distribution analyses was performed to assess the effect of crushing (or particle breakage) and the consequent generation of fines, as a result of CSL tests. Figure 12 illustrates the grading evolution of the three types of tailings.

From these results, the evolution of the behaviour in the Type 1 tailing can be attributed to the breakage of particles, which increased the fines content of the sample and consequently the compressibility of this material. However, no significant crushing was observed in Type 2 and Type 3 tailings. Changes in the morphology of the particles can also trigger the evolution of the behaviour of the material (Cho et al., 2006; Yang & Luo, 2015).

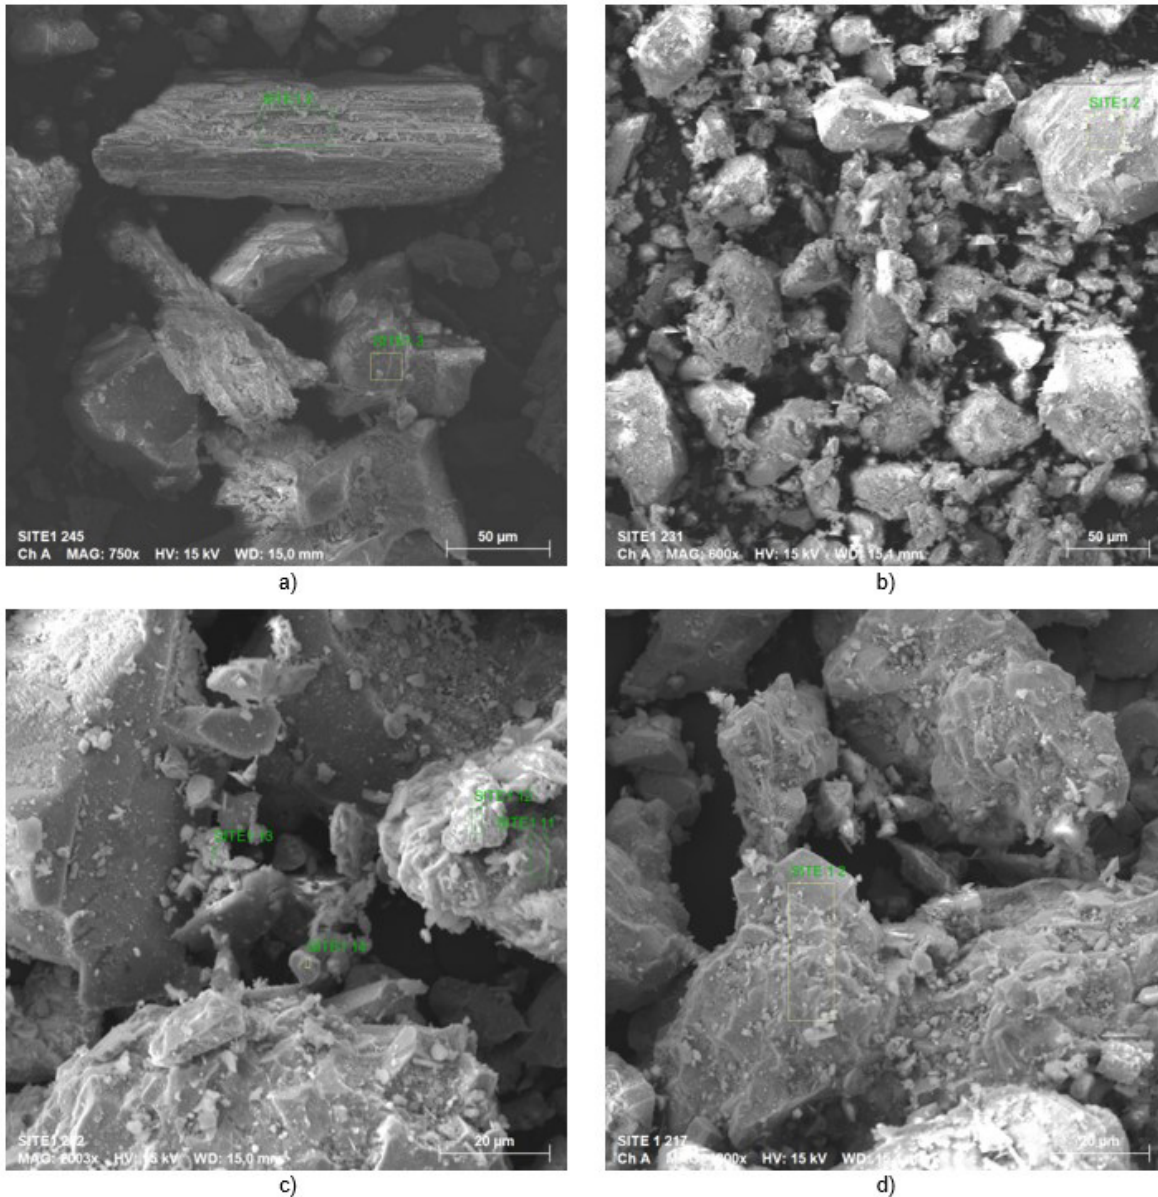
**Figure 13.** SEM images: Type 1 (a) natural; (b) evolved; Type 3 (c) natural; (d) evolved.

The assessment of the changes in particle morphology can be made by the careful observation of microscopic images of the soil in natural (intact) and evolved (after testing) conditions and by the identification of morphology parameters, such as sphericity, convexity, roughness and aspect ratio. For this purpose, scanning electron microscopy (SEM) photographs of the three types of tailings, in natural and evolved conditions, were taken and compared to observe changes in the morphology of the particles. As an example, SEM photos of natural and evolved samples of Types 1 and 3 are shown in Figure 13.

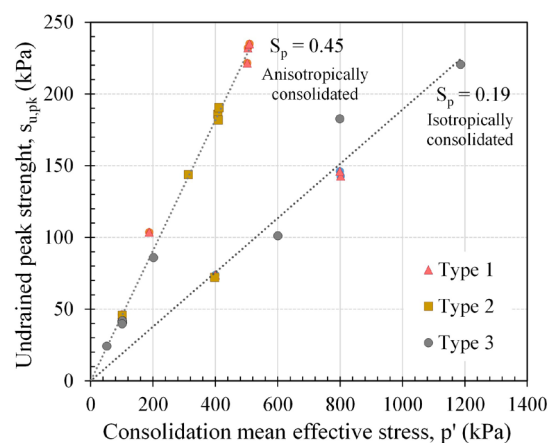
Figure 15. Relation between peak undrained strength and pre-shear consolidation stresses.

Figure 15 shows the relationships between the undrained peak strength and the consolidation mean effective stress derived from the undrained triaxial compression tests that exhibit instability mechanisms. The undrained isotropic consolidated tests presented in the CSL section were also added for comparison. The interesting aspect is that the normalised undrained strength ratio did not depend on the type and condition of the soil but on the consolidation path, presenting much larger values of  $S_p$  for anisotropic consolidation than for isotropic. The underlying reason is that soil fabric is strain-path dependent (Fourie & Tshabalala, 2005).  $S_p$  is dependent on the fabric associated with anisotropy and particle orientation.

The figure clearly shows that the undrained peak strength ratio towards mean effective stress  $[(q/p'_p)]$  when starting from isotropic consolidation stresses ( $K = \sigma'_{ht}/\sigma'_{vt} = 1$ ) is considerably lower, about half, that at anisotropic consolidation stresses ( $K_0 = \sigma'_{ho}/\sigma'_{vo}$ , in this case assumed equal to 0.5). Thus, the at rest consolidation condition, assumed representative, should be considered for the modelling of TSF since the maximum undrained strength, which indicates the onset of soil instability,

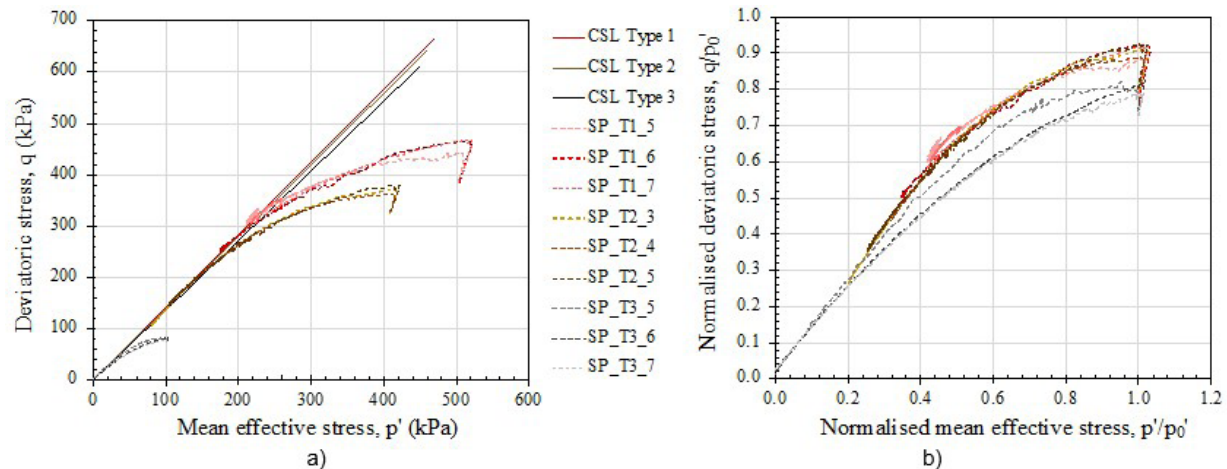
**Figure 16.** Assessment of stress-strain dependency on the different tailing types.
