Performance of In-Line Sediment Control Devices Under Field Conditions

C.P. Cavalhieri, S.J.A.M. Campos, A.L.C.F. Gallardo, O.Y. Bitar

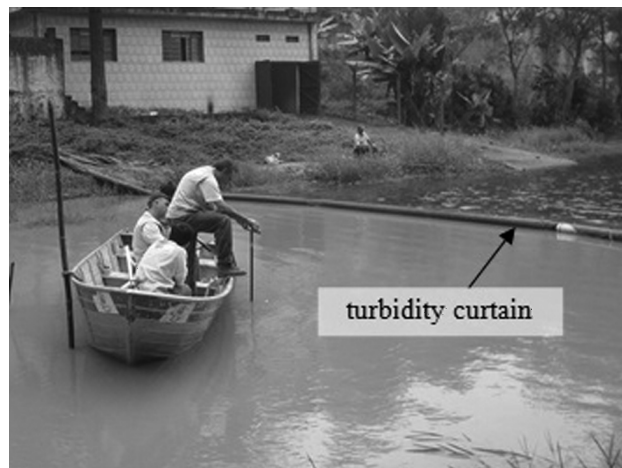
Figure 3 - Sediment sample being collected upstream of a turbidity curtain (3rd BMP at drainage exit # 6) during the monitoring activities.

The performance of each device was assessed by inspecting the construction site after heavy rains and considering two aspects: visible changes in the apparent color of the water and the accumulation of sediments. Particularly in relation to sediment accumulation, those caused by the presence of a silt fence were identified essentially by means of visual inspections at the construction site. Accumulations related to the existence of turbidity curtains were recognized by means of sediment samples collected by the end of the construction activities from the bottom of the reservoirs, upstream and downstream of this type of barrier (Fig. 3).

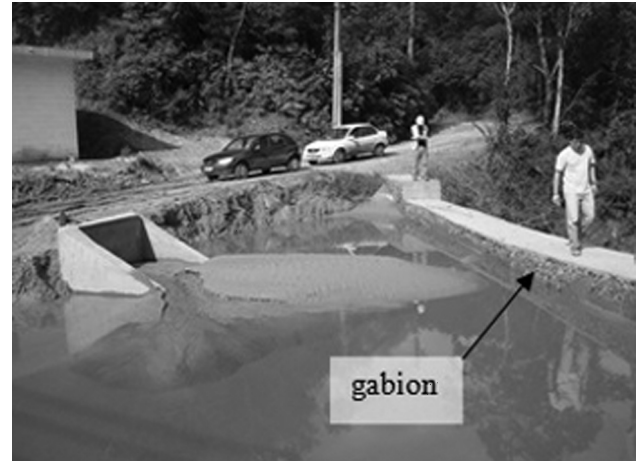
Figure 6 - Material accumulated behind the gabion (1st BMP) at drainage exit # 4, almost overtopping it.

Sediment accumulated behind (upstream) and in front of (downstream) gabions, silt fences and turbidity curtains. In general, material accumulated behind gabions had a larger equivalent diameter in comparison to those found near silt fences and turbidity curtains. In addition, gabions and silt fences that were not properly kept in good conditions were damaged by material overtopping them (Figs. 6 and 7).

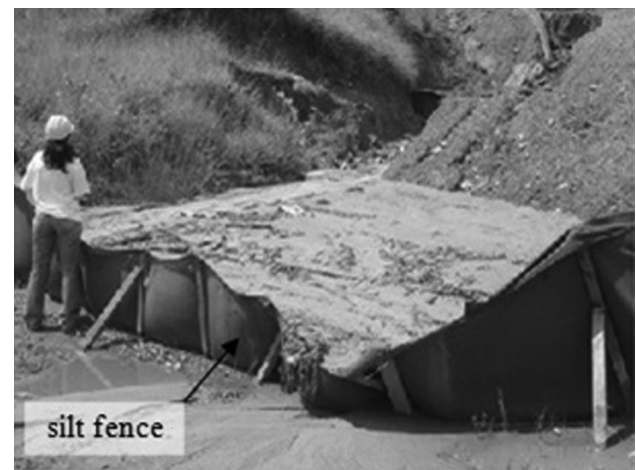
Figure 7 - Silt fence damaged due to the excess of sediment and the unsatisfactory maintenance (2nd BMP at drainage exit # 5).
