## Soil nailing stabilization of a failed hillside in Belo Horizonte (MG): modelling, design and execution

Case Study

Facing the advantage of this solution and its novelty, this work aims to present the design phases of a soil nailing project as an alternative retaining structure for the recovery and stabilization of the failed slope in the 'Buritis' neighborhood located in Belo Horizonte-MG.

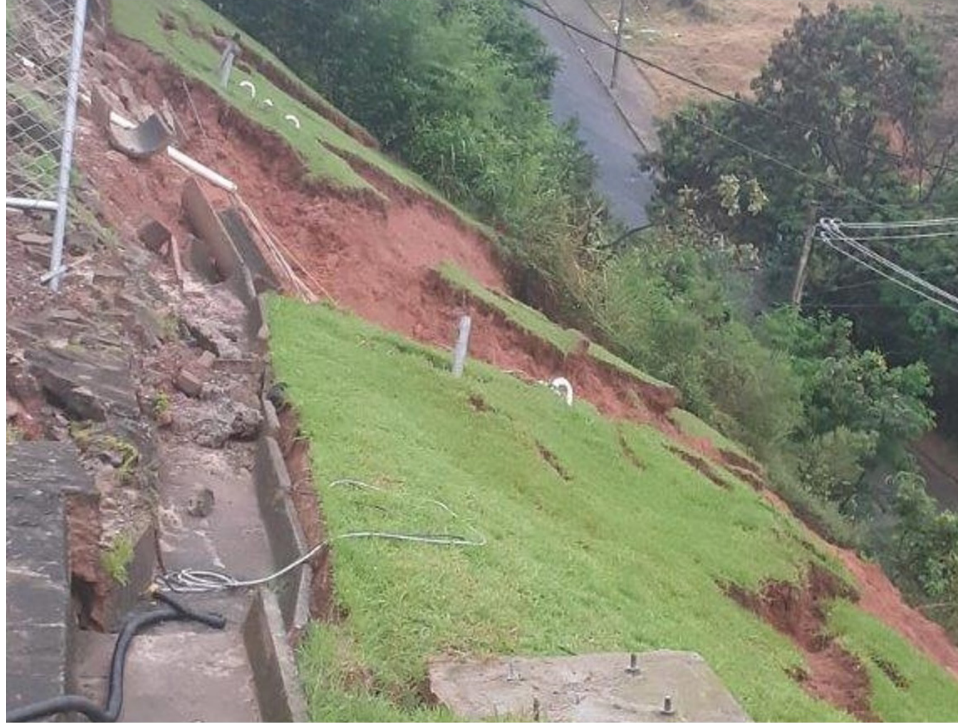
**Figure 2.** Soil Cracks in the surface indicating the initiation of mass movement.

In this area, at late January 2020, probably due to intense rainfall, the initiation of slope movement was observed (Figure 2), which developed to a mass movement in the following days. The rainy period between December 2019 and January 2020 was very intense, as shown by the rainfall records of Belo Horizonte (Figure 3). The most critical weeks of rainfall in the city occurred from 13/01/2020 to 15/02/2020 – the period that the slope came to failure and pathologies developed.

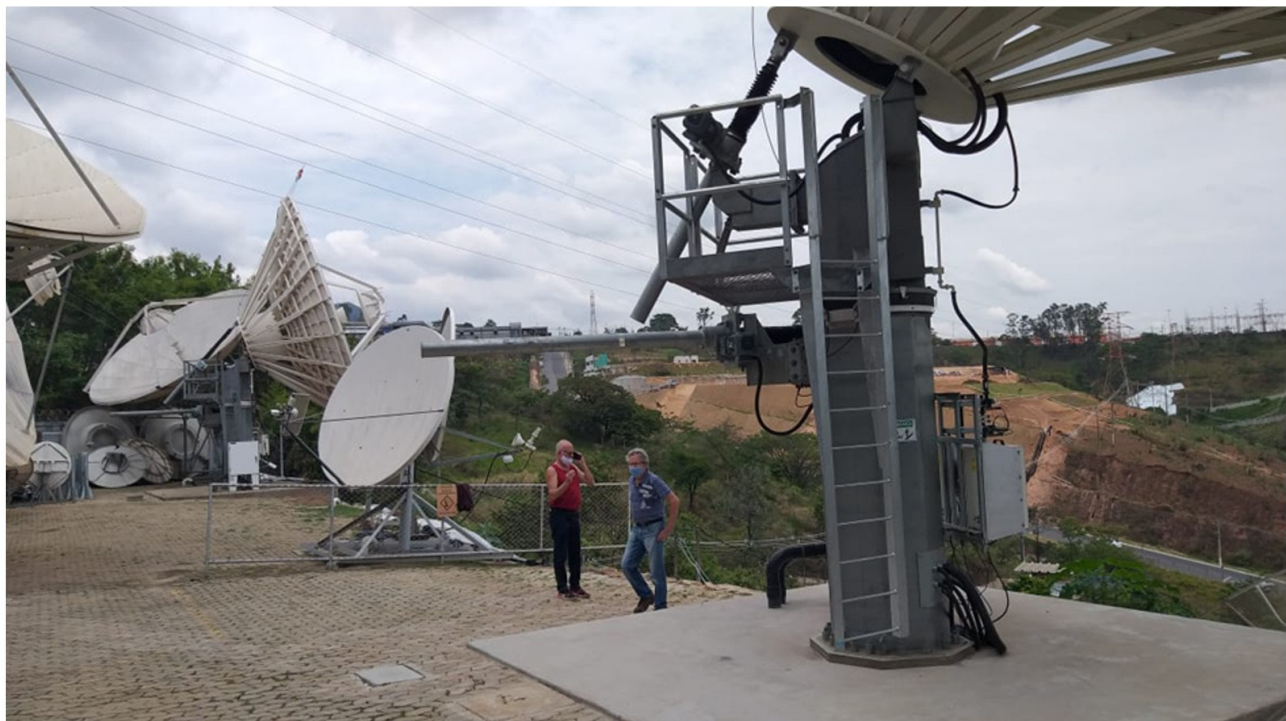
**Figure 5.** Overview of the antennas situated at the top of the failed slope.

Based on the technical investigations conducted, it was determined that the primary cause of this displacement was the sliding of the mass face, attributed to intense rainfall during the period. Initially, this instability was localized, resulting in a loss of confinement in preceding sections of the slope. This led to a widespread state of instability, triggering subsequent mass movements. The complete sequence is depicted in Figure 4, while Figure 5 provides a top view of the slope.

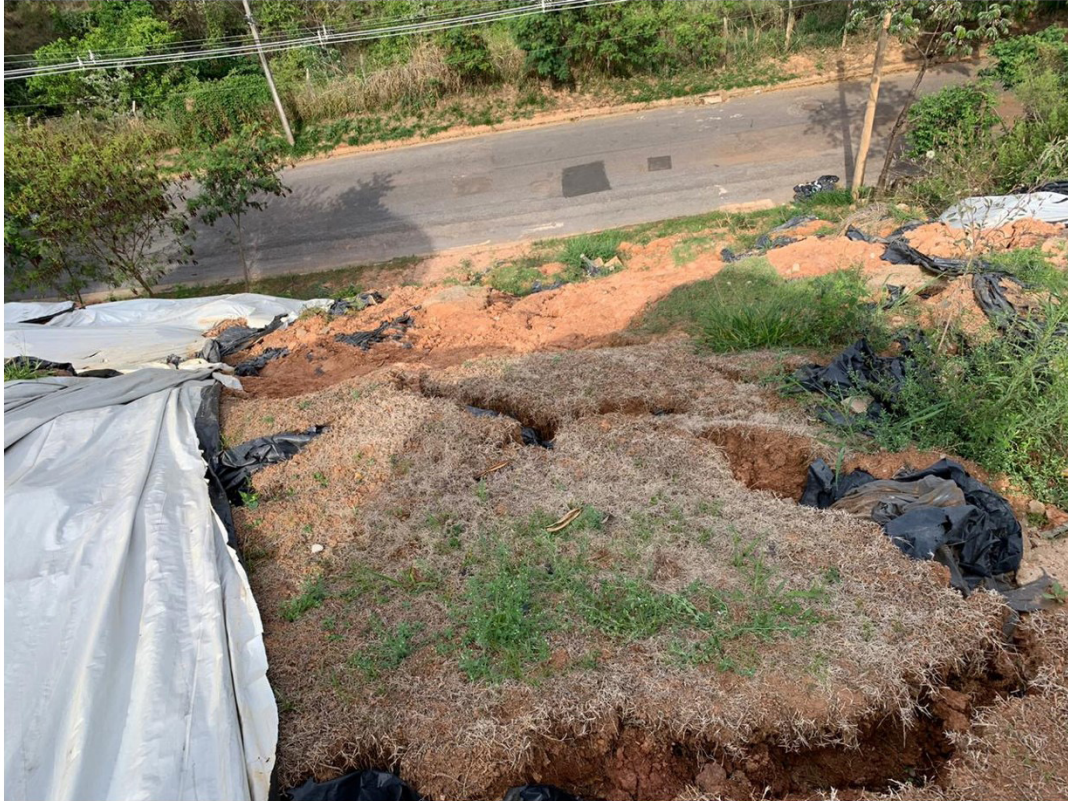
**Figure 6.** Erosion gullies identification alongside the slope surface.

The cracks observed on the slope are a direct consequence of erosion, and it is imperative to conduct a comprehensive mapping of these cracks prior to commencing any excavation work. It has been noted that a substantial portion of the slopes exhibits pronounced erosive grooves (Figure 6).

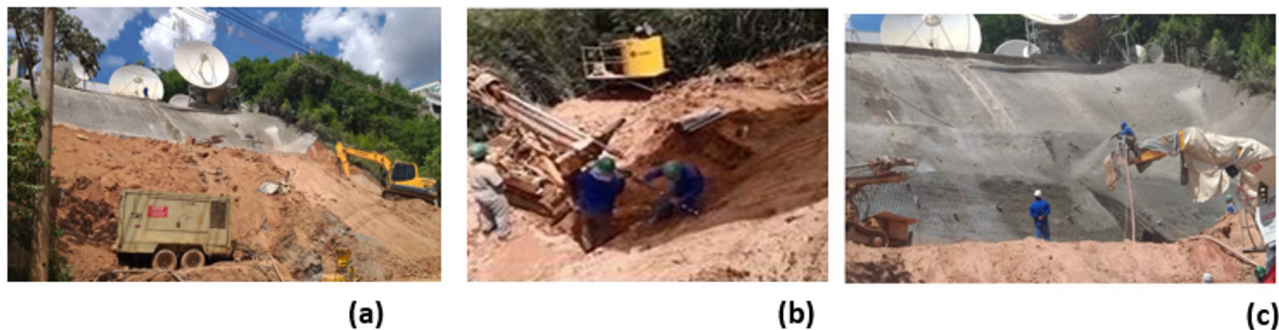
**Figure 14.** Phases of soil nailing execution: (a) partial Excavation; (b) Drill nail hole; (c) execution of permanent cover (including shotcrete, bearing plate and washer).

The facing of the Soil nailing was constructed using shotcrete with a thickness of 12 cm, reinforced with double

ribbed welded wire mesh with Q238 (inner side) and Q196 (outer side) wire diameters. Initially, a plate and nut connection between the anchors and the facing was planned, but during execution, this approach was changed to a simple connection by bending the anchor bar. Figure 14 shows the execution steps of the work.

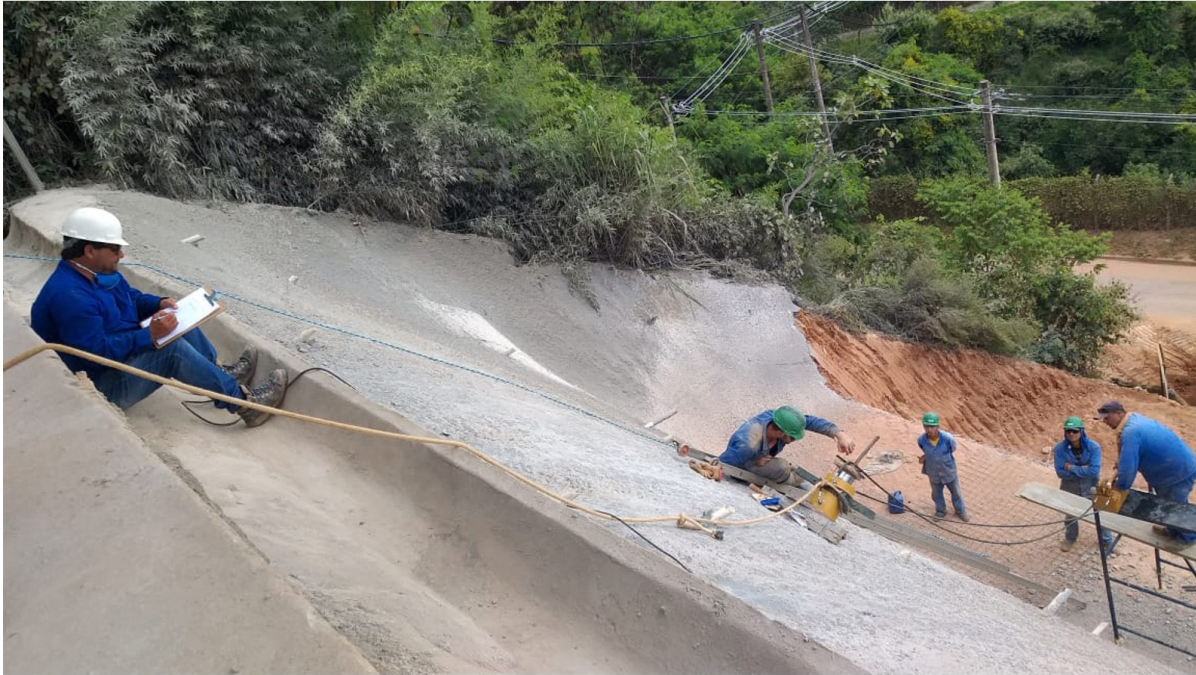
**Figure 15.** Performance of nailing's tensile test.

The filling of the hole with binding material was done in an ascending manner. In other words, an auxiliary tube was inserted to the bottom of the borehole, and then the binding material was pumped until it overflowed from the borehole. Pumping was continued until the overflowed binding material was visually free of drilling residues. Filling the sheath was mandatory for all anchors, and pull-out tests were performed. The pull-out tests were conducted satisfactorily, following all the precautions and assumptions established by the standard (Figure 15). The tests were performed according to NBR 16920-2 (ABNT, 2021).

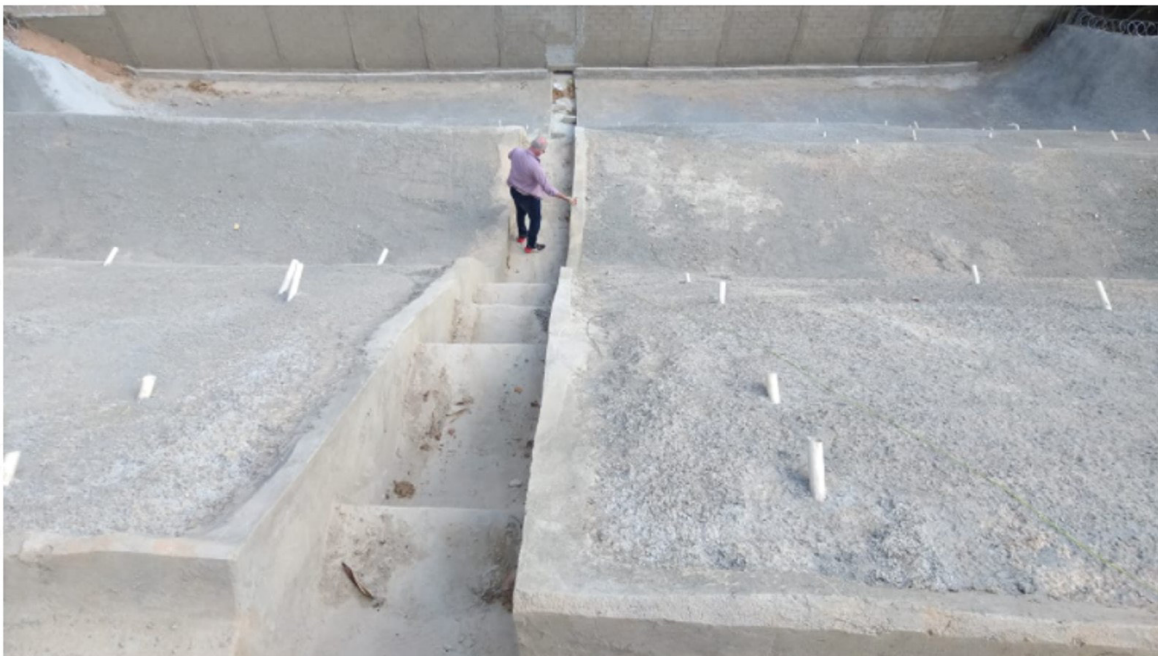
**Figure 16.** Completion of drain system.

with the surrounding environment, preserving the landscape and the region's aesthetics. They were able to evaluate both technical and aesthetic aspects of the implemented solution (Figures 16, 17 and 18). The work is concluded, as indicated in the figures 16 and 17.

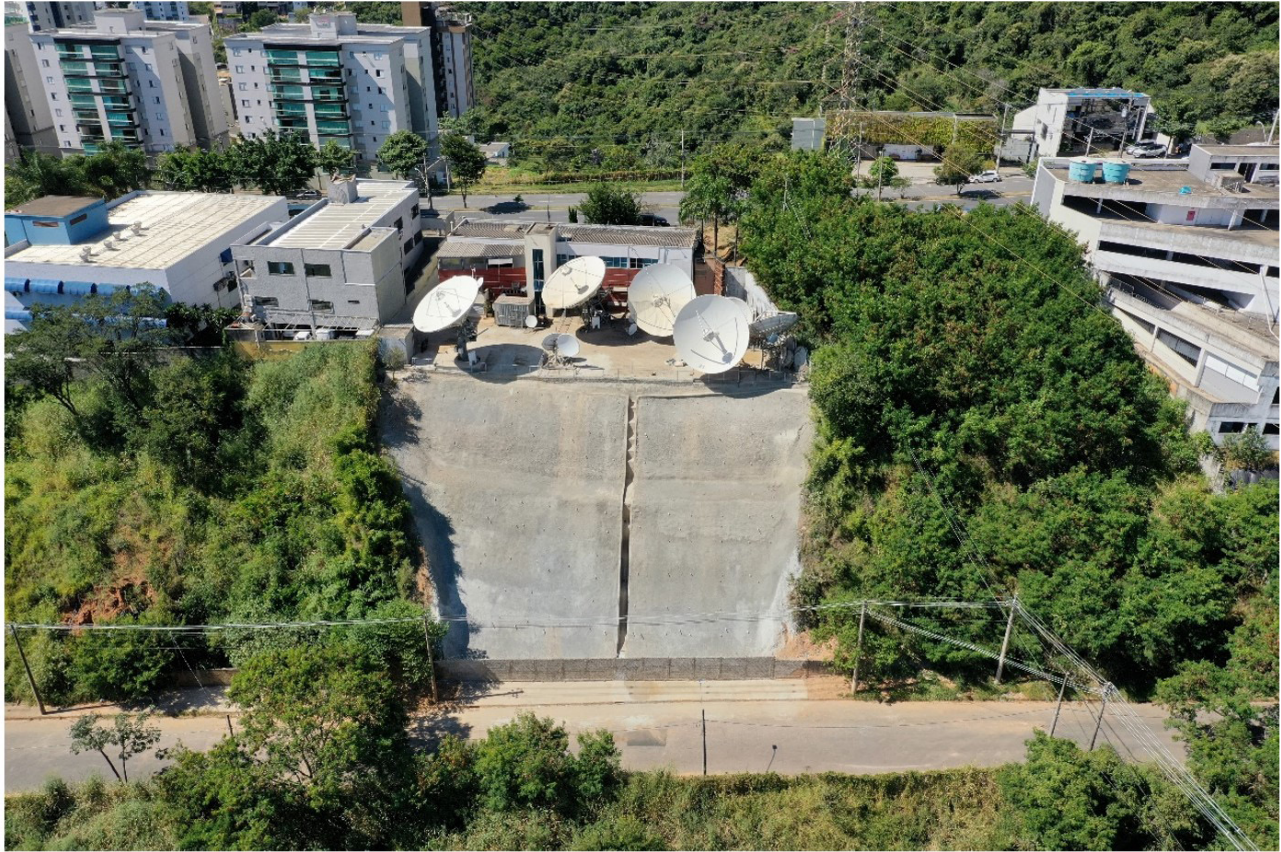
**Figure 17.** Front view of Soil nail technique.

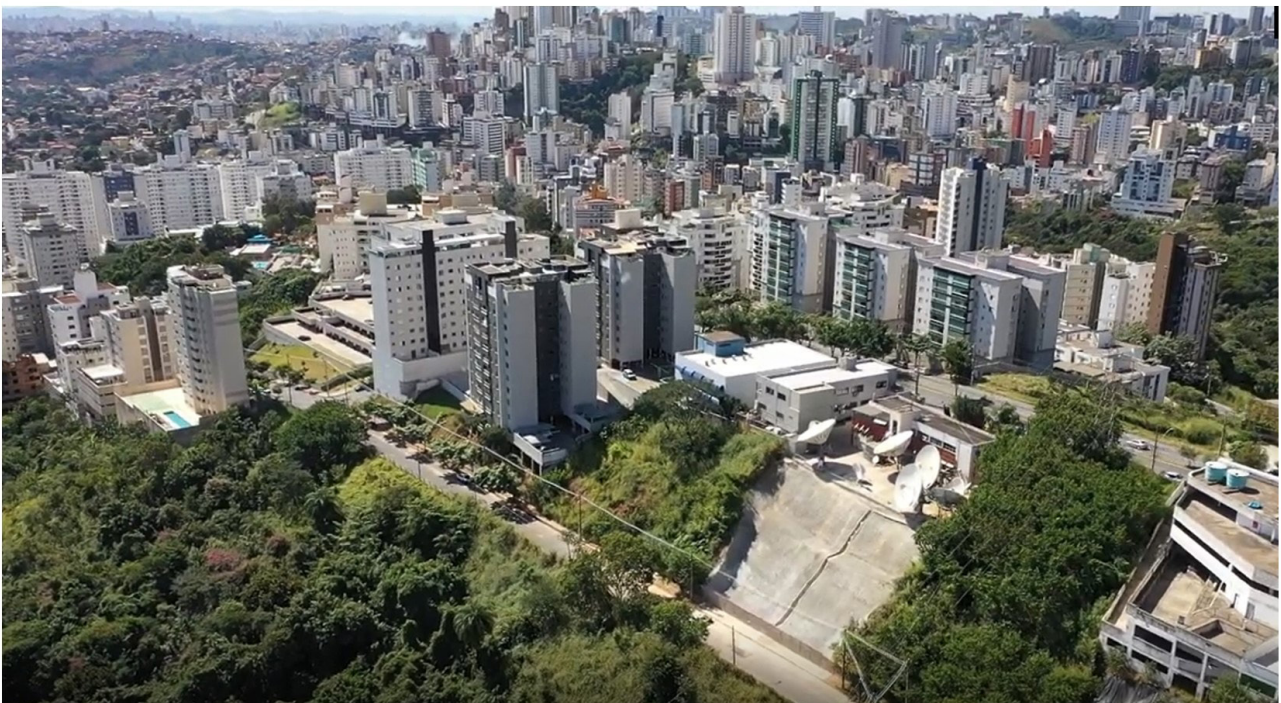
**Figure 18.** General view of soil nail technique and 'Buritis' neighborhood.
