## Gravitational mass movements in Brazil: causes, consequences, and solutions

**Review Article**

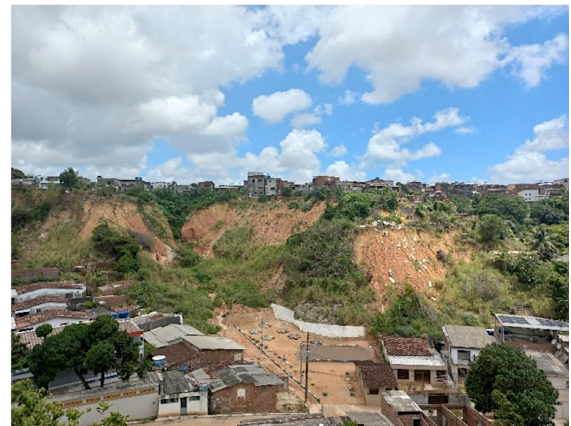
**Figure 15.** Illustrative image of the landslide that occurred on 05/28/2022 on Alto Santa Isabel Street, Jaboatão dos Guararapes (Coutinho, 2024).

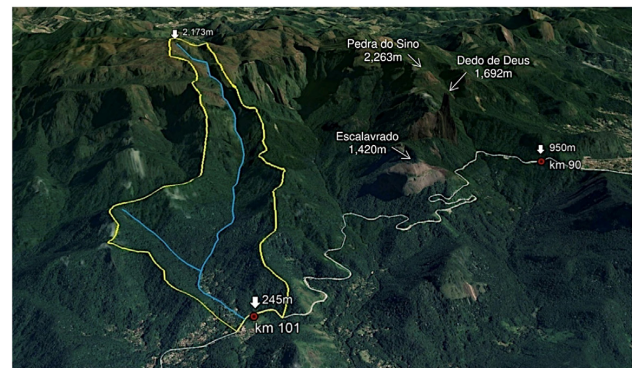
Figure 17. Topography and general view around the study site (BR-116/RJ km 101).

The area features rugged geomorphology, with steep slopes, ridges, and peaks, including the Pedra do Sino at 2263 m in the Serra do Mar. Figure 17 shows the topography and general view around the study site. The drainage basin feeding into the site spans 7.7 km<sup>2</sup>, with a main thalweg extending 7.4 km, and an altitude difference of 1928 m from the basin's highest point to km 101. Geologically, the study area lies at the interface of the Serra dos Orgãos and Santo Aleixo Units. The Serra dos Orgãos Unit consists of tonalitic to granitic rocks, while the Santo Aleixo Unit is made up of granodiorite with amphibolite enclaves and leucogranite intrusions (Figure 18). These formations are part of the Brazilian Orogeny, dating from 630 to 480 Ma.

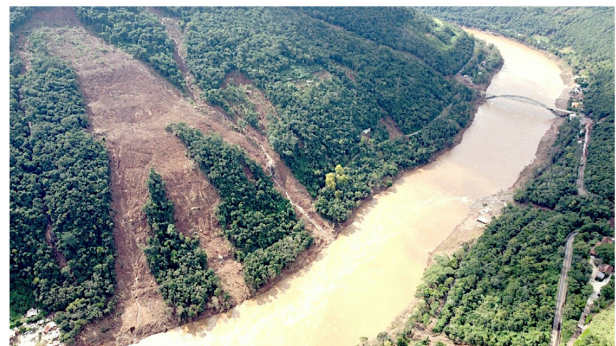
**Figure 43.** Debris flow along the thalweg in the Taquari-Antas Valley, causing the destruction of a restaurant near the BR-470 bridge (2024).

Analyses conducted by Egas et al. (2025) presented a mapping of landslide scars based on both satellite imagery and field surveys, aiming to identify the rupture, transport, and deposition zones. The authors concluded that most of the rupture points were primarily associated with translational landslides (with varying depths) and debris flows. These processes were identified over an area of approximately 63,000 km<sup>2</sup>, equivalent to 22% of the territory of Rio Grande do Sul, resulting in significant social and material losses. Figure 43 illustrates a debris flow that occurred in 2024 along the thalweg in the Taquari-Antas Valley, leading to the destruction of a restaurant near the BR-470 bridge.

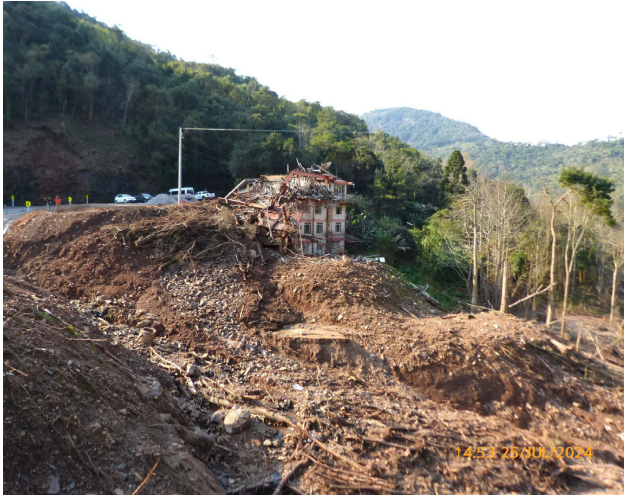
**Figure 44.** Landslide on slopes of Rio das Antas, near the BR470 bridge (Cleber Floriano).
