Lessons learned from dam construction in Patagonia Argentina

Oscar A. Vardé^{1, #}

Lecture

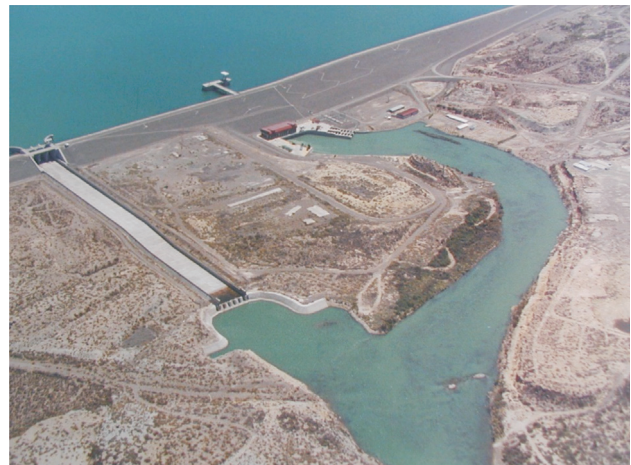
The earth dam has a total length of 11 km, a maximum height of 54 m in the 200 m river Gorge, and an average height of 20 m founded on both banks on the river Terraces. Seven kilometers are on the left bank (partial view in Figure 4).

Figure 4. Casa de Piedra - detail: spillway and powerhouse.

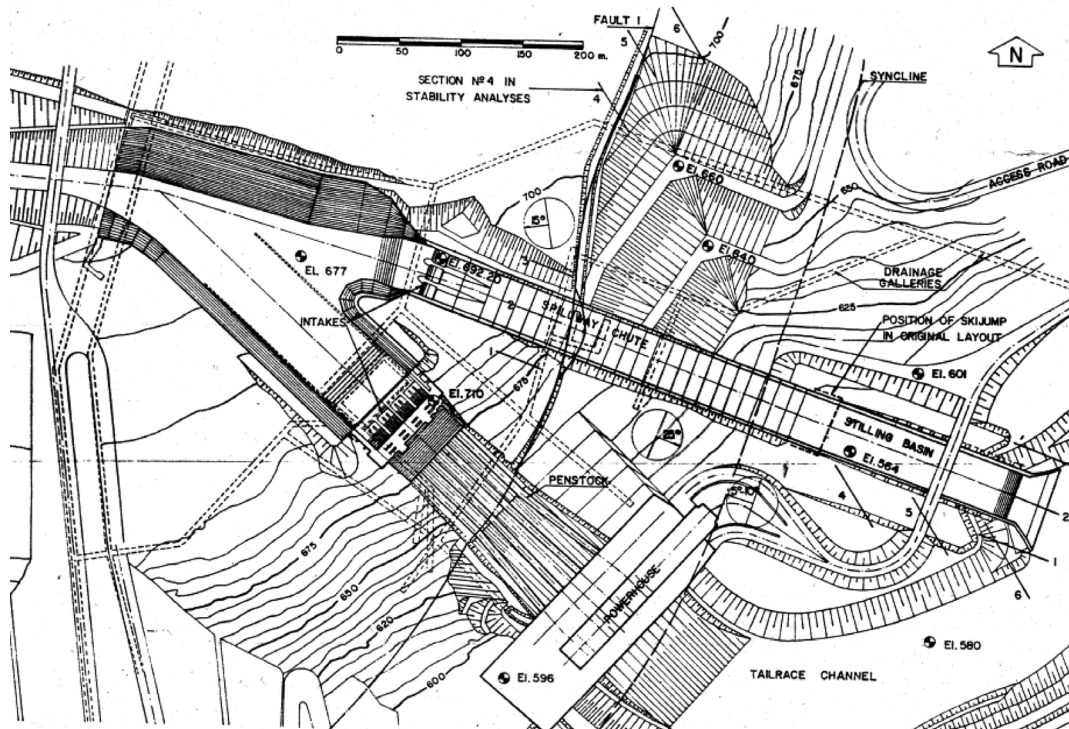
The bedrock of the project area consists of a succession of psammitic (sandstone) and pelitic (mostly mudstone and siltstone, some claystone) rocks of Liassic (Lower Jurassic) age. Planar sedimentary structures do not persist over any considerable distance and individual sandstone or pelitic layers cannot be correlated between drillholes and outcrops, affected by neotectonics movements (Vardé et al., 1986). The bedding interfaces are the dominant structural element in the bedrock, being in general horizontal with some very gentle folding. A major fault, denominated fault 1, running roughly NNE to SSW and dipping steeply SE intersects the penstock trench and spillway chute downslope of the corresponding intake structures (Figure 9 and Figure 10).

At the downhill side of the fault, in the penstock, as well as in the spillway area, the bedding of the rock abruptly changes to a dip of 20 to 38° SE to E, i.e. parallel to the slope (Figure 11). The existence of the zone of inclined bedding on the left bank was not known at the initial design stage, when the investigation was based mainly on geological mapping of outcrops and 8.000 meters of rotary drilling borings size NX. The inclined bedding was subsequently encountered in trench excavations in the area of penstocks

Figure 10. Detail of the left bank.

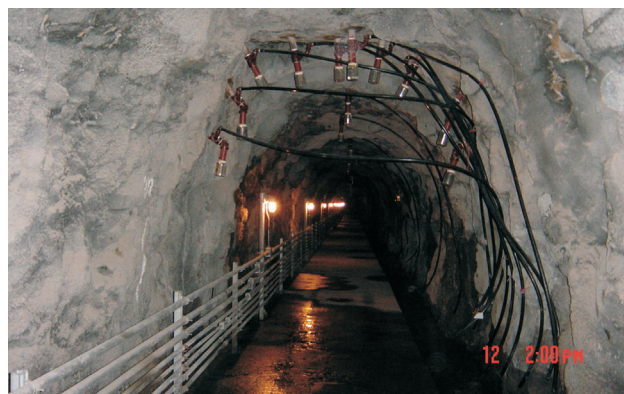
On the left bank, three interceptors fronts of the water coming from the reservoir have been located by means of different galleries located at different levels, 605, 635 and 666. The first two are in the same vertical plane and are connected to each other by means of drains. The last one, at level 666 is 20 m upstream and continues towards the river valley to become an injection gallery below the earth dam, at level 556. Three parallel galleries conformed a second drainage curtain. They were connected to each other with vertical drains and to the previous ones. Those of the upper and lower levels extended parallel to the spillway to the surface of the hillside as a lateral drainage curtain. Two other superimposed galleries in the form of “U”, also connected by vertical drains, were located at heights 635 and 655 in the area of foundation of the intake structure and in correspondence with the sheared pelite layers. The drainage galleries section was rectangular, 2 m wide and 3 m high; the walls and roof were protected with sprayed concrete and have a concrete floor slab with a draining gutter (Figure 14).

Figure 14. Drainage gallery.

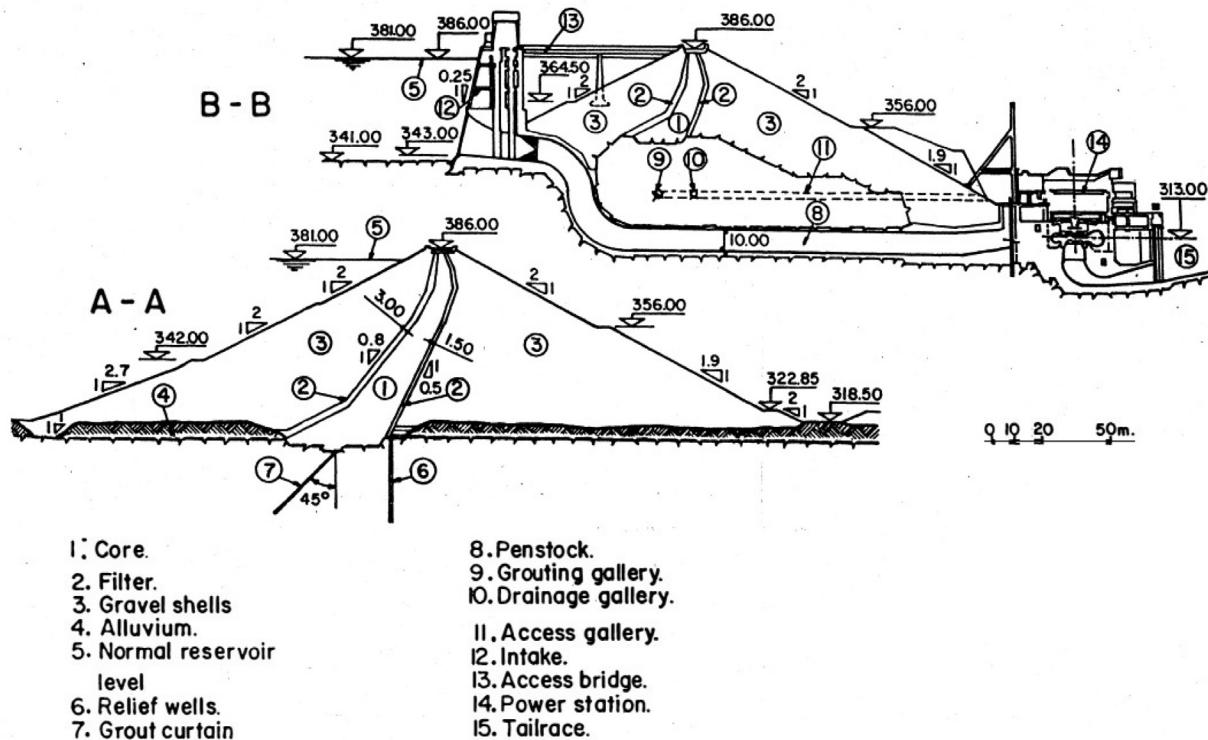
The dam cross section was designed using a thin sloping clay core between sandy gravel shells to reduce the differential settlements between the clay core and the gravel shells and also reducing the risks of horizontal cracking due to arching of the core between the shells. The top 14 m of the core were vertical (Figure 17).

Figure 17. El Chocón dam - cross sections.
