# Grouting of TBM Rock Tunnel for the Pinalito Hydroelectric Plant, Dominican Republic

Marcos Eduardo Hartwig

**Abstract.** The Pinalito main hydroelectric tunnel, with a length of 11 km, is located in Cordillera Central mountain range, Dominican Republic. This mountain tunnel has been mined through extremely fractured andesitic-basaltic and rhyolitic tuffs. These rocks are been subjected to shear and collisional displacements between Caribbean and North America plates since middle Eocene. As a result, geological and hydrogeological conditions along the tunnel alignment are rather complicated. This paper presents the main aspects and results employed in order to overcome an unexpected water bearing incompetent rock zone, approximately eleven meters wide, that cross the tunnel alignment at Sta. 5+237.40. Ground treatment was well succeeded and took six months to be concluded. Procedures adopted took into account three steps, respectively: (1) geological drilling; (2) drainage; and (3) spilling and grouting injections.

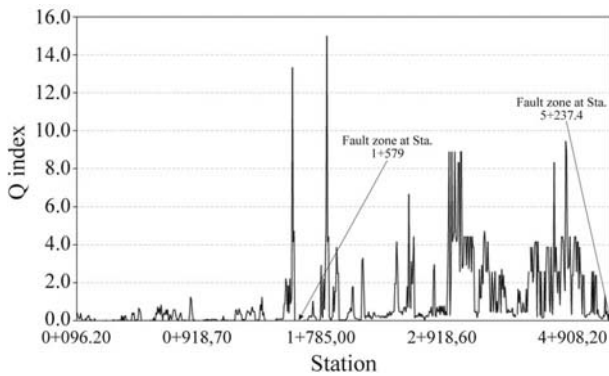
The rock mass geotechnical classification adopted in the Pinalito main hydroelectric tunnel was the Q index (Table 1, Barton *et al.* 1974). Most of the tunnel mined before the fault zone at Sta. 5+237.40 was in rock class III to IV/V, which means, regular to poor rock mechanic quality (Fig. 4).

**Figure 4** - Q index along Pinalito main hydroelectric tunnel, before the fault zone at Sta. 5+237.4.
