The Breach Problems in the Tunnels of the Boston Central Artery/Tunnel Project (Big Dig)

John T. Christian

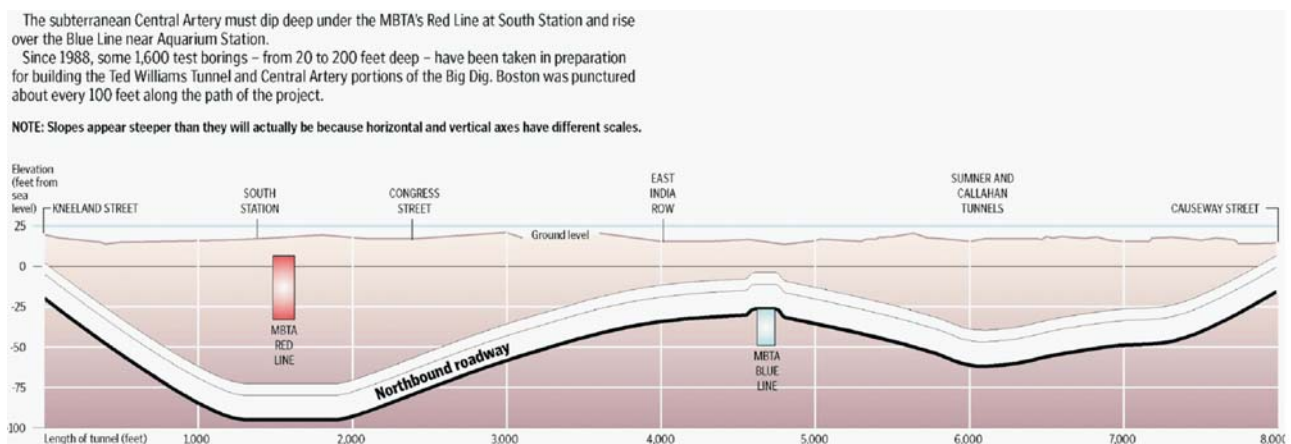
Figure 3 - Elevation along length of I-93 tunnel.

A further complication is that the elevation of the tunnels vary considerably over their lengths. As can be seen in Fig. 3, the I-93 tunnel comes from the south (the left of the figure), drops to its deepest point to pass under the existing

red line metro line, rises nearly to the surface to pass over the blue metro line, drops down again to pass under the access ramps for the existing Sumner and Callahan tunnels across the harbor, and rises to connect to the new Zakim bridge across the Charles river. Thus, a considerable variety of loadings and soil conditions occurs even in this short distance. The section that is the principal subject of this paper is in the deepest part of the project just north of the red line.
