# Evaluation of slope failure through the assessment of meteorological conditions and earthworks management

Rainfall triggered landslide  
Infrastructure damage  
Site restoration  
Numerical analyses

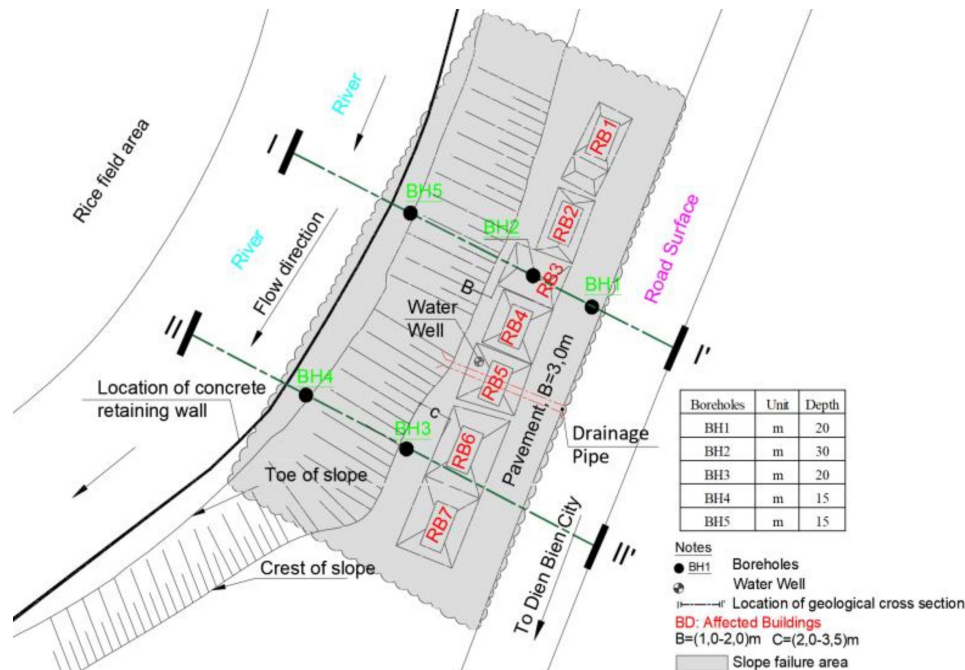
Figure 5. Site investigation cross-sections and boreholes' locations.

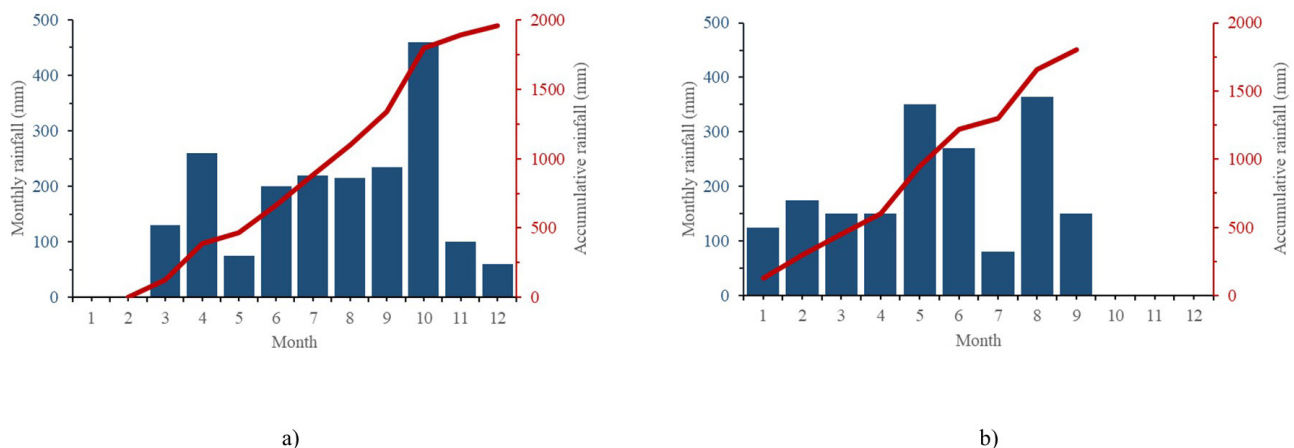
Since the rainfall events in the study were concerned with having a major effect on the failure, the precipitation data were also analyzed. To allow further understanding of the failure cause, the rainfall data was collected from the nearby monitoring station (Na Sang station, 10 km from the study area) and is presented in Figure 7. Important for the study is the accumulative rainfall recorded for October 2021, when 2000 mm of accumulative precipitation was reached.

**Figure 7.** Rainfall data record for particular months a) in 2021 and b) in 2022 in Dien Bien district.

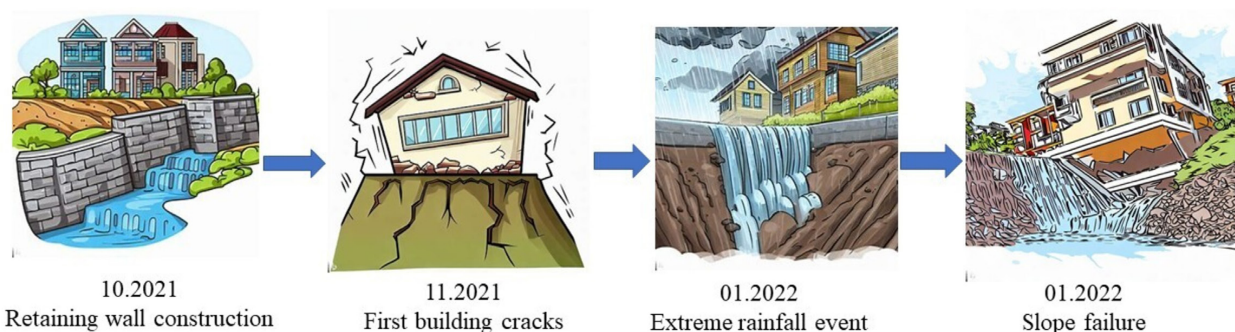
Figure 10. Graphical presentation of the sequence of events leading to a structural failure of residential buildings (AI generated).
