## Malpasset arch dam: an example of major accident caused by the effect of water in a rock foundation

Case Study

Malpasset dam accident is considered as the classical example of the detrimental effects of water in a rock foundation. Technically, it represents a unique case of arch dam collapse induced by the water and the subsequent uplift pressures acting on a very large rock wedge in a fractured rock foundation. At the time of the accident (1950's), such an effect was totally unknown by the dam designers and geologists as well. After a summary of the background and geological context, the investigations and the design (initial and final one) are presented. Then, the chronology of events is reconstructed in detail, including the structural deformation of the arch during the filling of the reservoir and the heavy rainfalls. After all, the collapse is analysed based upon the observation carried out immediately after the accident as well as the post failure investigations that took place during the following years. Despite the total failure of the arch dam, the origin of the accident cannot be attributed to the dam structure itself but solely to the rock foundation. The accident o

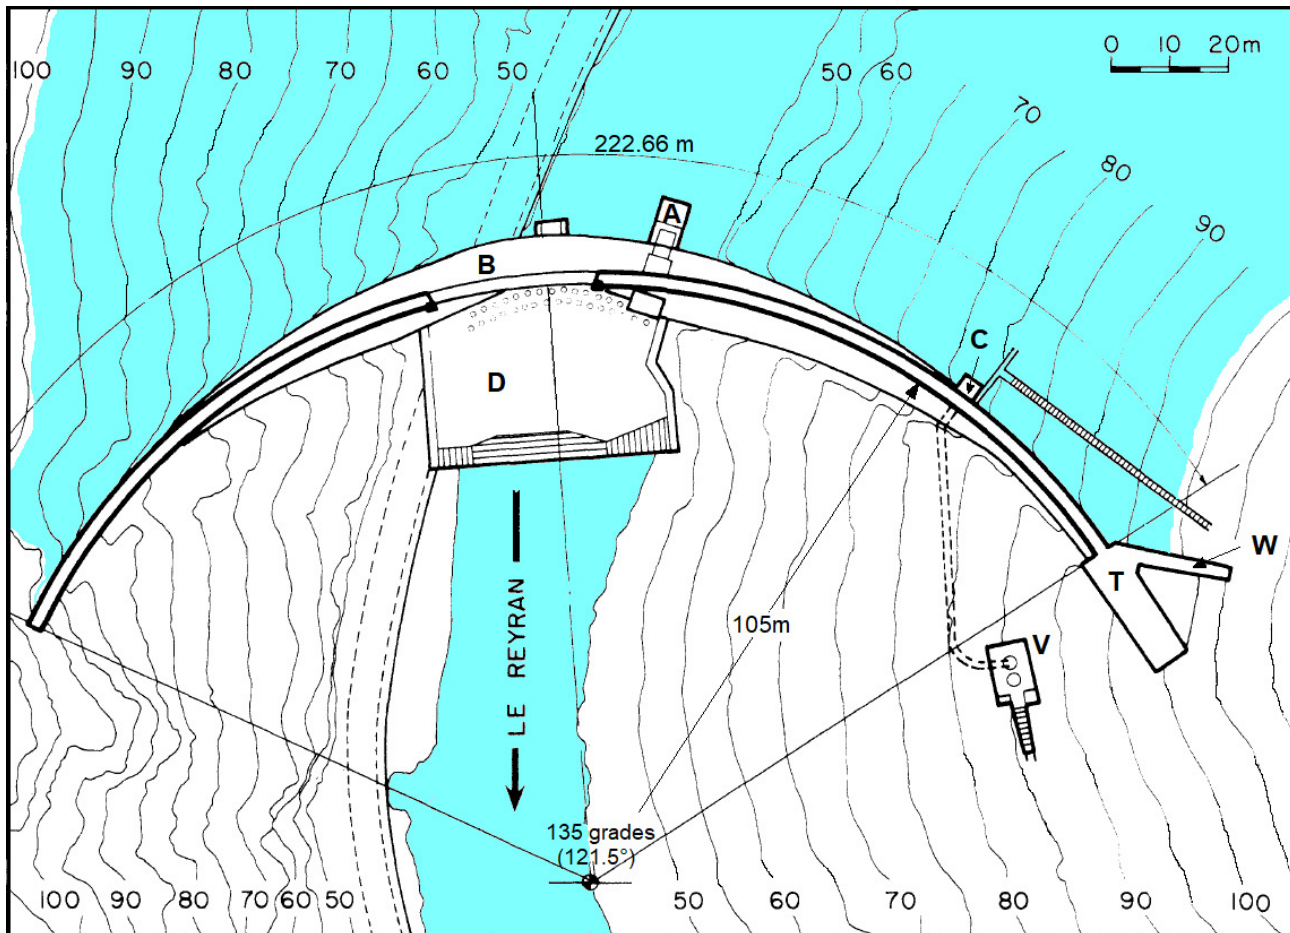
**Figure 1.** Location of the arch dam on the valley slope. Contour lines in m. (A) Bottom valve gate; (B) Surface overflow weir control; (C) Water intake; (D) stilling basing. V = control valve. In the left abutment: a gravity thrust block (T) counteracts the crest arch thrust and is protected from the water thrust by a wing wall (W) perpendicular to the contour lines. Modified from Bellier (1967) and Duffaut (2013a).

The dam was designed as a pure double curvature arch, following the practice in the fifties. The concrete arch structure had a 105.0 m axis radius and a central angle of 135 grades (121.5 degrees) between the two rock abutments on the Reyran river (Figure 1). The maximum thickness of the structure was 7.0 m on the base and 1.5 m on the crest (Figure 2). The right abutment consisted of a massive rock mass. On the left bank, a wingwall was needed due to the site topography of the site (the left bank being smoother than the right steep bank).

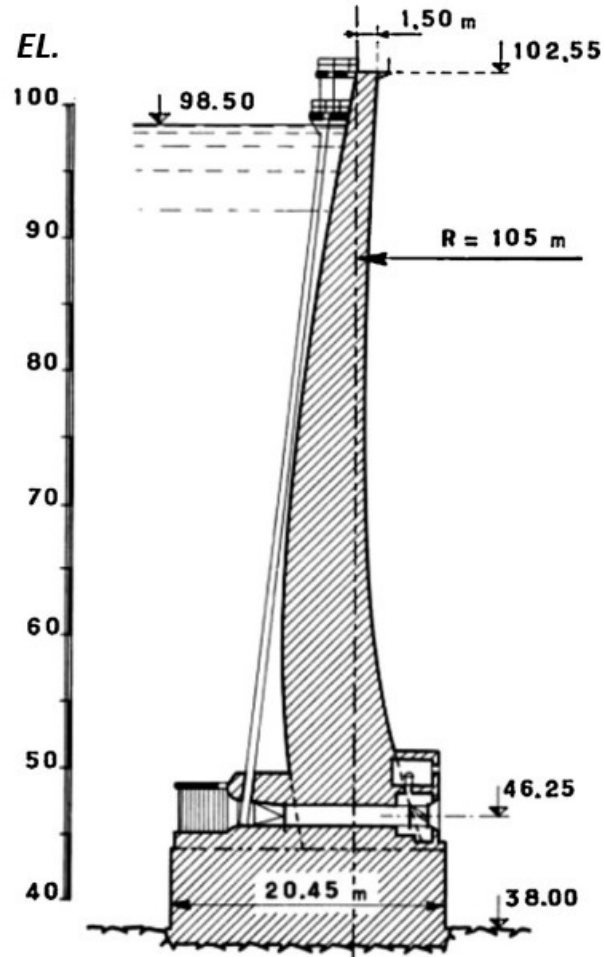
**Figure 2.** Highest dam cross section. The support of the hollow valve and its control gate explains the widened foundation at this place. Crest elevation: 102,55 m; crest length 223.0 m; spillway elevation: 104.40 m; normal operation level: 98.50 m; bedrock level: 38.00 m (Duffaut, 2013a).

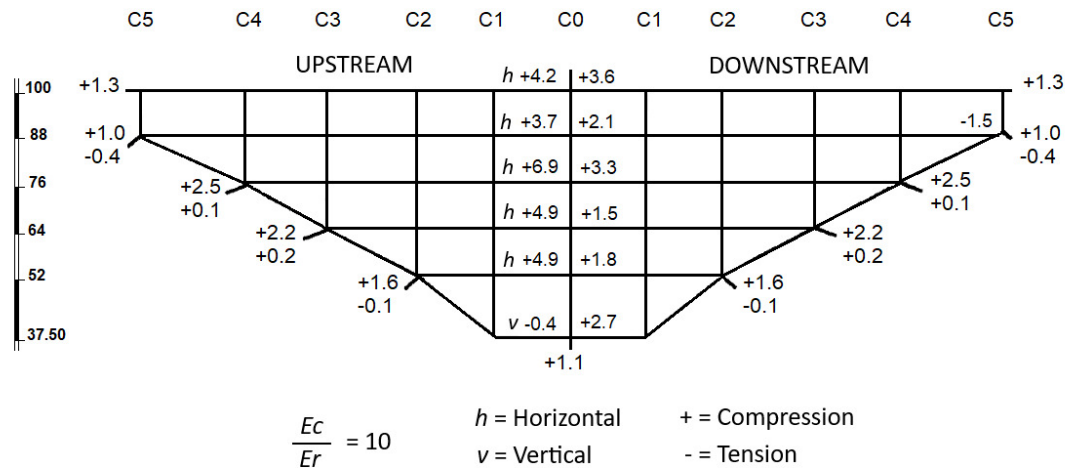
was 32.5 MPa. The average stress at the foundation surface was 2.5 MPa and the maximum local value was 5.0 MPa. For the same rock mass deformability, the thrust of the arch on the left bank abutment was 4800 t providing a high factor of safety against sliding. Figure 3 shows the principal stresses, computed from the trial-load method assuming a simplified symmetrical arch, on the upstream and downstream face of the full reservoir, as usual at that time.

**Figure 3.** Stresses calculated according to the trial-load method. The calculations considered a rock mass ten times more deformable than the concrete and a maximum elevation of 100 m for the reservoir (data from Londe, 1965).

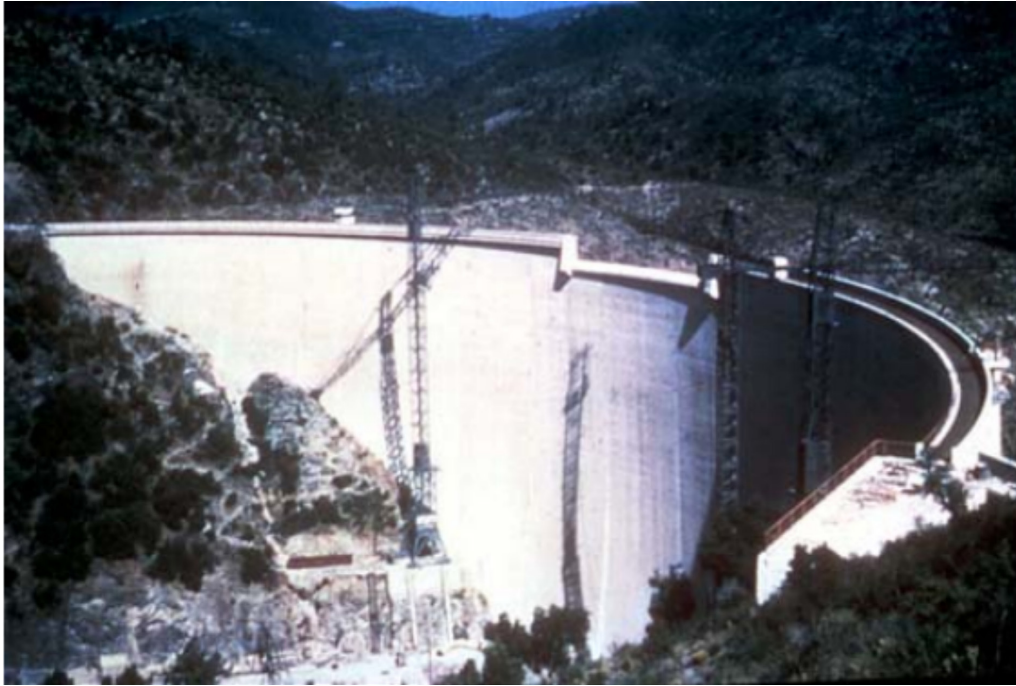
During the 1950's, mostly of the rock masses characteristics were not considered in the design of dam structures. In general, technical reports used to refer only to the "bedrock" (in this case the gneiss), excluding some significant characteristics of the rock masses such as joints, faults, shear zones, intrusion dykes and weathering. After the Malpasset collapse, the design started to integrate the concrete structure of the dams with the properties and behaviour of the rock masses, following the approach developed by Wittke & Leonards (1987) during the analysis of the collapse. A photo of the dam at the end of the construction is shown in Figure 4 (Duffaut, 2011).

**Figure 4.** Photo of Malpasset dam at the end of the construction (photo from Coyne and Bellier, in Duffaut, 2011). The construction started in April 1952 and was completed two years later, in October 1954, say 5 years before the accident.

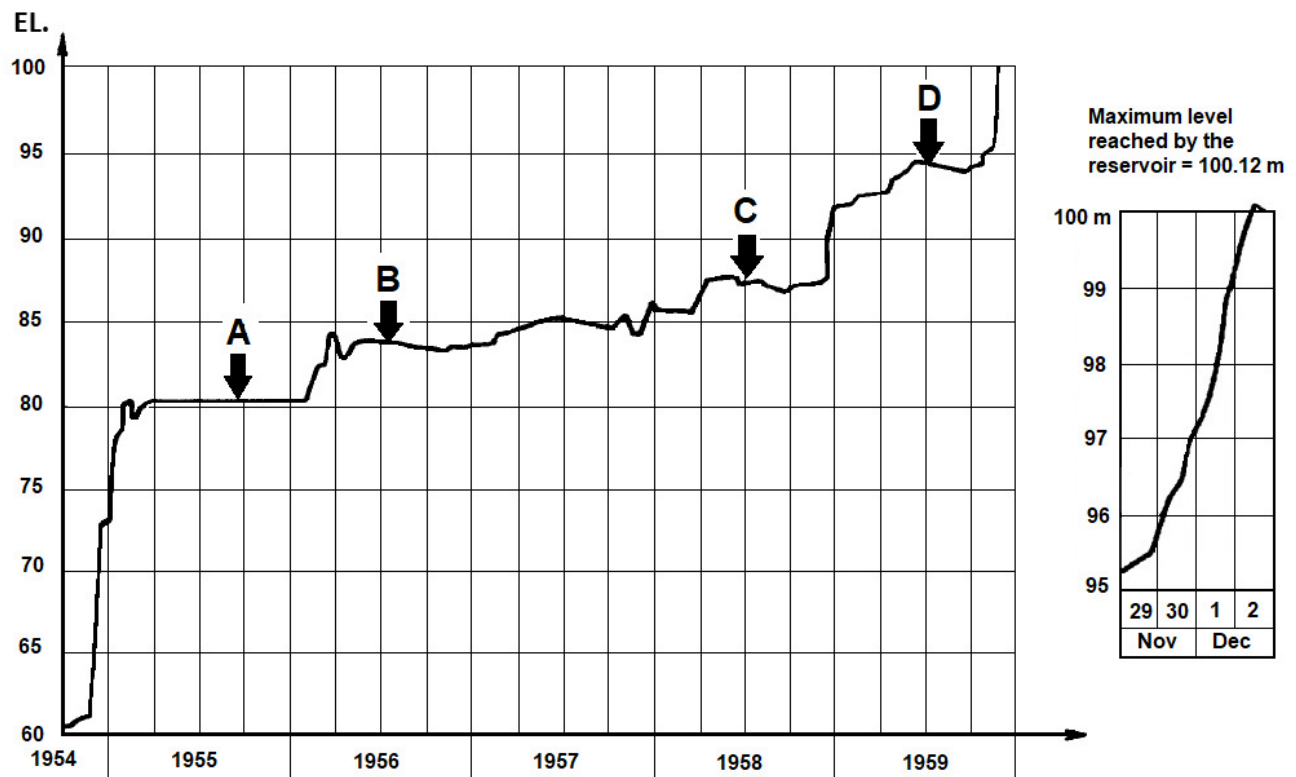
In the middle of November, the reservoir was at EL. 95.20 m, 5.20 m below the maximum level. Some few weeks before cracks have been also observed in a small area in the concrete adjacent to the toe of the dam. At that time, the operator discovered a trickle of clear water at the right abutment about 20 m downstream, at EL. 80 m. On November 28th the water level reached EL. 95.75 m. Due to heavy rains, the level increased to EL. 97 m on November 30th. It was also noted that the seepage had increased. On December 2nd at noon, the level was at EL. 100 m. At 18h00 the outlet valve was opened and a very small lowering was registered an hour and a half later.

**Figure 5.** Graph of the reservoir filling, showing position and dates of the four geodesical measurements (A to D). Readings were registered along 1954-1959. The insert in the right shows the very fast 5 m rising of the reservoir level in just 3 days, before the dam failure. The opening of the bottom gate 3 hours before the catastrophe, allowed a lowering of only 2 cm on the water level (Mary, 1968; Duffaut, 2013b).
