A Short Review on the Importance of Colonnades, Entablatures and “Fault Joints” for the Excavation of Basaltic Rocks

Abstract. Entablatures, colonnades and “fault-joints” have been found in many excavations of dam foundations, tunnels and quarries in basaltic rocks of southern Brazil, but frequently they were not formally identified as such, and the two first, only rarely. This lack of recognition led many times to misunderstanding of their importance to slope stability and foundation problems. This short note reviews their basic definitions and stresses the influence of their properly consideration in the development of geotechnical projects.

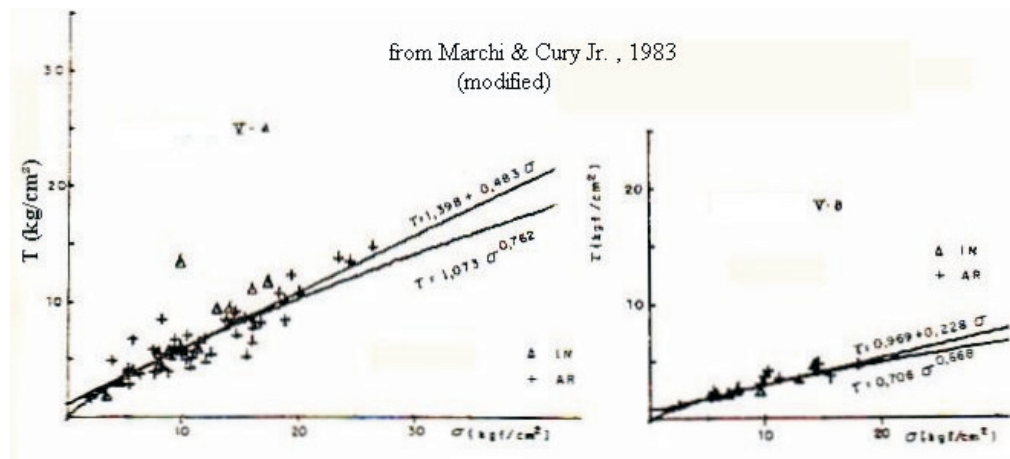
Figure 6 - Mohr Coulomb direct shear strength envelopes for sound and weathered fault joints (IN = intact, AR-after rupture) from Marchi & Cury Jr (1983).

hibiting striations which allowed some tectonic speculations. Their origin has been related to different mechanism such as differential contractions during cooling, stress relief effects or even shallow tectonics. Being relatively permeable, they are frequently percolated and affected by differential weathering. Consequently, the laminated platy rock of the densely jointed zone may be totally or partially weathered. Shear strength properties are usually substantially lower than those of the rest of the rock mass. Mohr-Coulomb strength parameters have been determined, some with the help of “in situ” shear tests, to spread frequently around ~ 0.05 MPa for the cohesion and a ϕ of around 20 to 35° depending on the type of filling or the presence of evidences of pre-shearing (Marchi & Cury Jr., 1983) (Fig. 6). Figures 7 and 8 show their aspect in other dam construction sites.
